Identification of Failing Septic Systems

Final Report

Huron River Watershed Council

10/2/12

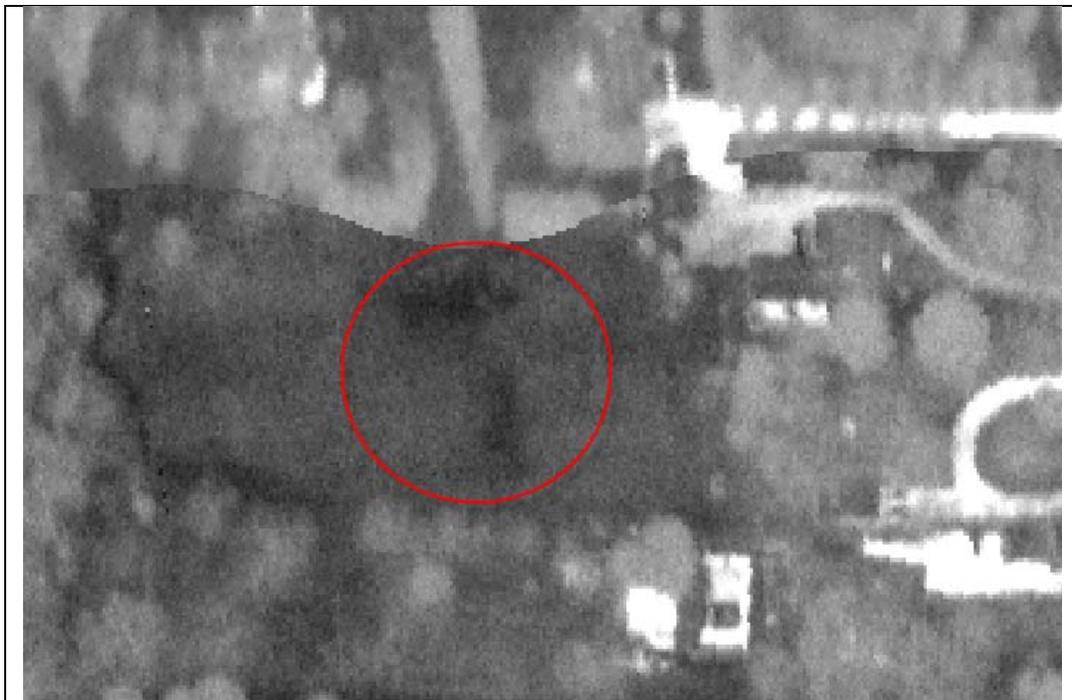
Figure 6: Possible septic signatures for a property in Scio Twp. These areas seem to indicate a lower temperature than the surrounding ground; this is probably an indication of a wetter area, which could indicate failure.

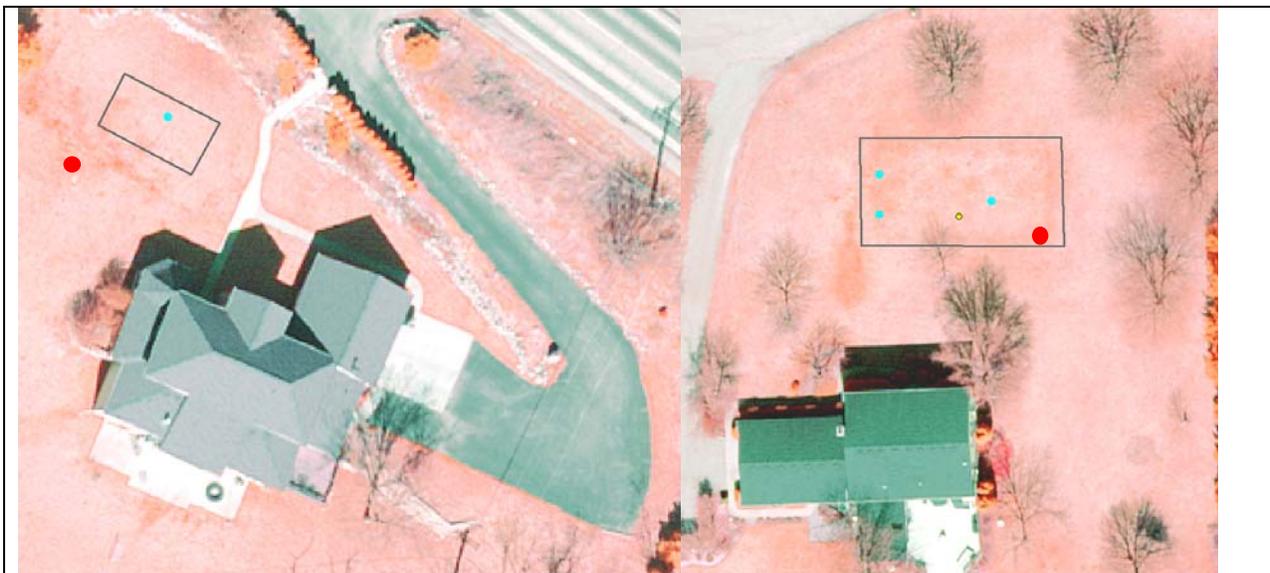
Figure 13a: Property 1 CIR imagery: Red point indicates location of anomaly found in imagery. Blue point and polygon indicate the true location of the field. Visual identification of the field in thermal imagery, possible identification in the CIR. Point was placed away from the field, most likely indicating a downslope area in which effluent was leaching from the field. No effluent was seen on the surface.

Figure 13c: Property 2 CIR imagery: Visual identification of the field in thermal imagery and the CIR. Inspection of the imagery revealed both the location of the tank and the septic field. WCEHD sampled 3 locations on the field, indicated by the 3 blue points. No effluent was seen on the surface, however.

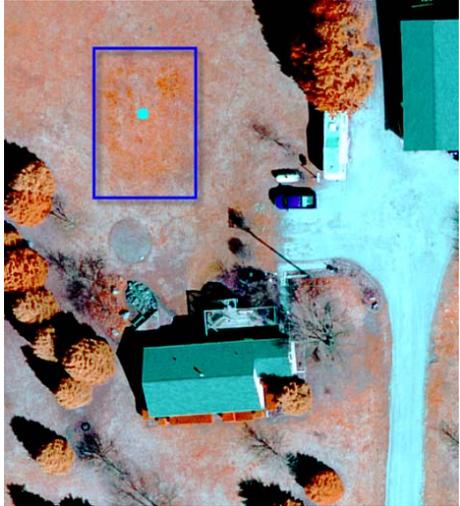
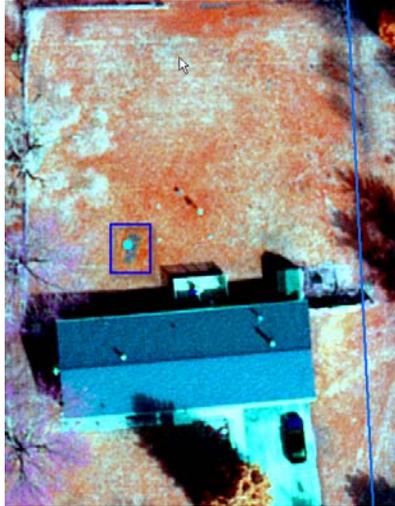
<p>Object ID 48: Visible in both the CIR and Thermal imagery. No field sampling performed.</p>	<p>Object ID 60: Visible in the CIR, but no signature in the Thermal imagery. No field sampling performed.</p>

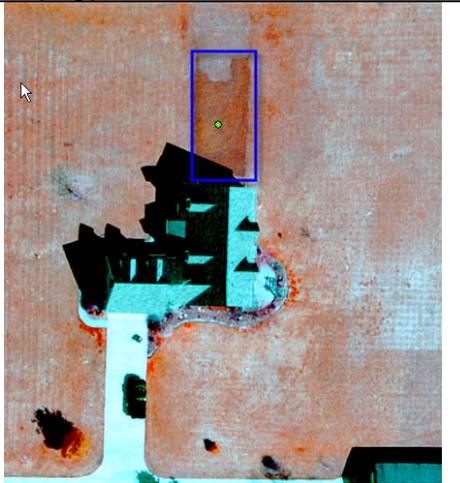
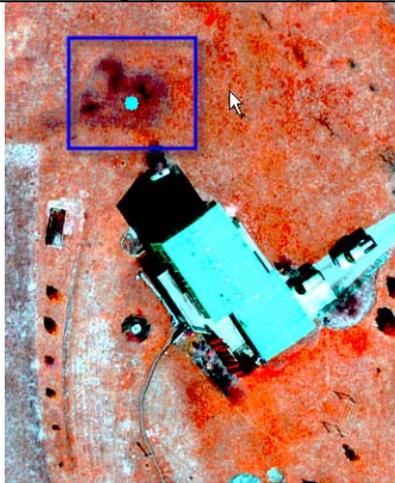
<p>Object ID 74: Visible in both the CIR and Thermal imagery. No field sampling performed.</p>	<p>Object ID 100: Visible in the CIR, but no signature in the Thermal imagery. No field sampling performed.</p>

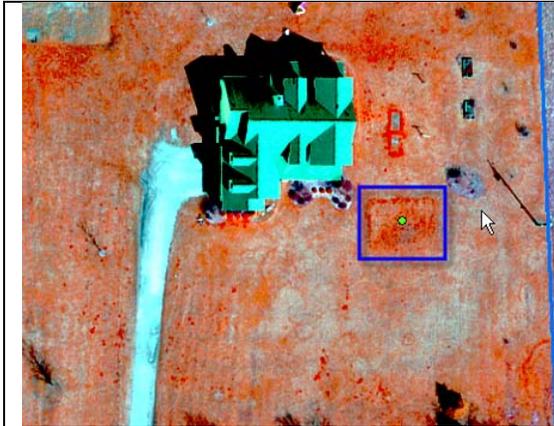
Object ID 101: Visible in the CIR, but no signature in the Thermal imagery. No field sampling performed.

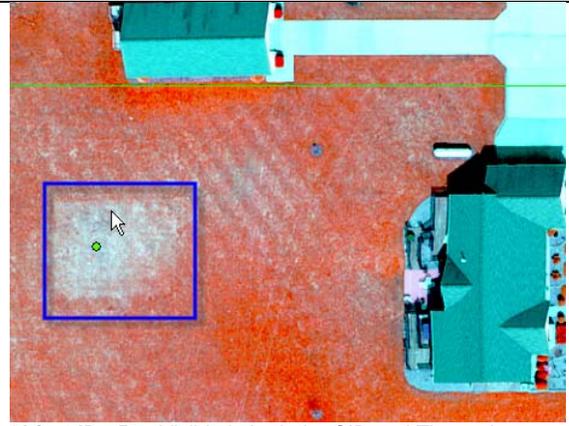
Object ID 152: Visible in both the CIR and Thermal imagery. Location confirmed by field sample 24 May 2012, field was found to have no saturation or biomat.

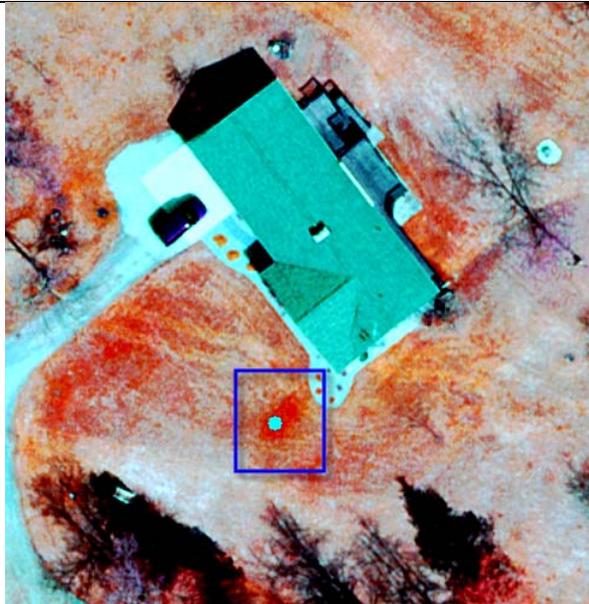
Object ID 1016: Visible in the CIR, but no signature in the Thermal imagery. No field sampling performed.

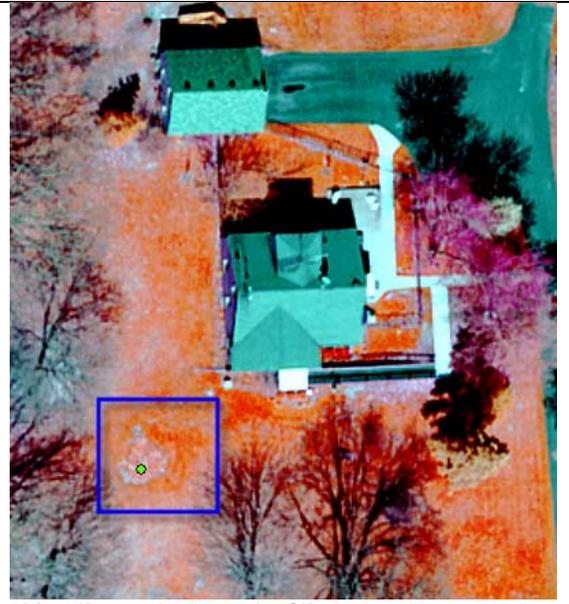
Object ID 947: Visible in the CIR, but no signature in the Thermal imagery. No field sampling performed.

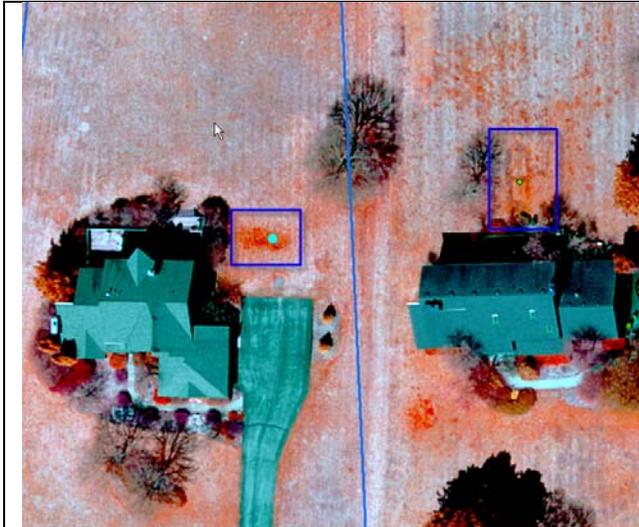
Object ID 925 and 926: Both locations were visible in the CIR, but no signature in the Thermal imagery. No field sampling performed.

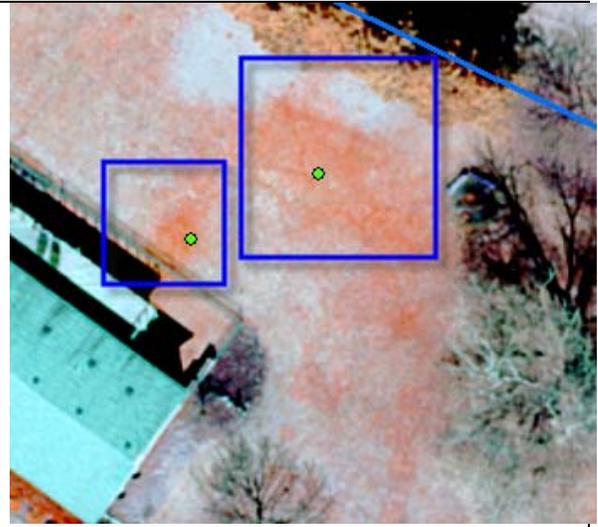
Object ID 741 and 742: Both locations were visible in the CIR, but no signature in the Thermal imagery. No field sampling performed.

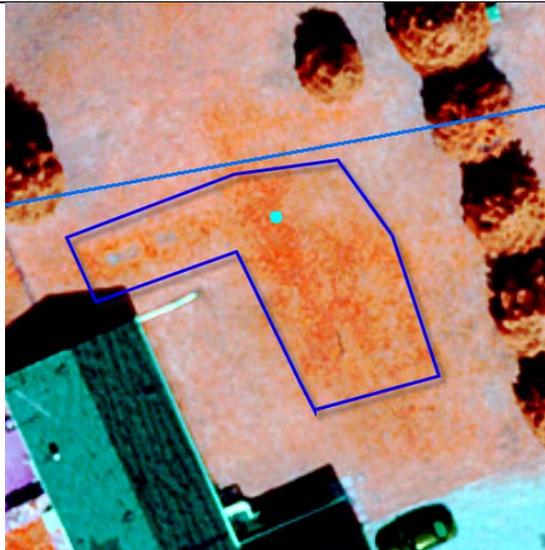
Object ID 676: Visible in both the CIR and Thermal imagery. No field sampling performed.

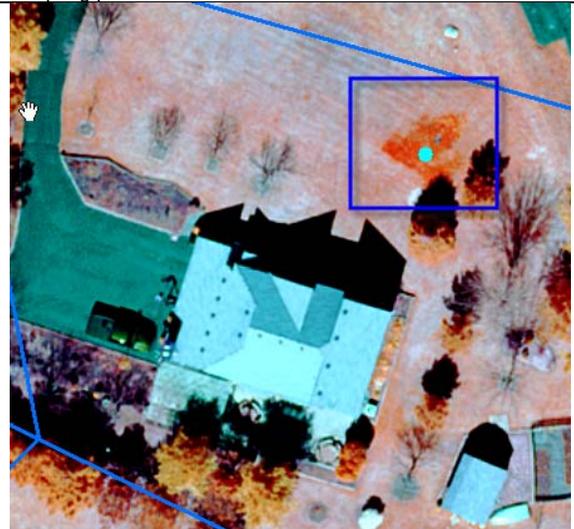
Object ID 621: Visible in both the CIR and Thermal imagery. No field sampling performed.

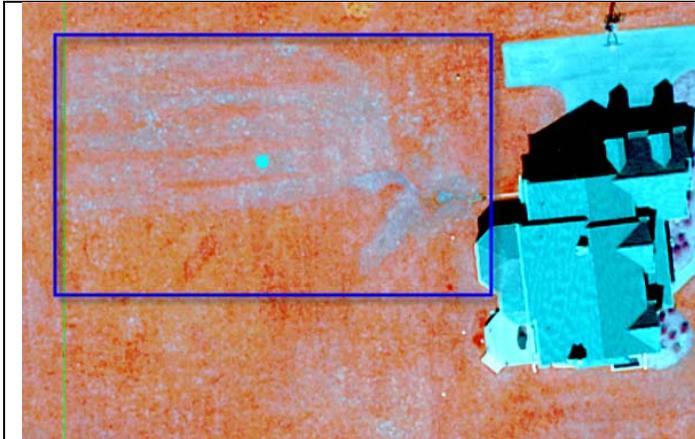
Object ID 588: Visible in the CIR, but no signature in the Thermal imagery. No field sampling performed.

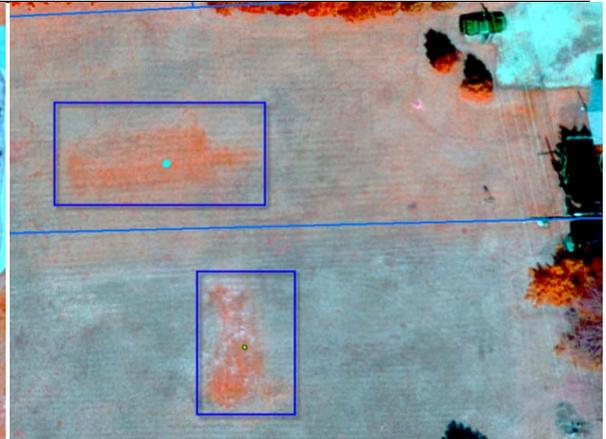
Object ID 353 and 354: Both locations were visible in both the CIR and Thermal imagery. No field sampling performed.

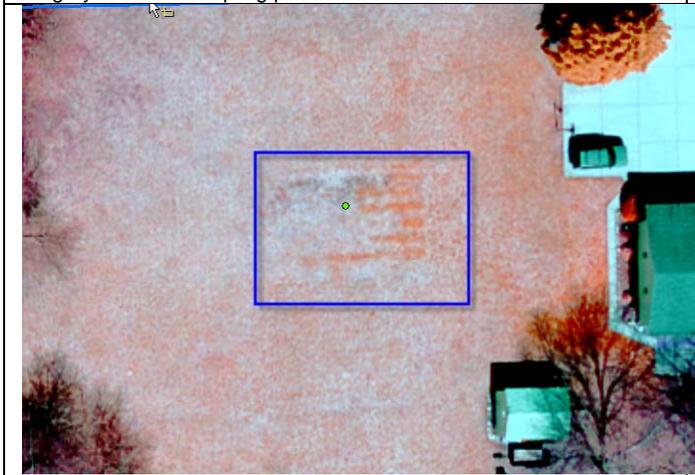
Object ID 656: Visible in both the CIR and Thermal imagery. No field sampling performed.

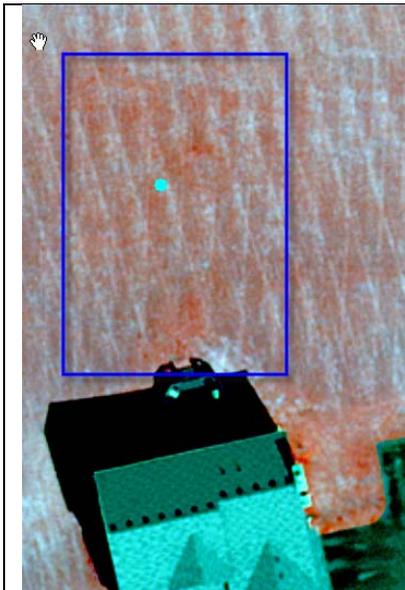
Object ID 2: Possible detections in both the CIR and Thermal imagery. No field sampling performed.

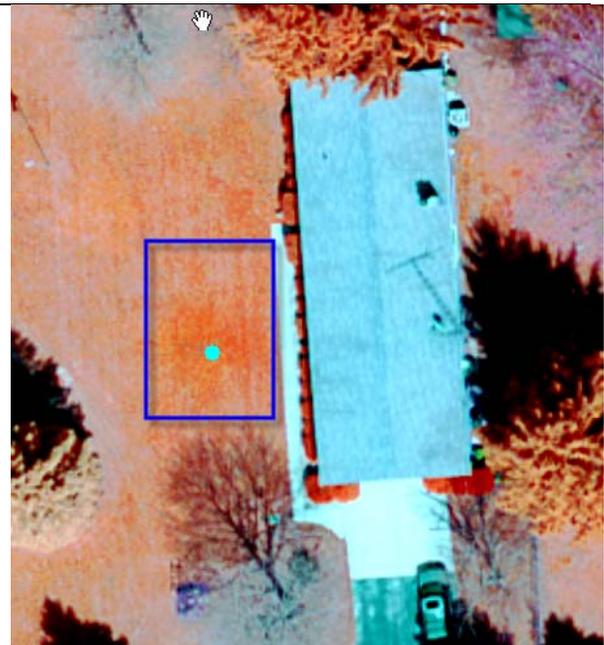
Object ID 14: Possible detection in the CIR imagery. Location confirmed by field sample 15 June 2012 as a septic tank. Field is 30 ft to the northwest, and was found to have no saturation or biomat.

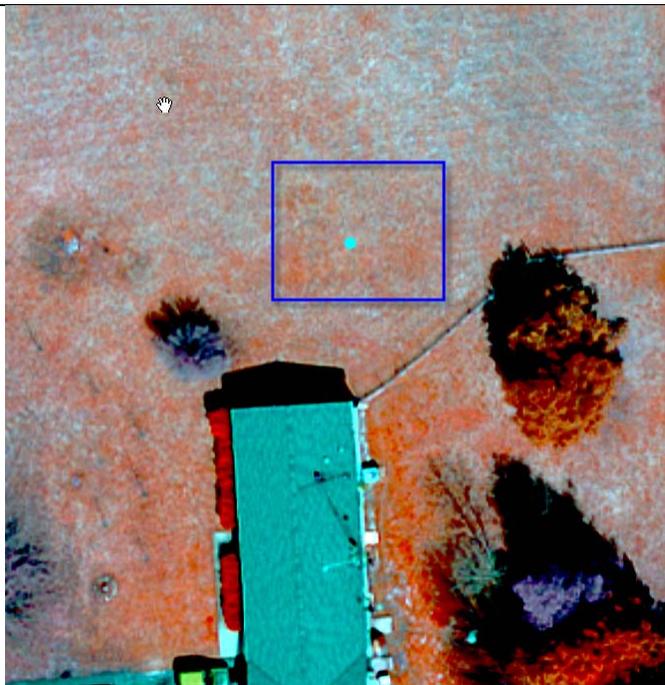
Object ID 18: Possible detection in the CIR imagery. Location was found in a field sample on 5 April 2012 to NOT be the septic field. Field is 90 ft to the north, and was found to have no saturation or biomat.

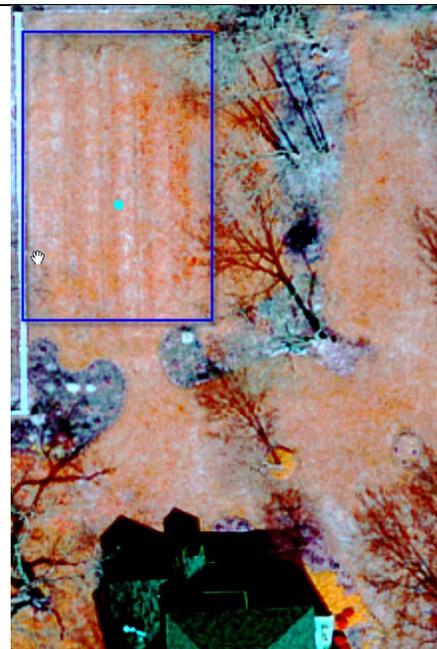
Object ID 19: Possible detections in both the CIR and Thermal imagery. No field sampling performed.

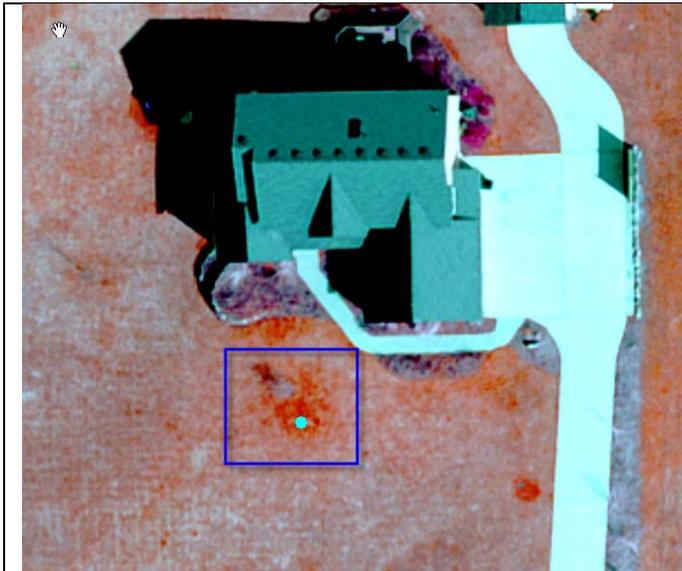
Object ID 38: Possible detection in the CIR imagery. No field sampling performed.

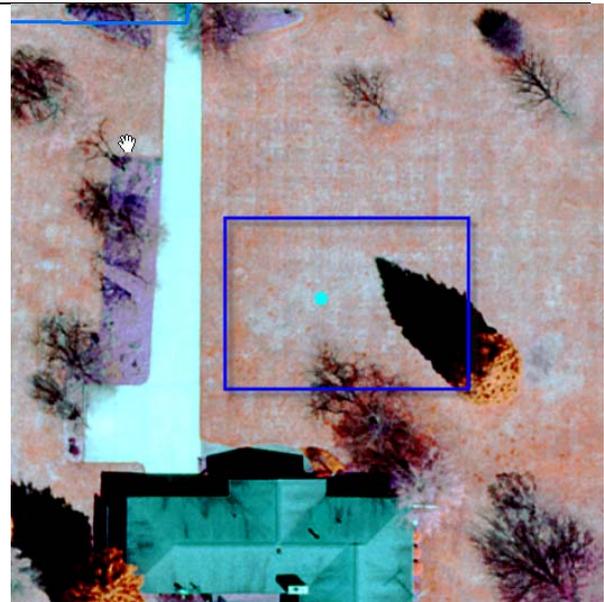
Object ID 73: : Possible detection in the CIR imagery. Location confirmed by field sample 20 June 2012; field was found to have no saturation or biomat.
