Summary of Geomorphology Assessment Results for the Middle Huron River Watershed, Section 1

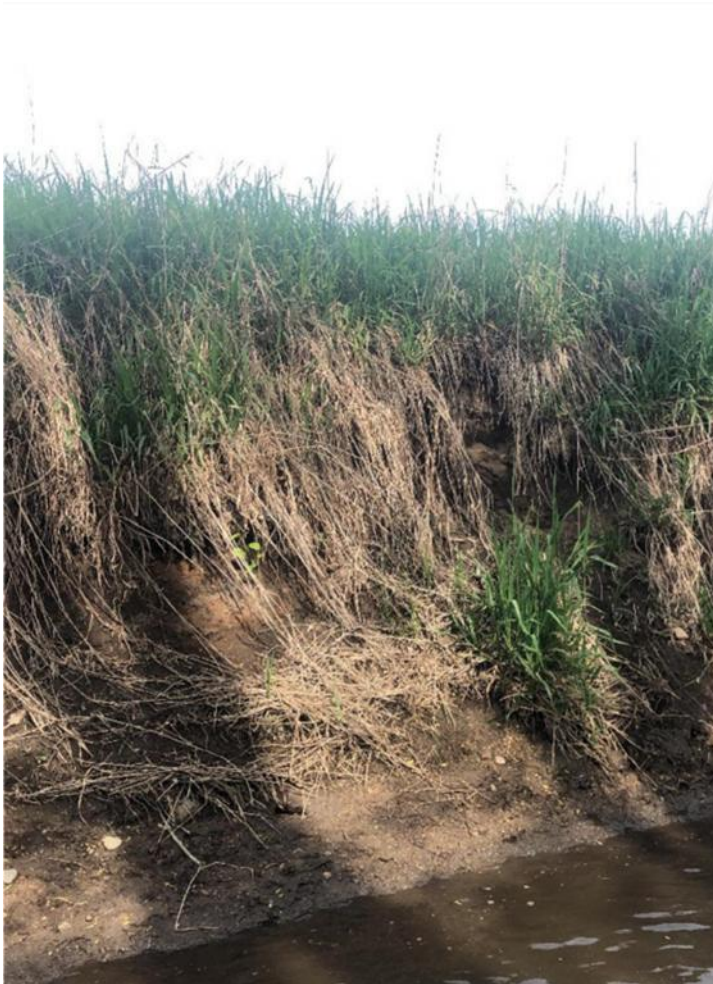
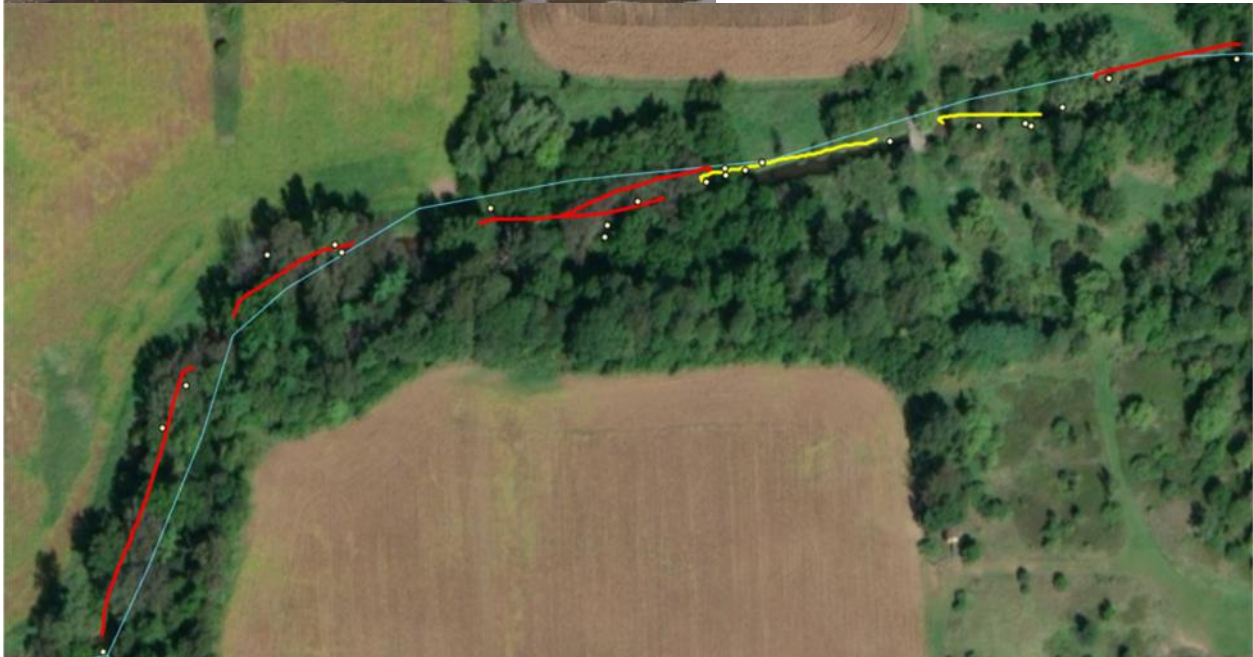
432 – W. Branch of Mill Creek

This short (< 1/3 mi) bend of Mill Creek is downstream of a significant confluence in an area with a history of channelization and drain tiling for agriculture. The reference bankfull depth is > 2 ft. Banks are high on both sides with limited riparian cover (< 50 ft in some places) protecting the bank slopes. Floodplain is non-existent.

The upstream hydrology should be fairly stable with little impactful development, gentle slopes and a mix of agriculture and wooded/wetland land cover. Land ownership is private agriculture adjoining stream, and access would require easement.

At bend curve, natural stabilization techniques should be applied. Downstream of bend, some form of 2-stage ditch or modified floodplain connection could be designed. Riparian cover along downstream section could provide more room to work with, but slopes are still high.

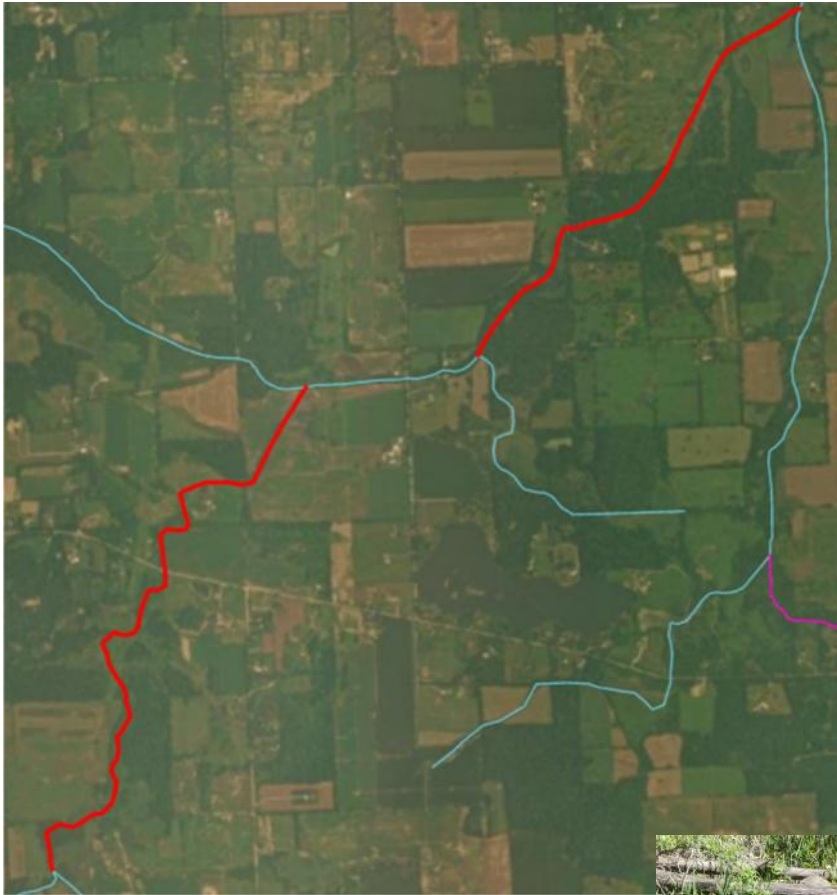
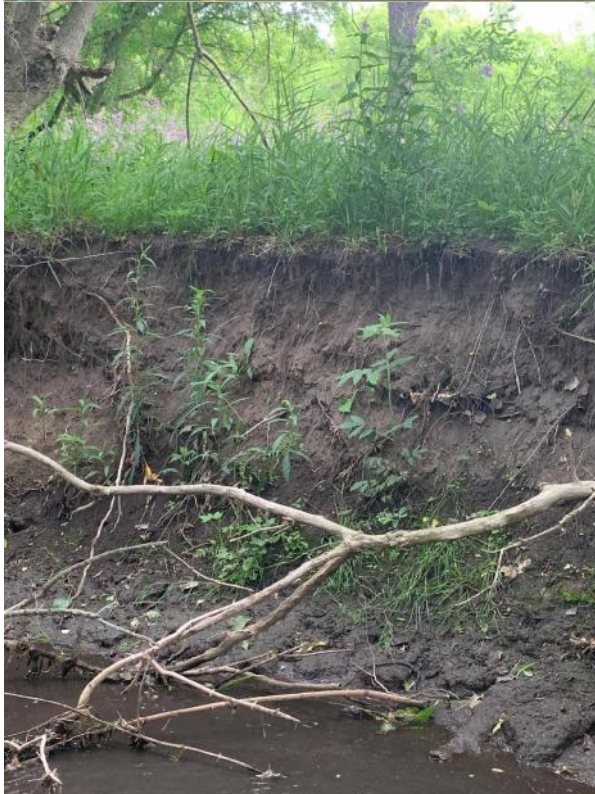
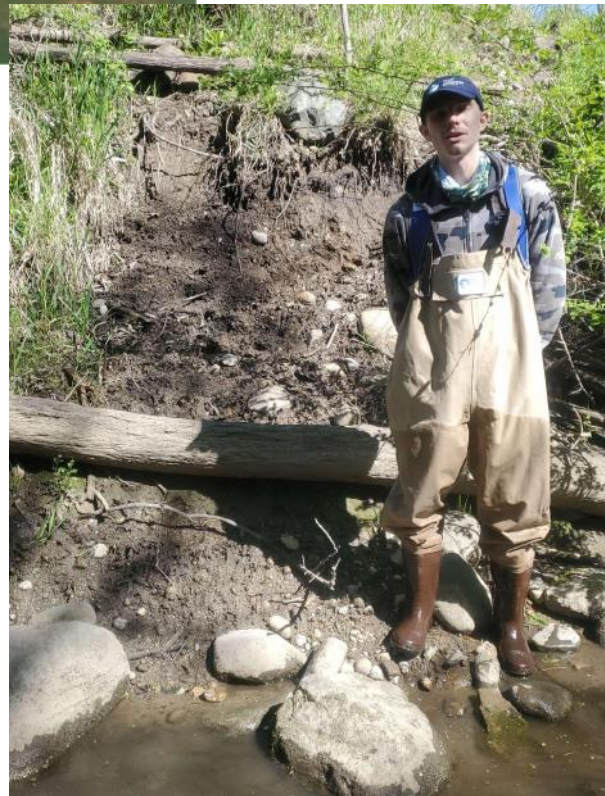
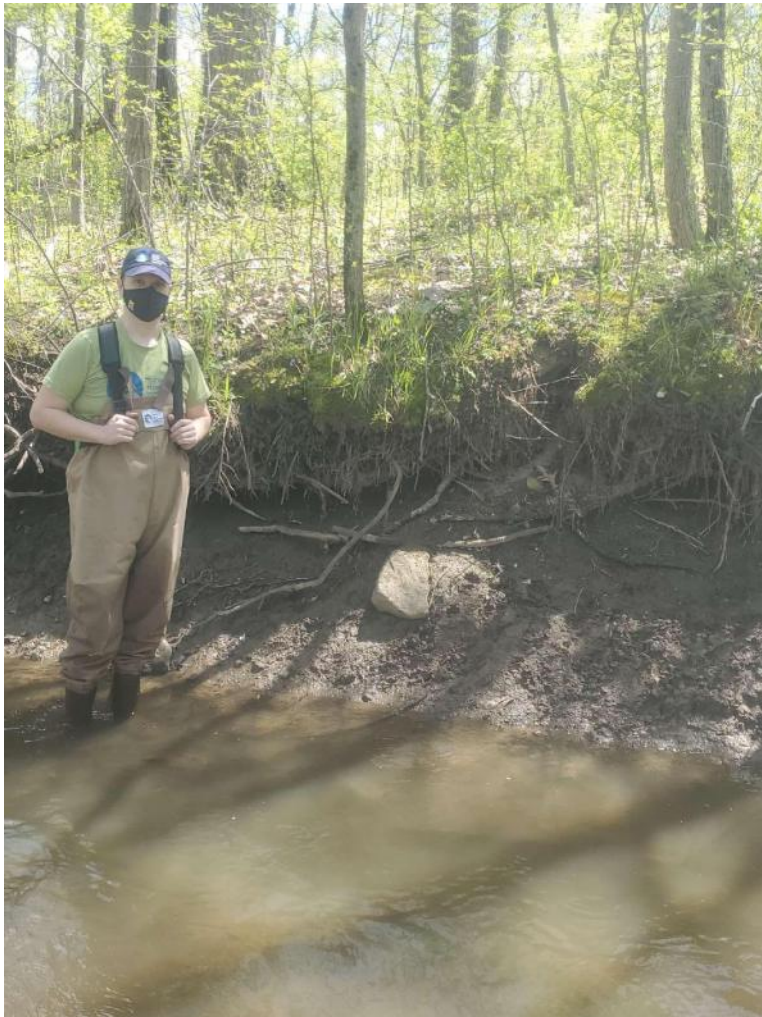
501 & 427 – Main fork of Mill Creek

These two reaches are quite long (~3.5 miles combined). Both reaches have been significantly deepened by intentional channelization or by upstream alteration of hydrology leading to downcutting.

Only a short section (1/3 mi) of 501 was assessed, but visually was determined to be representative of upstream creek. Further evaluation of upstream sections may be needed.

Together, these two reaches generate an estimated 2,063 tons of sediment per year from streambank (and bottom?) erosion.

Given the total length of these reaches, restoration will need to be approached in phases. Stretches of 427 that pass through wooded parcels could be approached first. Banks are a bit lower in some of the downstream portions of the reach, but it will still require significant effort to reconstruct banks to connect them to some form of floodplain. Natural stabilization will be required in places, as well. These lands are privately held, but may have conservation easements and could be eligible for state and federal grants or partnerships with land conservancies.

Once a section of the reach is stabilized and restored to connected function, additional projects could be pursued. Hydrology is likely stable at this point, if that was the original cause of downcutting. Moving upstream, there are additional sections with good forest/wetland land cover in riparian areas. Again, restoration techniques would include earth alteration to re-establish some amount of floodplain connection to give the floodwaters room to expand and drop sediment rather than carrying it all downstream.

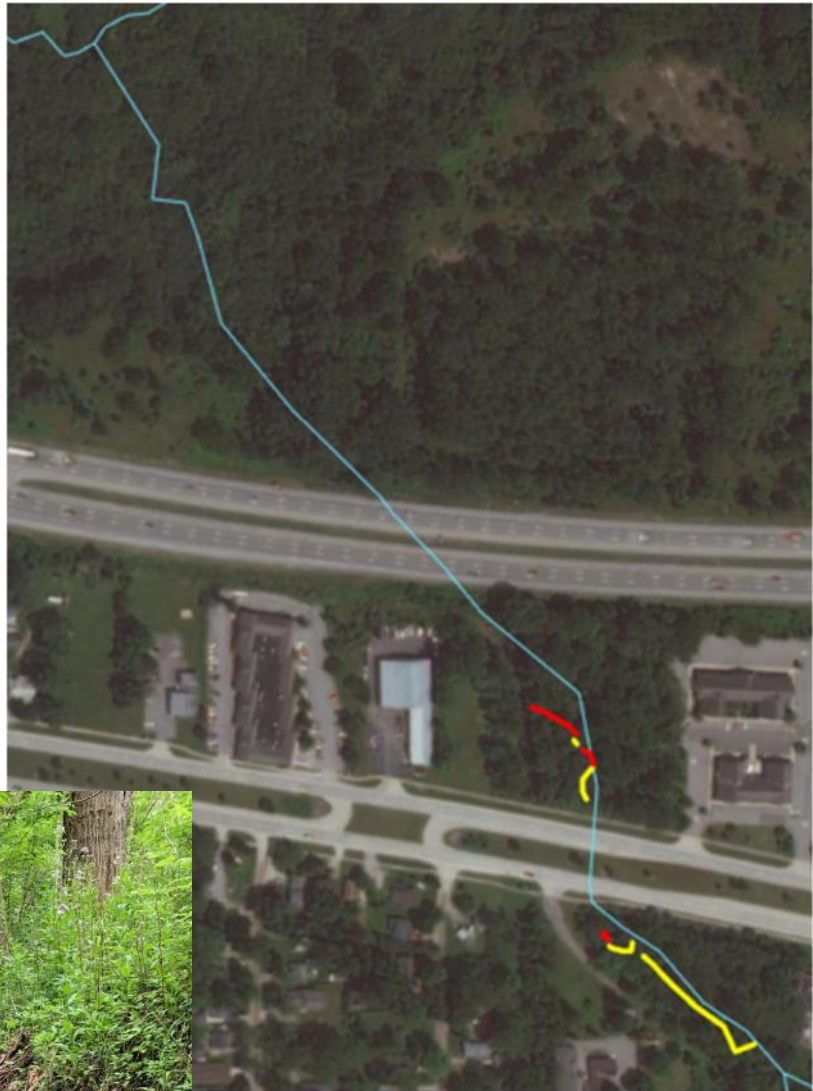
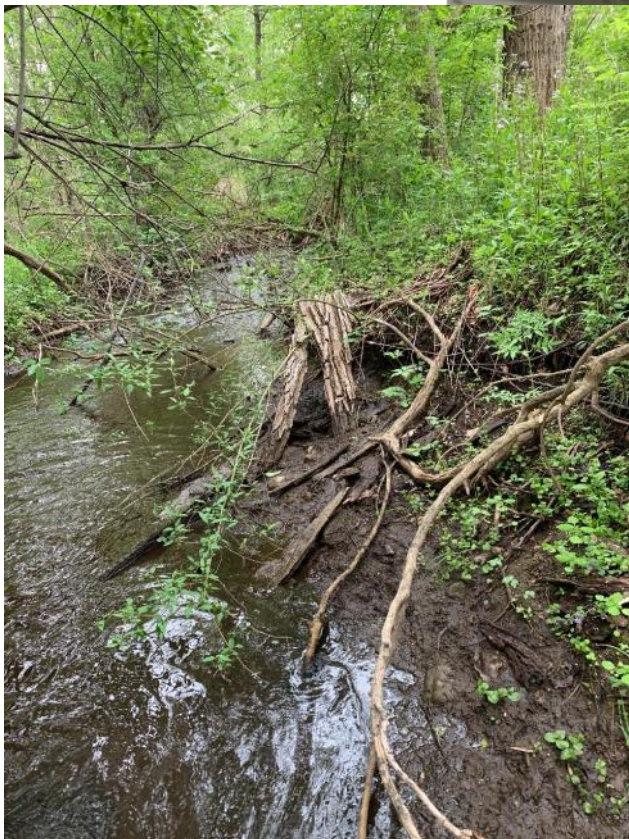
588 – Honey Creek

This reach is interrupted by two major road crossings – I-94 and the Jackson Road business corridor. The stream has been highly impacted by development of these throughfares and the retail development in between. It appears that flood flows may backup behind the crossings when woody debris blocks through flow. The crossings first need to be evaluated to determine if significant maintenance or re-engineering is needed. The creek approaches Jackson Road at an angle that could present issues at the

upstream end of the culvert.

The downstream portion of the reach was not evaluated. If culverts are determined to be functioning properly, the downstream section should be assessed to determine if road runoff is impacting banks downstream. Ample floodplain is available for any needed restoration.

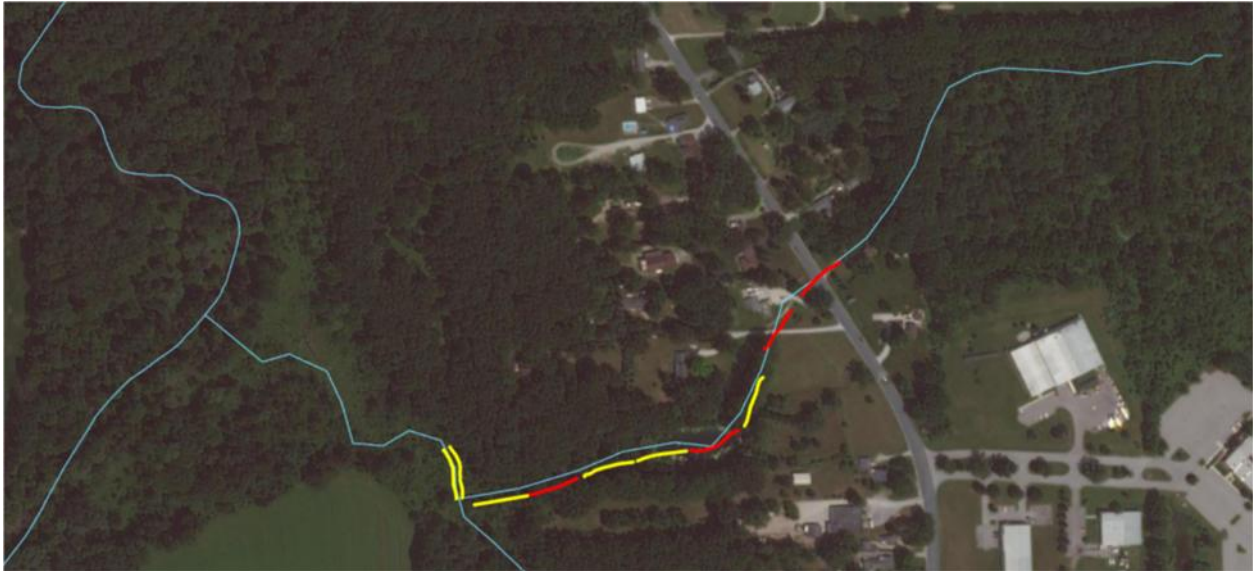
474 & 401 – small tributary to Mill Creek

This small tributary system draining to the main branch of Mill Creek may have been impacted by local residential and industrial development. Banks are significantly higher than reference bankfull depths for a drainage area of this size. Bank material may be more susceptible to erosion than in other parts of the Mill Creek watershed.

Banks may be stabilized at bends and restored to reference heights within a floodplain that currently has good riparian cover. Participation from private land owners would be required to succeed.

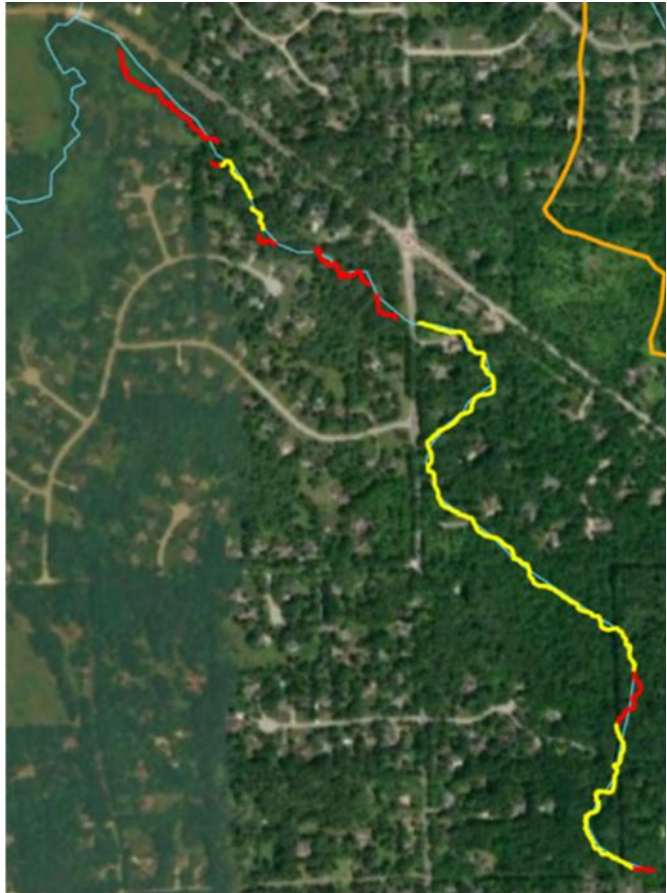
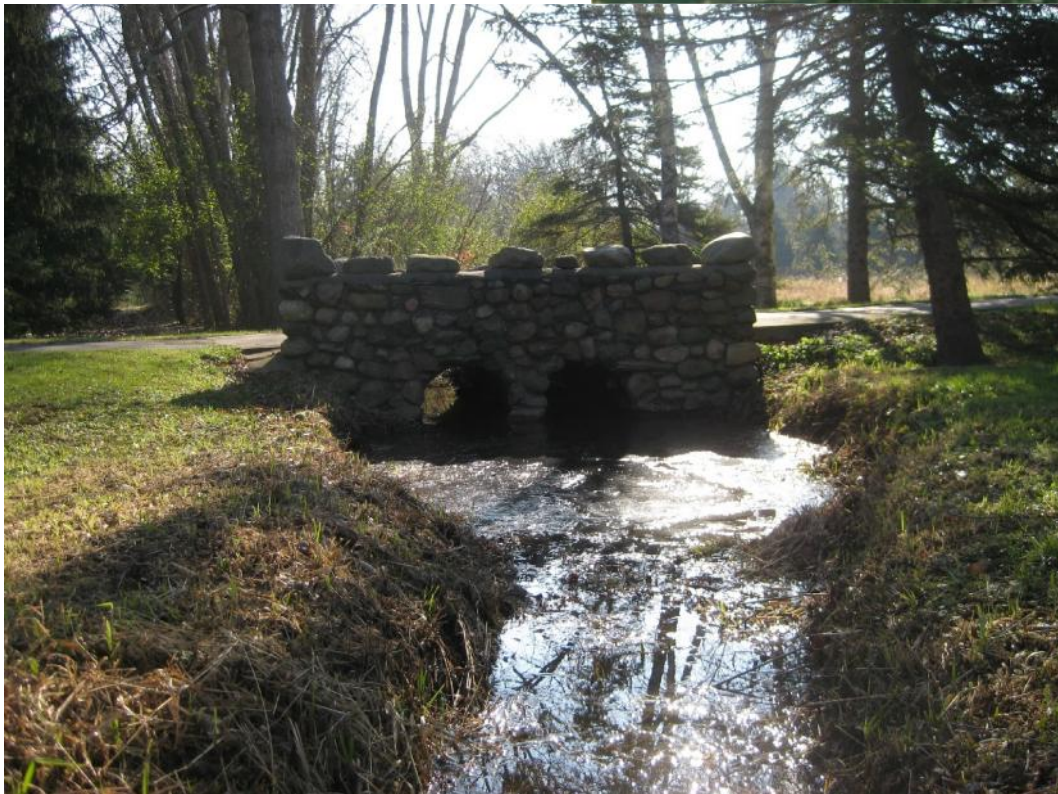
373 – Honey Creek

This relatively long reach has been significantly altered in a number of places by local residents and by development in the drainage area overall. Residents have constructed ad hoc crossings and bank stabilizations over the years with mixed success. The estimated erosion rate is not as high as previous examples, but the overall length, slope and geology suggest that it may generate a significant amount of sedimentation.

Restoration should focus on the downstream portion, with targeted crossing reconstructions, a natural bank stabilization where the creek is carving close to a property boundary and reconnection to floodplains throughout. There is ample riparian cover along this lower part of the reach. Access is feasible at a number of points, but will require easements from local residents.

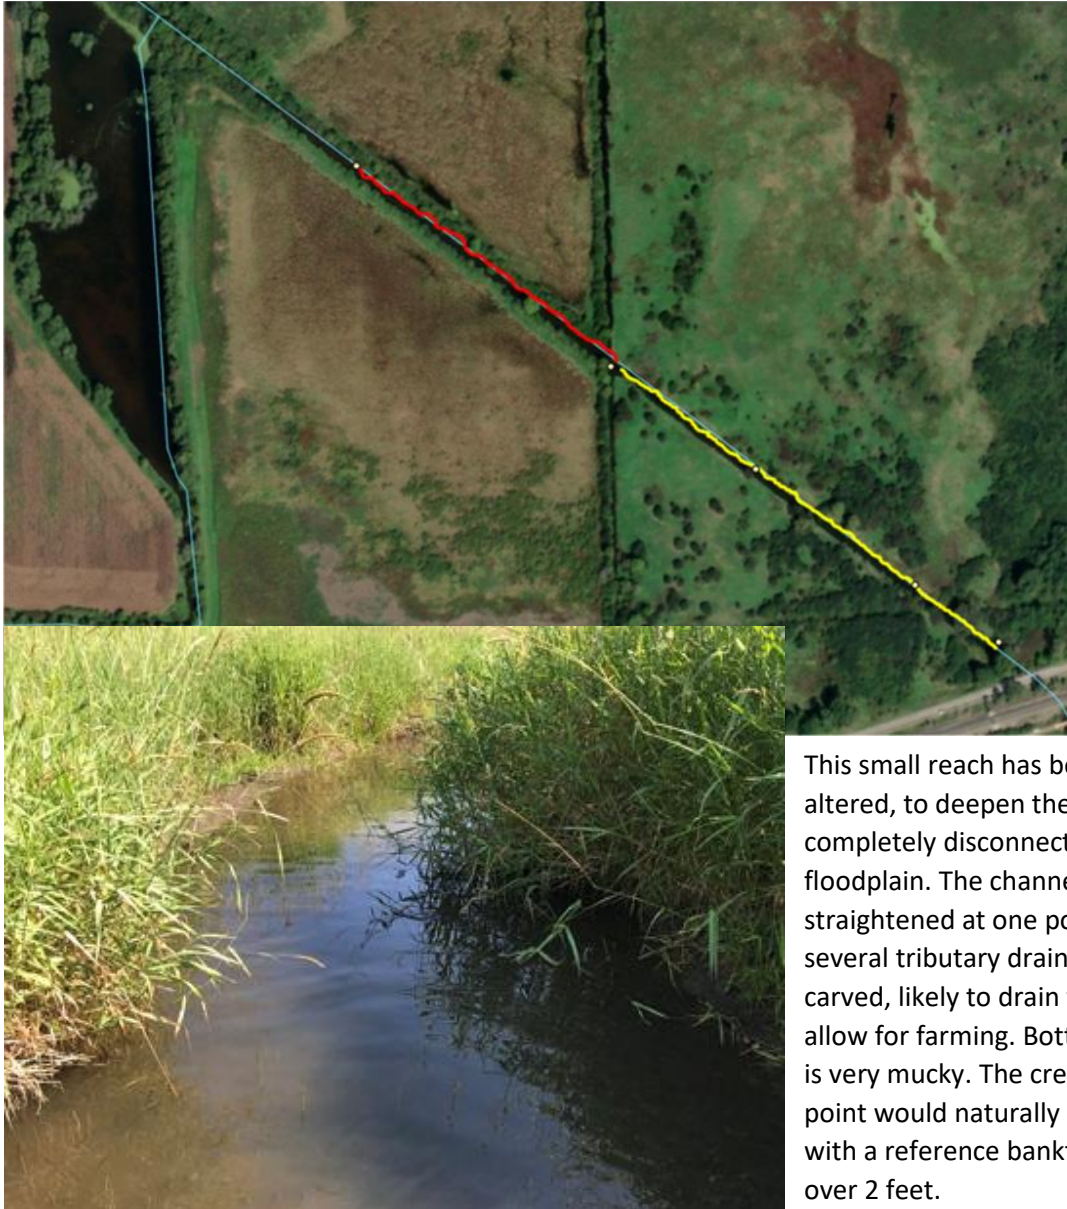
368 – North Fork of Mill Creek

This small reach has been severely altered, to deepen the channel and completely disconnect it from its floodplain. The channel was straightened at one point and several tributary drains were also carved, likely to drain wetlands and allow for farming. Bottom substrate is very mucky. The creek at this point would naturally be quite large with a reference bankfull depth of over 2 feet.

Restoration will be challenging. Ideally, dikes and artificial embankments would be broken or removed to allow waters to flow back onto fields to restore wetlands. This would require landowner participation, but could be funded through Farm Bill programs. It might be more possible on the lower parcel that is not actively being farmed at this time. A wetland connection there could capture and settle sedimentation generated upstream.

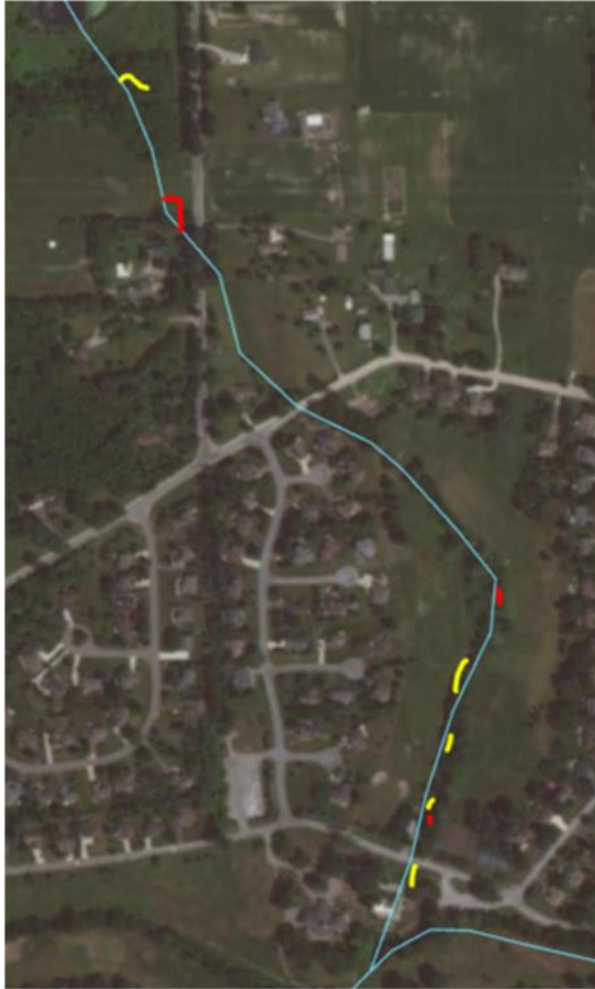
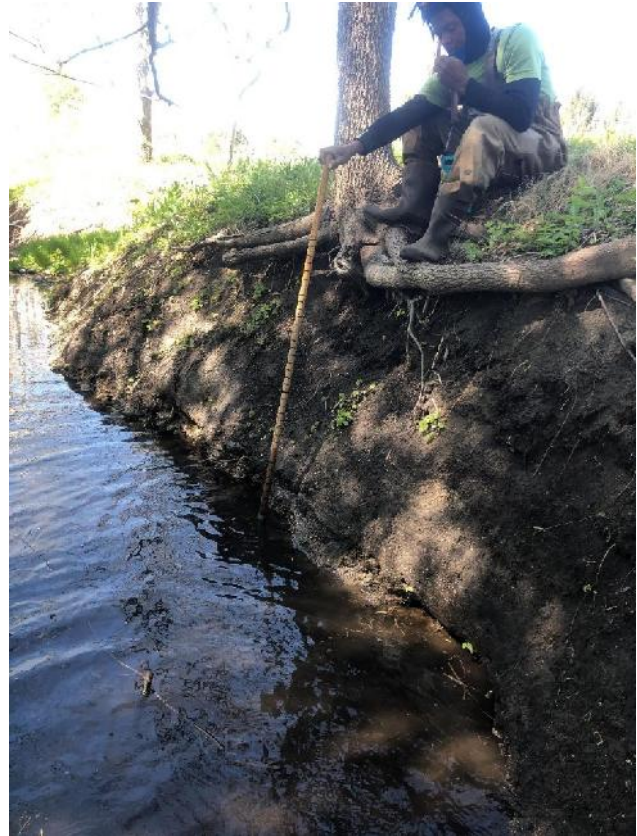
538 – West Branch of Boyden Creek

This reach of Boyden Creek is generally in good condition, with long lengths showing no evidence of active bank erosion. However, there are a few spots that show impact from human interaction. The most significant area is the section of stream that runs through a former golf course in the Loch Alpine residential community. Streambanks look to be artificially confined in places to maintain golfing fairways.

The few active erosion areas could be stabilized with natural materials and techniques, while allowing the rest of the stream reconnect to its floodplain within the defunct golf course, which is no longer being actively managed and is returning to a natural state. The golf course property is currently in ownership and land use dispute, however, so ensuring long term management of the stream may be difficult until disputes are resolved.
