Summary of Geomorphology Assessment Results for the Middle Huron River Watershed, Section 3

Overview

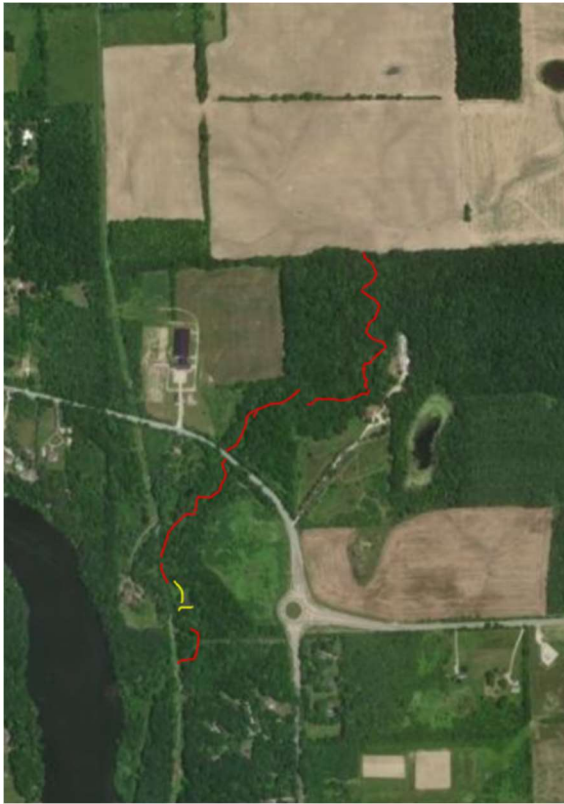
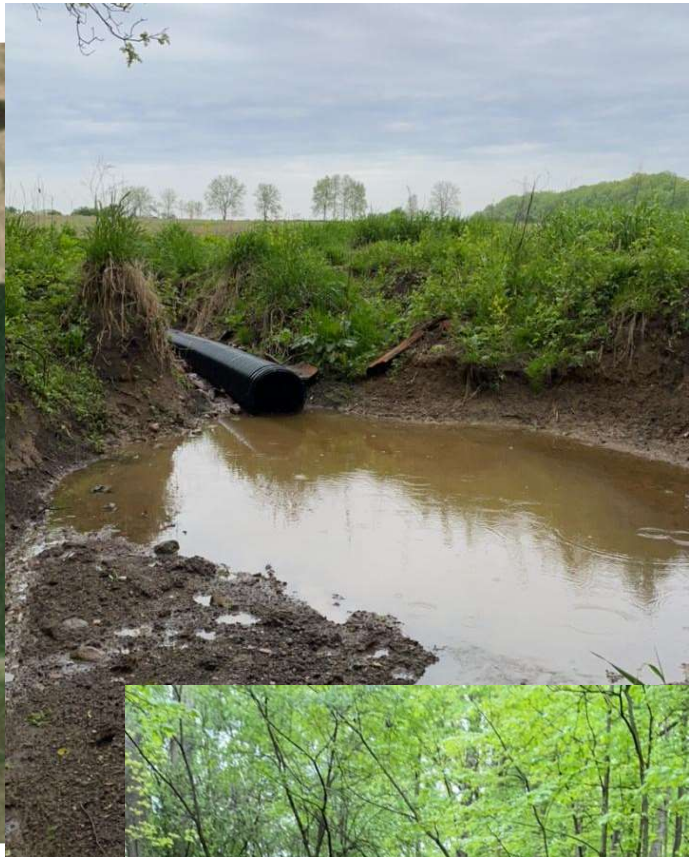
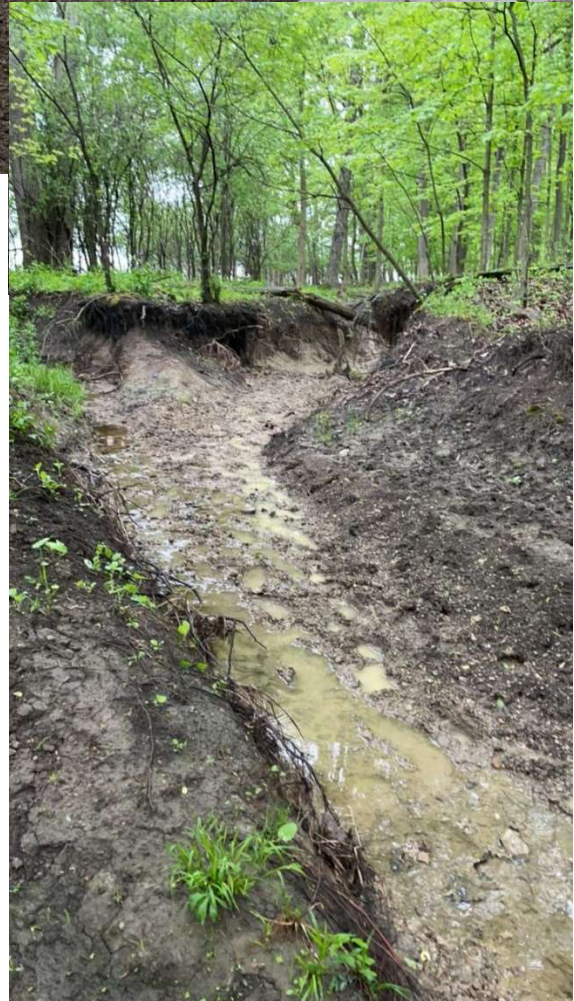
771 – Unnamed Superior tributary

A good portion of this 1.25-mile reach was assessed, up to where tile flow ran off from farm fields (see top right photo). It appears that significant storm runoff accumulates at that point to create high velocities beyond the capacity of the stream banks to withstand.

Downstream, the riparian cover is good, but soils are sandy, unstable and erosion prone. At points, the channel has disconnected from the floodplain. Given the ample space, efforts to reshape banks and reconnect to floodplains and wetlands would be recommended. Despite forest cover, woody debris in the channel is generally absent but could be used to improve flow patterns. Land ownership is private adjoining stream, and access would require easement.

Agricultural practices, such as buffers or two-stage ditches, to slow drain flow should be the first remediation efforts.

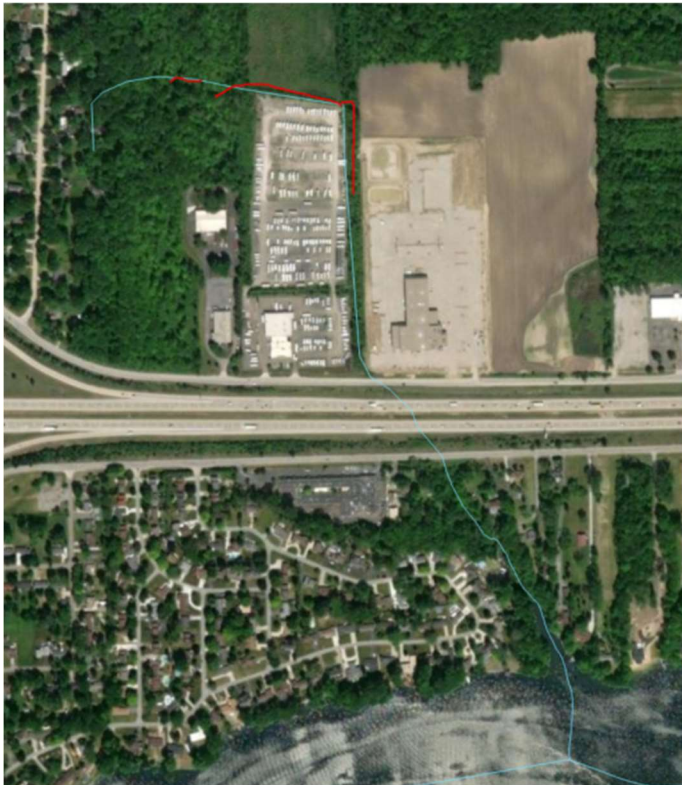
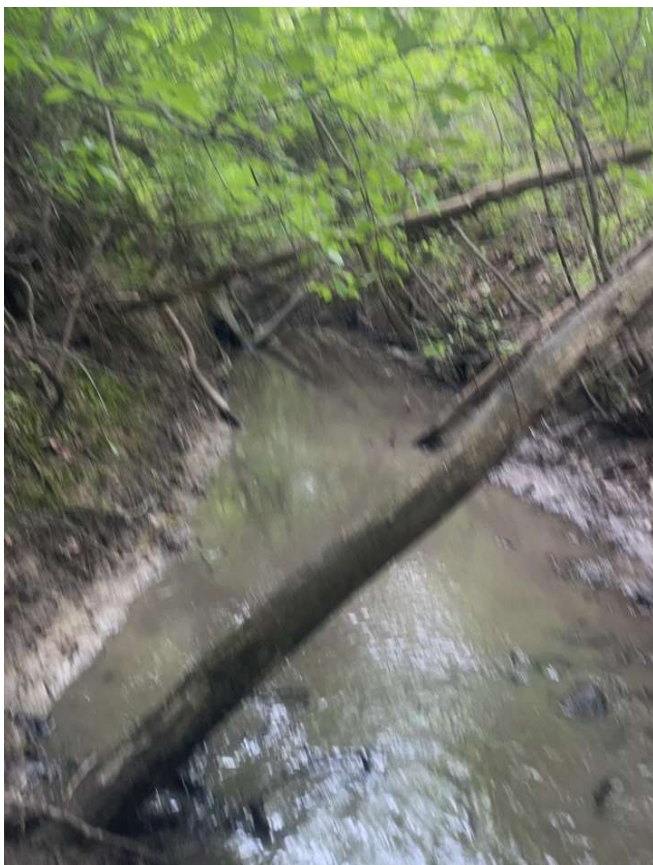
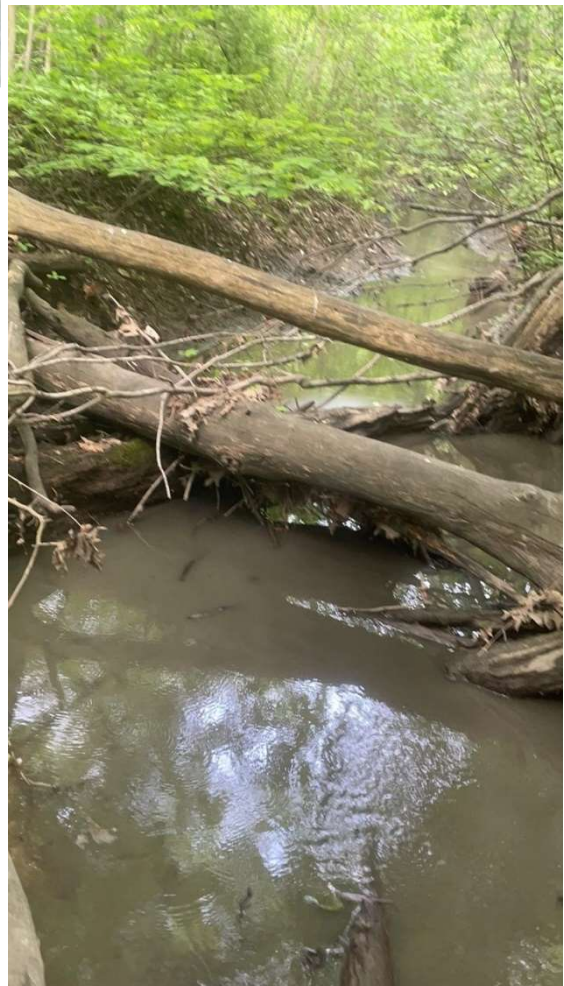
365 – Unnamed Belleville Lake tributary

This small reach has obviously been channelized and possibly rerouted to accommodate development. Hydrology is altered from the channelization and the recent developments. The best opportunity to improve hydrology and reduce erosion is to require stormwater improvements as the bordering industrial and commercial developments expand. If stormwater can be captured and infiltrated on-site, and a more natural hydrology returned, perhaps the banks could then be restored with a 2-stage design and native vegetation.

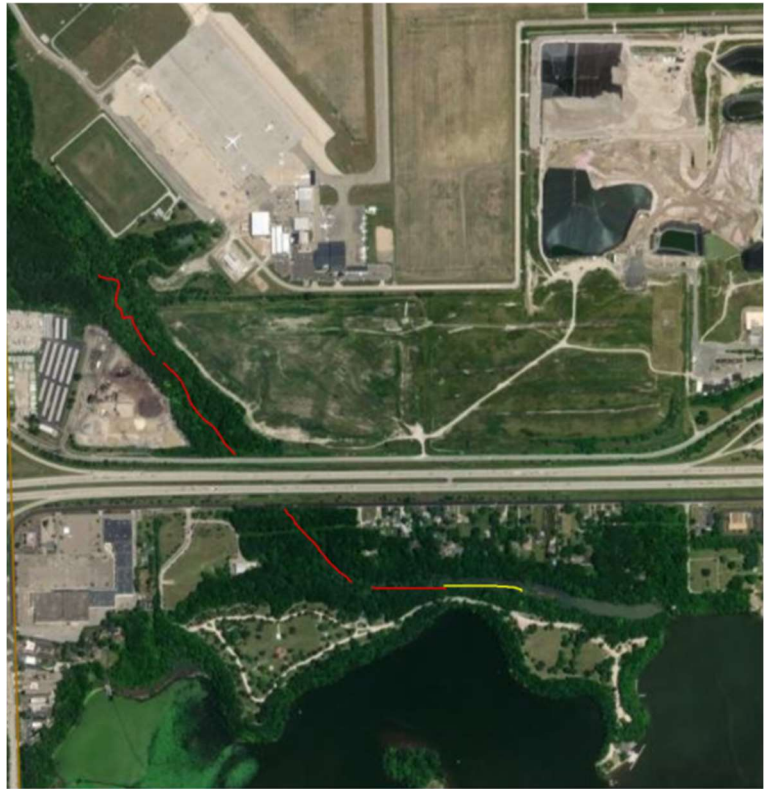
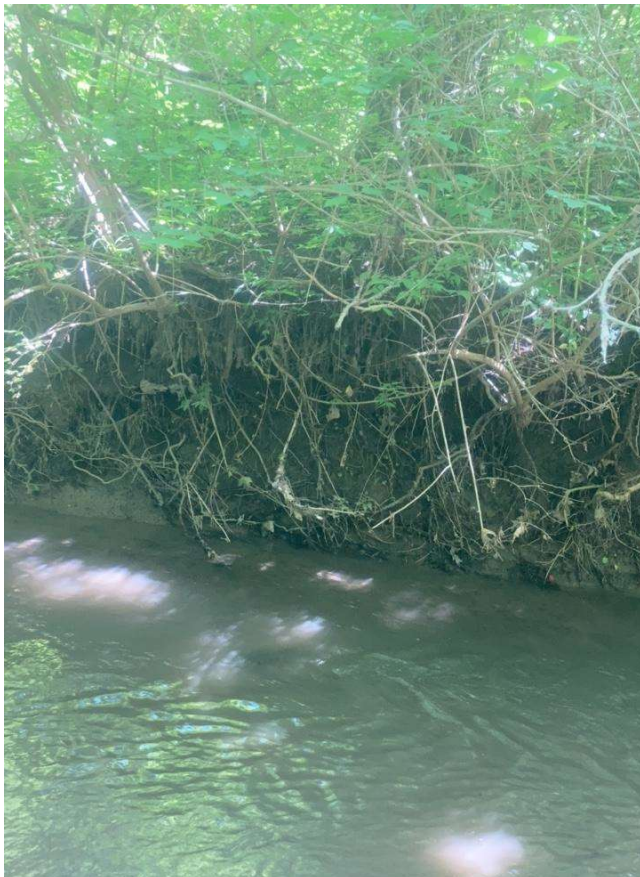
372 & 531 – Willow Run

These reaches are separated by the I-94 highway and severely impacted by runoff from Willow Run airport. Rapid runoff from the airfields and related industrial lands has over-widened the creek and eroded stream banks. However, there is reasonably good riparian cover on both sides of the creek, which could offer some restoration potential, as additional development is not likely.

Some consideration will need to be given to the quality of water in the creek, as it has a long history of contamination from past industrial operations. High slopes along the park ridge will also present a challenge, though there are still ample flat areas north of the ridge.

Current bankfull flows should first be determined. If flow rates allow, a low flow channel and flood flow benches could be established using ample natural materials in the riparian corridor. Additionally, the lower reach runs through Van Buren Park, where additional floodplain could be established as the creek flattens out.

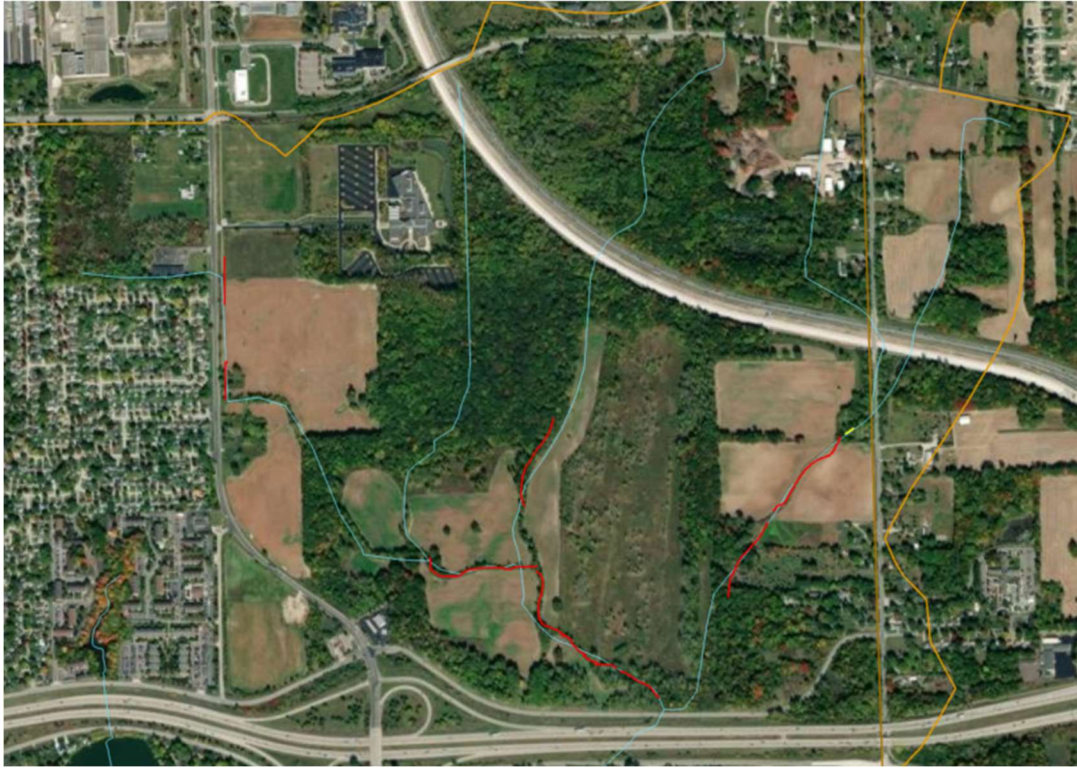
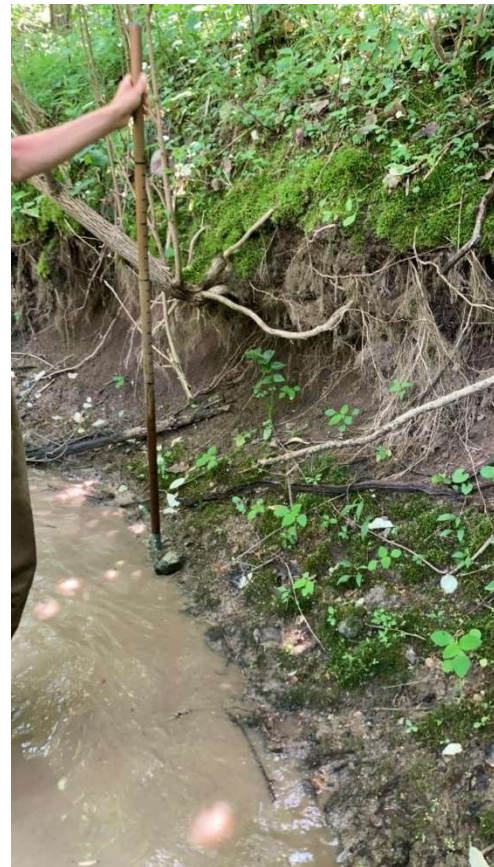
543, 600, 464, 564 & 379 – Unnamed tributary network to Belleville Lake

This cluster of tributaries at the far eastern edge of the watershed come together just prior to flowing under I-94. The channel widens and deepens into the impoundment, and is not possible to access south of the highway. The drainage area is bracketed by I-275, I-94 and Haggerty Rd. (to the west). These are the last Belleville Lake tributaries upstream of French Landing dam. The land use in between is a mix of row crop agriculture and forest and wetland cover.

The channels are general narrow in upstream headwaters, but downcut or artificially deepened throughout beyond expectations from banfull estimations. The soils are quite sandy and susceptible to erosion. The westmost channel was altered and likely moved by residential development.

Agriculture is sporadic here. Lands could be potential candidates for riparian buffer and easement purchases. There is good forest cover in some areas, so if enough buffer width could be obtained, stream banks could be brought down to create flood benches throughout. Woody debris management could also be improved to diversify habitat and flow regime.

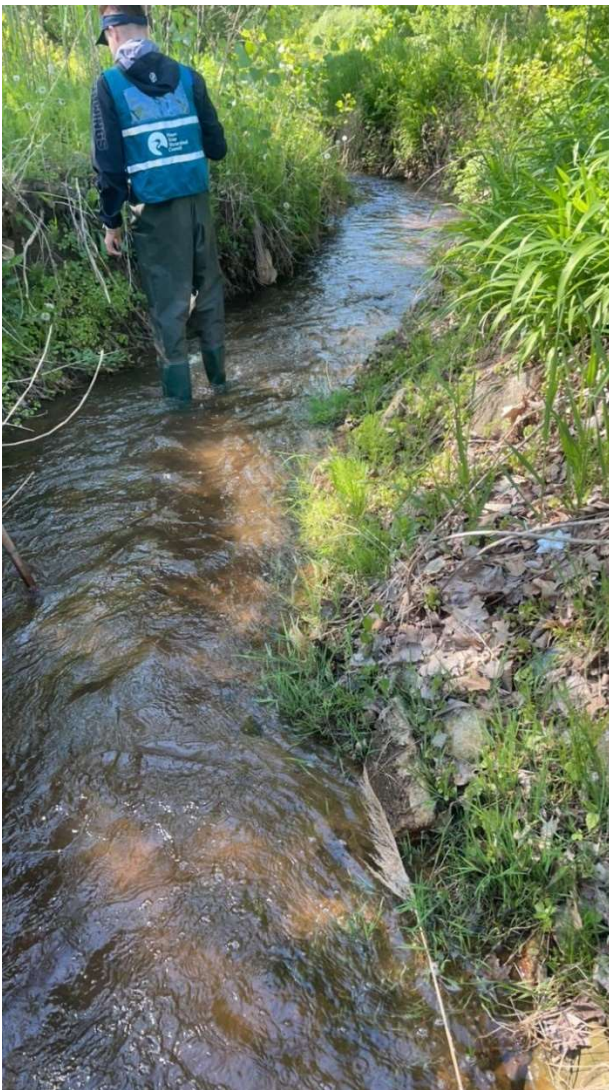
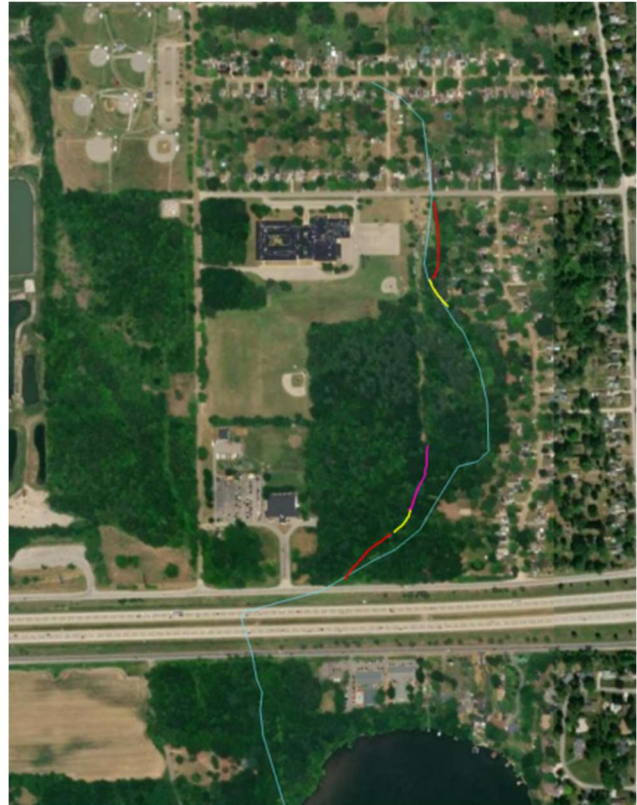
359 – Unnamed tributary to Belleville Lake

This tributary is an interesting opportunity. There are significant bank erosion issues where the stream crosses McBride Ave. and where it enters a culvert under I-94 – the top and bottom of the reach evaluation. In between the stream runs through wooded area with good riparian cover and opportunity to meander. Banks show only moderate erosion, likely from altered hydrology from upstream development. The western parcel is publicly owned by Van Buren Township, so could be a candidate for grant funding.

Culverts at both road/highway crossings should be evaluated for possible

Improvements in allowing for distribution of high storm flows. Stream banks could then be lowered to provide some amount of floodplain before the stream flows into the woods.

The downstream end could be improved by redirecting flow to properly align with the culvert entrance and providing more floodway.

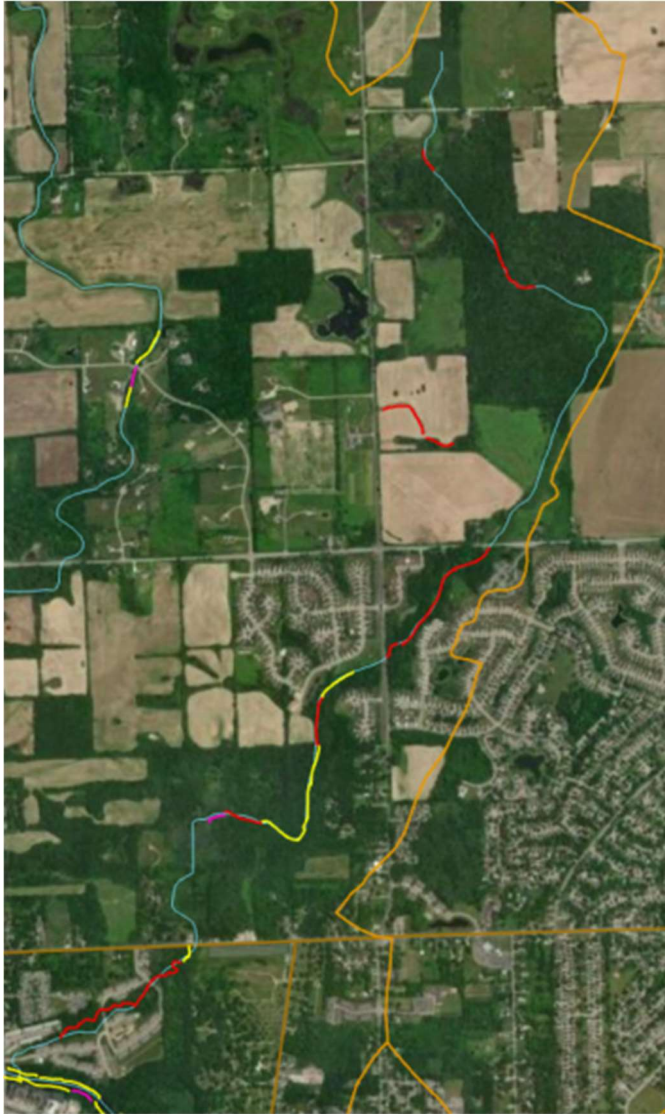
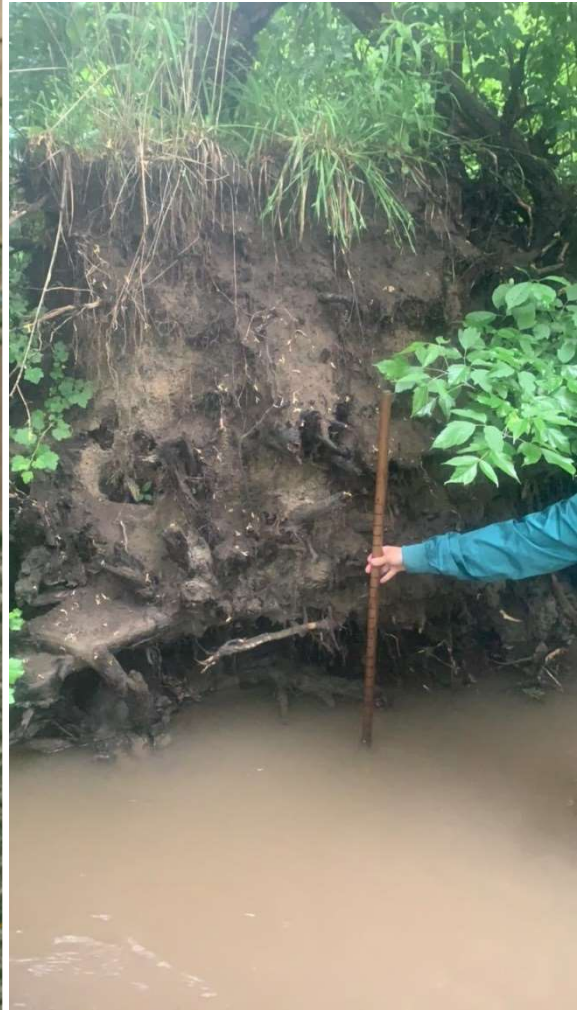
485 – Superior Drain #1

The final reach on our recommendation list is the full Superior Drain #1. While the creek doesn't have one the highest average

erosion rates, it is the longest reach recommended. Altogether, it produces the largest sediment load in the watershed. The creek passes through a mix of land covers, taking on agricultural drainage in the headwaters, through large swaths of forest cover, and splitting several recent residential developments complete with detention ponds. Evidence of erosion is periodic with long lengths of very little erosion, followed by spots of tall, highly eroded banks (see photo).

Vulnerable spots will likely need to be addressed as separate projects, but in most cases, there is ample riparian cover and space to work with. Where possible, banks could be lowered or energy redirected and sinuosity added, especially in forested areas. Wood and other natural materials are ample to use in redirecting flows. Given it's location north of Ypsilanti, new developments are likely and should be reviewed carefully to minimize further hydrologic alteration.
