Millers Creek at Baxter Road

Adopt-a-Stream Site Report, 2011

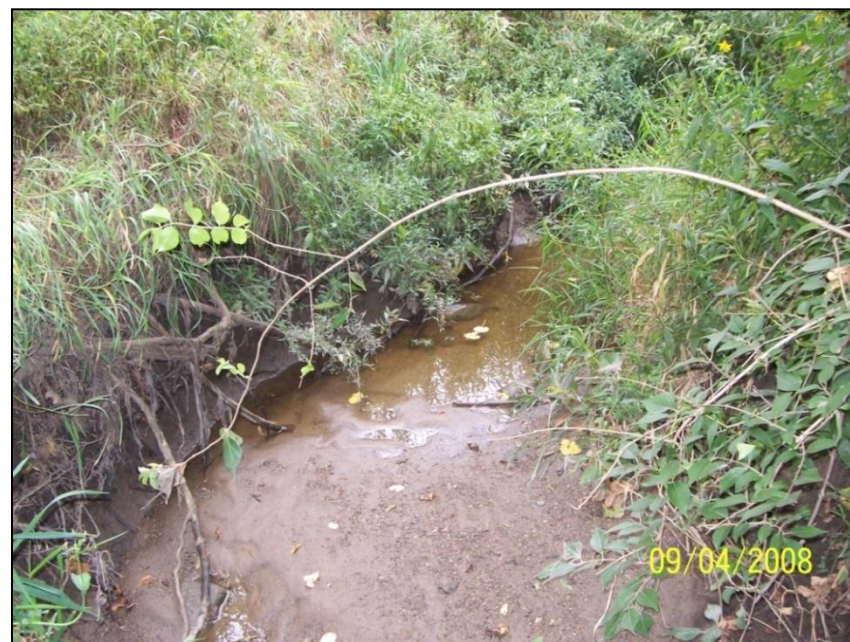
Overall Condition: **Poor**

At this site there are very few kinds of bugs and none of them are sensitive. The water has a high concentration of unknown pollutants. The stream banks, streambed, and streamside vegetation are also very poor. This site is heavily affected by water runoff from storms. This site is in the worst condition of all sites monitored by HRWC.
