Millers Creek at Baxter Road

Adopt-a-Stream Site Report, 2011

Overall Condition: **Poor**

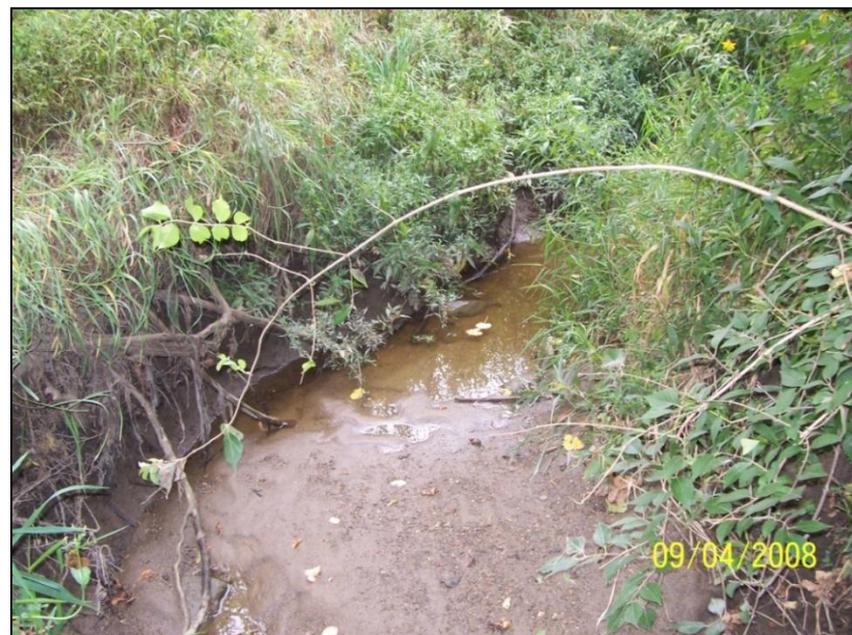
At this site there are very few kinds of bugs and none of them are sensitive. The water has a high concentration of unknown pollutants. The stream banks, streambed, and streamside vegetation are also very poor. This site is heavily affected by water runoff from storms. This site is in the worst condition of all sites monitored by HRWC.

This site on Millers Creek is a foot wide and shallow (a couple inches, with an occasional two-foot deep pool). In 2008 we found a very poor habitat here with bare banks, a mucky bottom and the rocks in the swift water (riffles) were somewhat clogged with silt. It has cool water (seldom over 70°F) containing a high concentration of unknown pollutants. The extent of development (51% impervious surface) creates urban runoff that has already degraded the stream.
