Malletts Creek at I-94 Fact Sheet

Site History

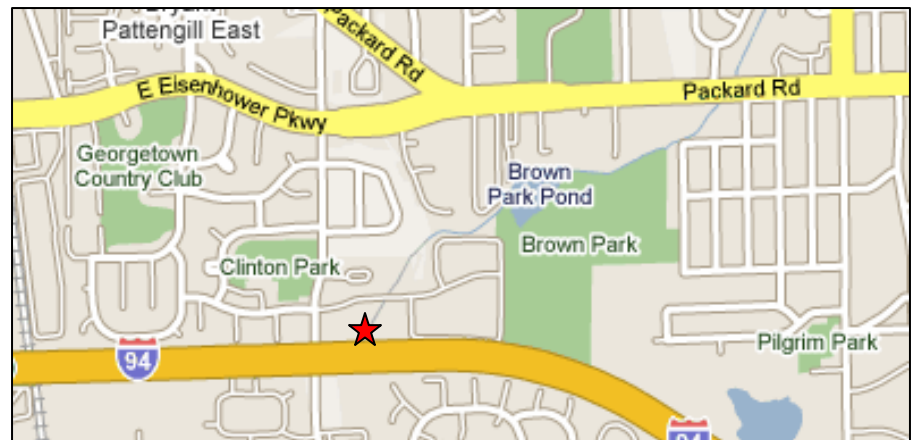
Area of land draining to this site: 4 mi²

Watershed land use: 3% Agriculture, 81% Urban, 2% Forest, 11% Open, 3% Wetland.

49% of this land is impervious surface

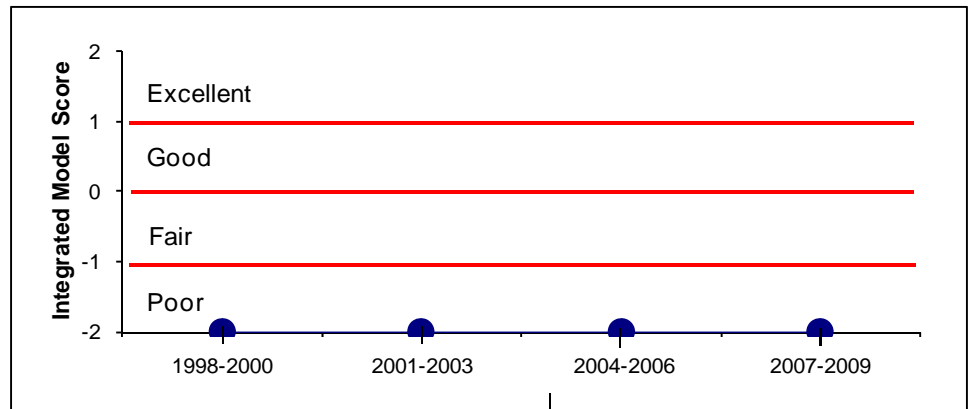
Site Rating: Poor

Each site is rated as one of the following categories (going from worst to best): poor, fair, good, and excellent. This rating comes from an integrative model that is based on the last 3 years of insect data, the most recent habitat data, stream temperature, and stream size.
