# Fleming Creekshed Report

## Creekshed Profile

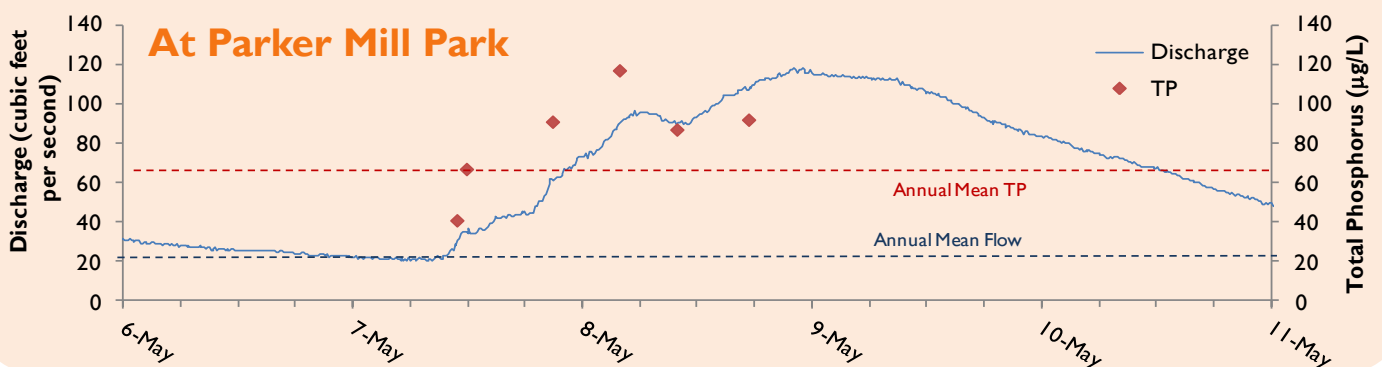
### 2010 Storm Event

One inch of rain fell on May 7, between 8 AM through 8 PM.

### At Parker Mill Park

Phosphorus is the limiting nutrient in most freshwater systems, meaning that too much phosphorus can cause algal blooms and water quality problems. The target for area streams is < 50 µg/l. Fleming Creek's mean total phosphorus (TP) is 66 µg/l, which is elevated, particularly after heavy storms (see below). This is likely due to residential and agricultural runoff.

Stream flow is an important underlying factor for determining likely erosion rates, stream habitat quality, and aquatic community diversity. An important measure is "flashiness" or the rate a stream rises and falls through a storm event (see below). Fleming Creek has a flashiness rating that is high for comparable Michigan streams, but average for the Midwest.
