# Davis Creekshed Report

## Creekshed Profile

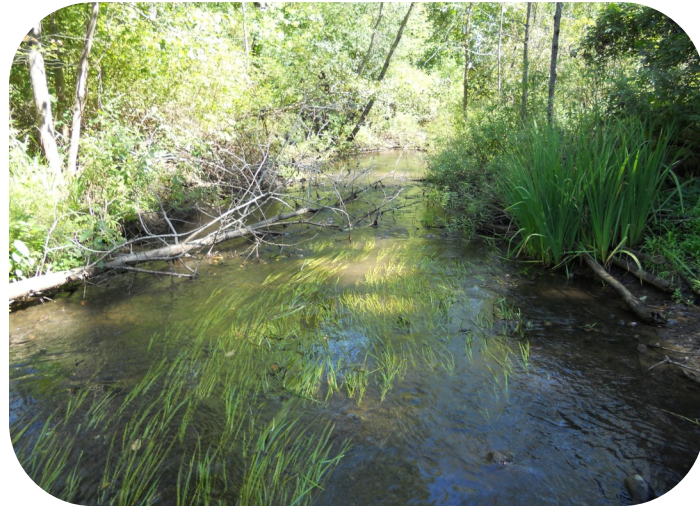
In stream plants and woody debris offer plenty of habitat variety at this site on Doane Road. Credit: Cheryl Tabacki

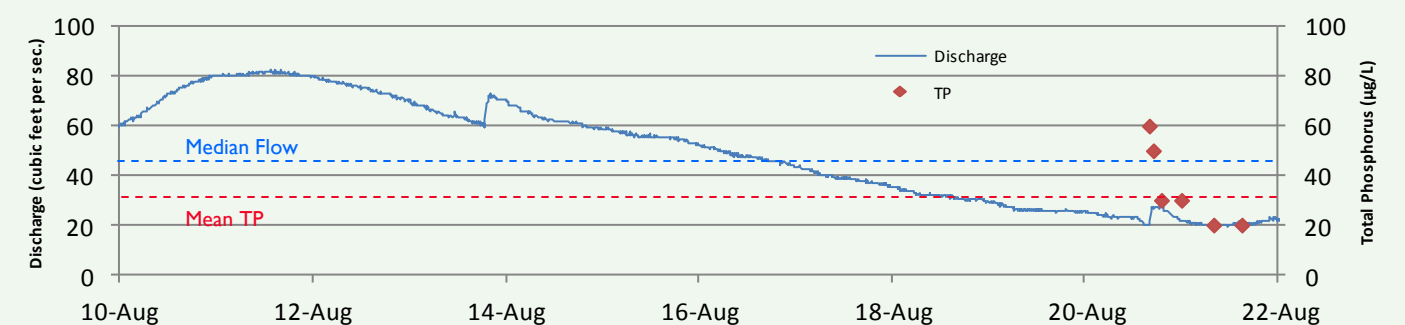
## 2010 Storm Event Graph 0.38 inch of rain fell on August 20.

Stream flow is an important underlying factor for determining likely erosion rates, stream habitat quality, and aquatic community diversity. An important measure is "flashiness" or the rate a stream rises and falls through a storm event (see below). Davis Creek has a flashiness rating that is low or more natural than comparable Michigan and Midwestern streams.
