The State of the Huron's River and Tributaries

The State of the Huron
Conference
April 24, 2014

Welcome to the Huron River Watershed

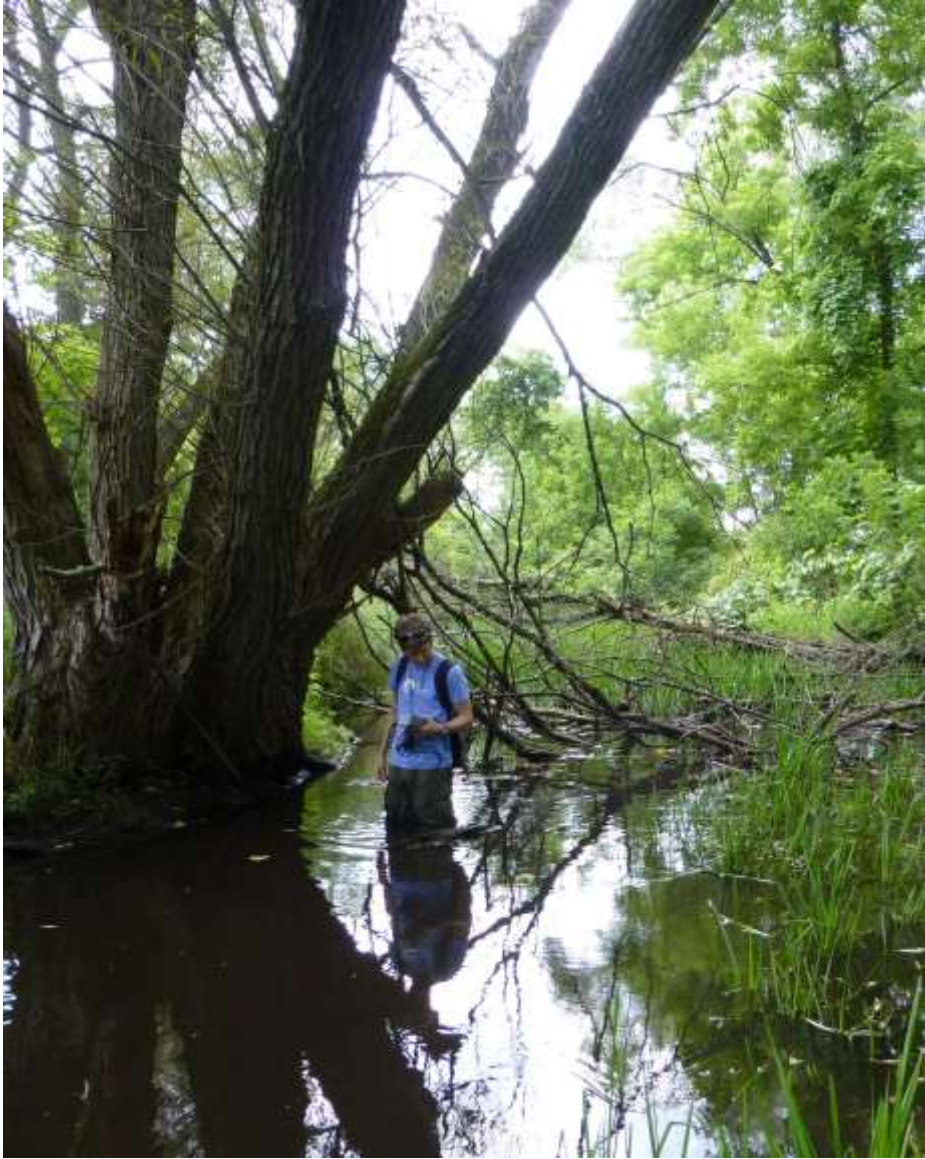
Arms Creek land preservation

- 3,400 acres of land have been protected from development by:
 - Greenbelt Program
 - Legacy Land Conservancy
 - Independence Park
 - Webster Township
- Part of the creek is in a State Natural River Zone; Webster township has expanded protection to the entire creek.

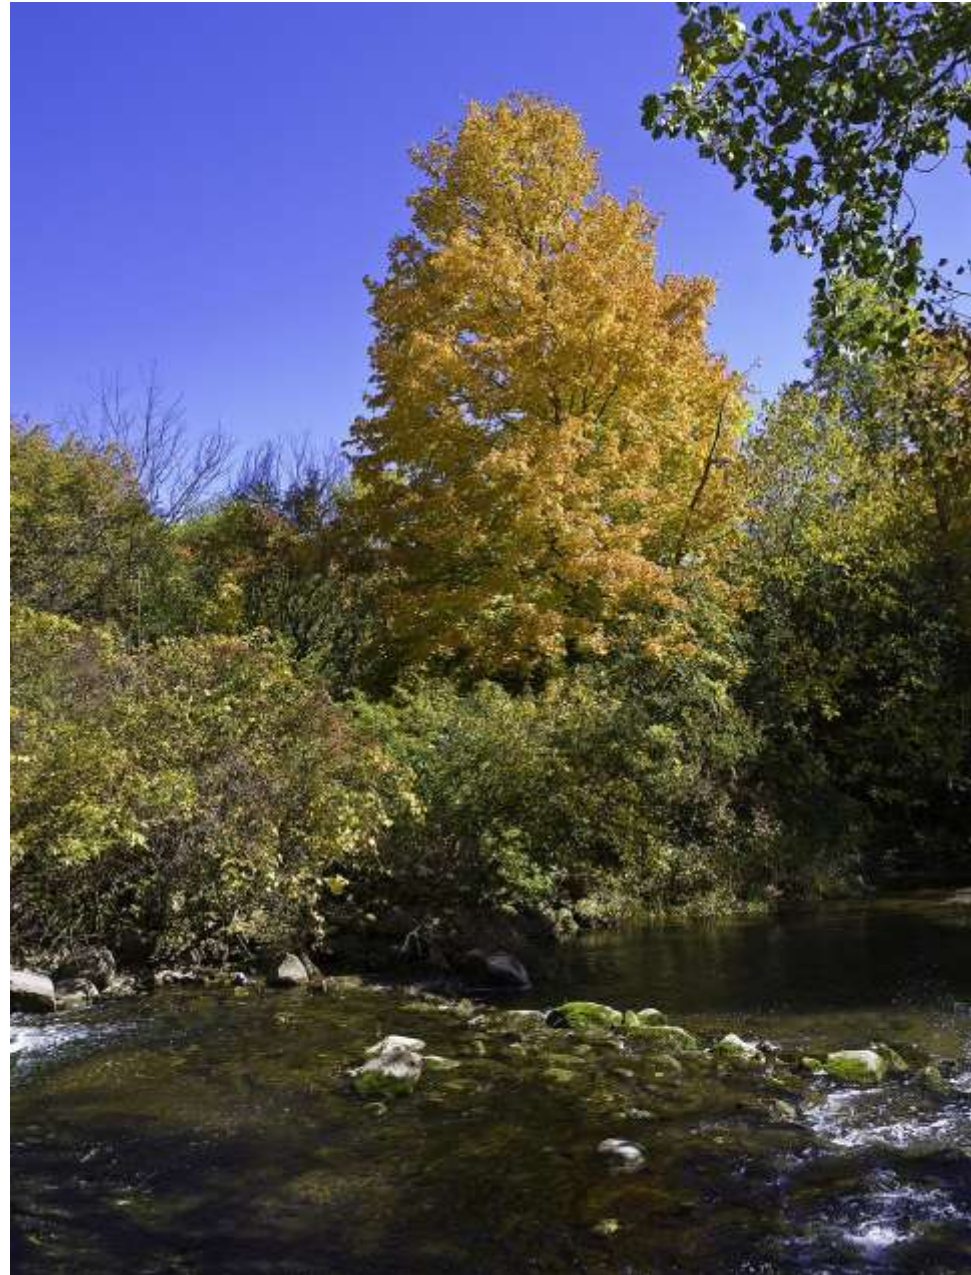
Fleming Creek Happenings

- Re-establishment of the Fleming Creek Advisory Council
- Bank stabilization projects and stream restoration work.
- Radrick Farms and Fox Hills Golf Courses
- Lands protected by Ann Arbor's Greenbelt program (450 acres since 2006).
- The northwest area of Fleming Creek has the second best macroinvertebrate population in the Watershed.

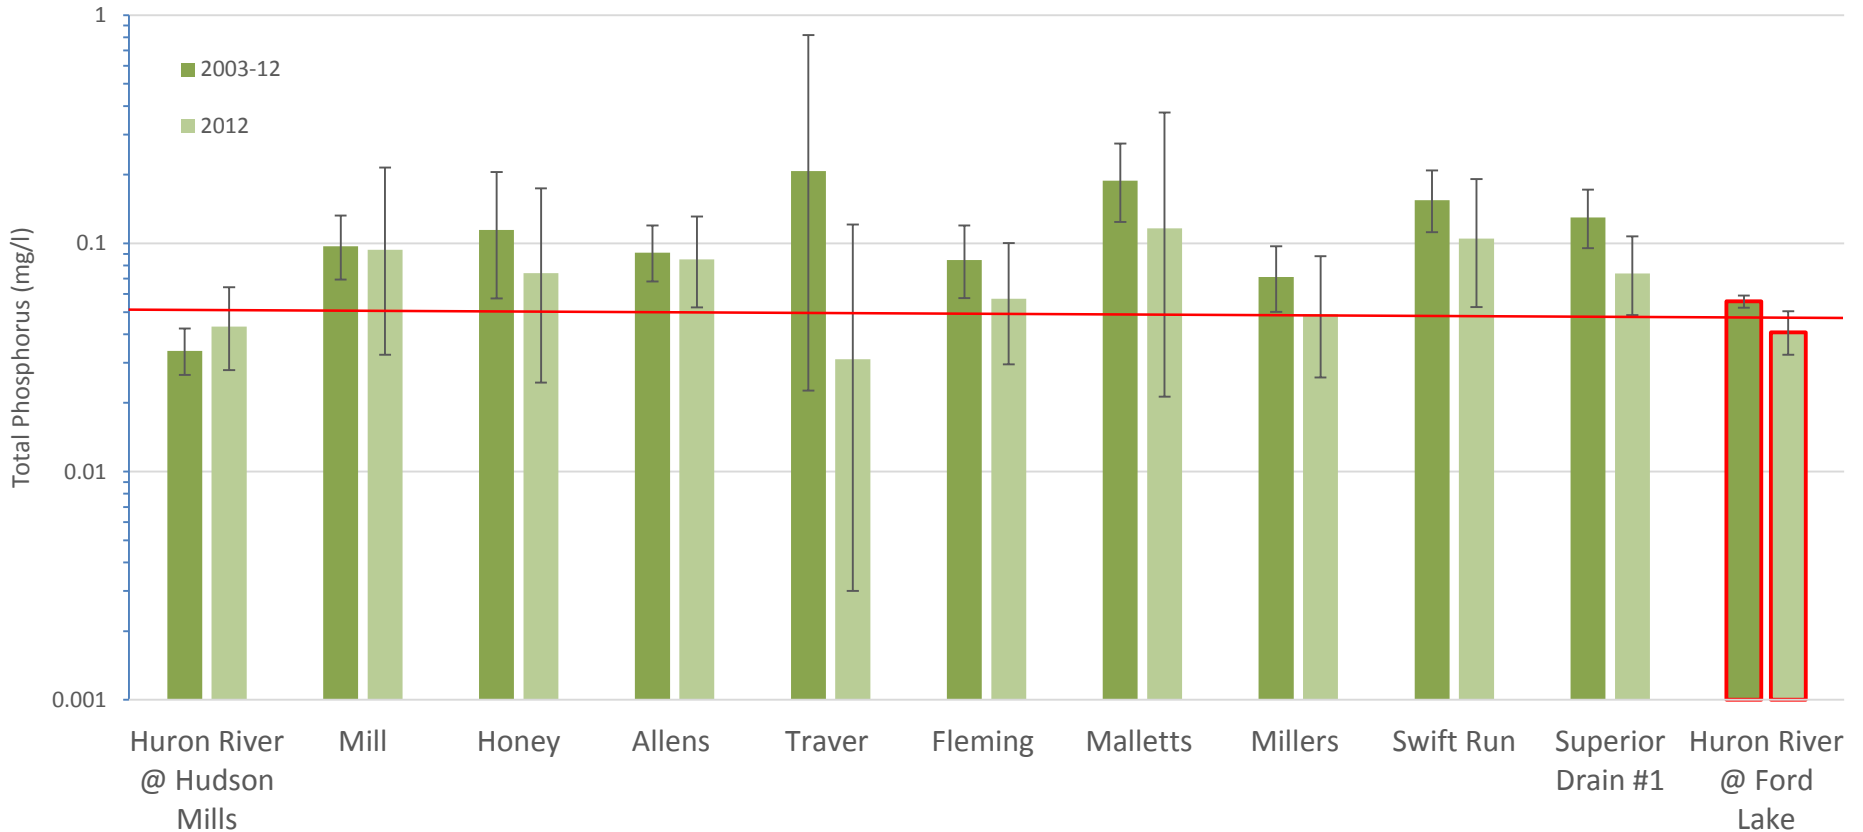
Phosphorus in the Middle Huron

Bars show flow-weighted mean total phosphorus at 11 monitoring stations for the entire monitoring period (2003-12) and the most recent calculated year (2012). The red line is the target concentration of 0.05 mg/l.

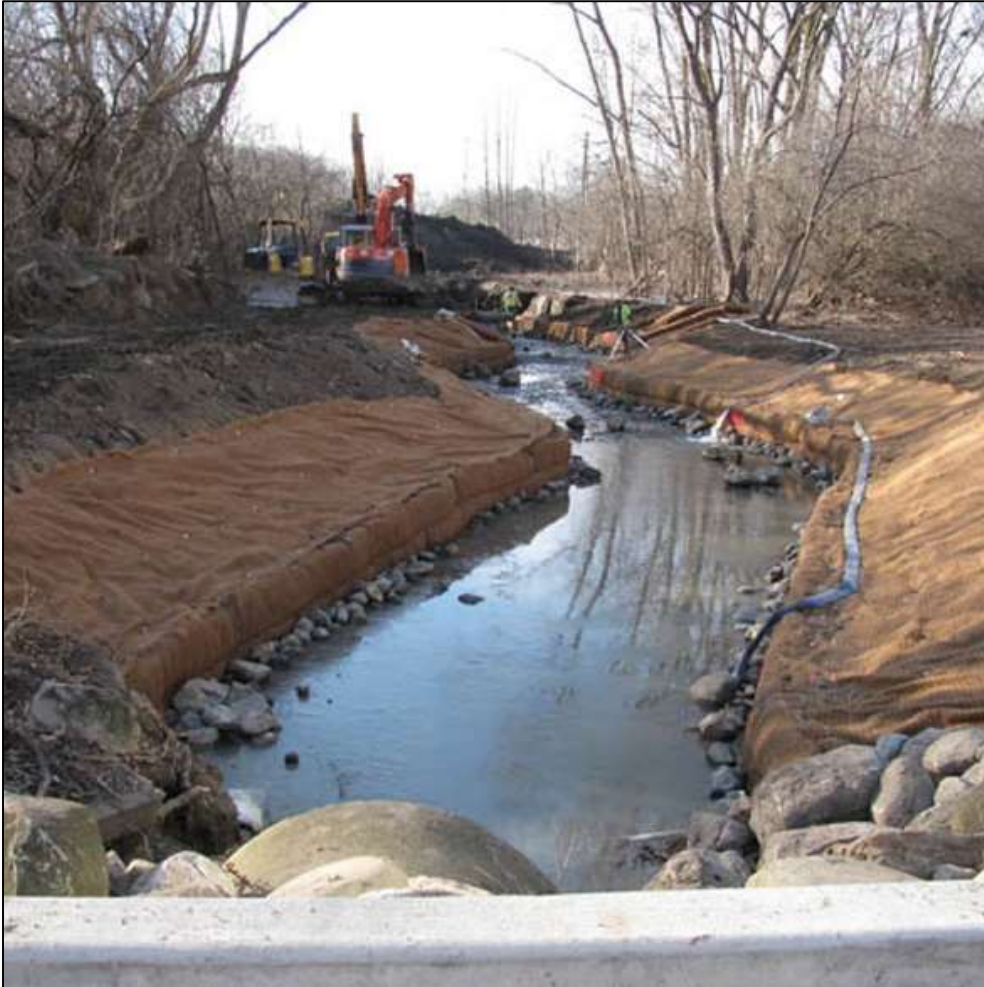
Stream reshaping at County Farm Park

Holding back stormwater and fixing erosion:

- 1) Malletts Creek Library (2002)
- 2) Mary Beth Doyle Park wetland restoration (2006)
- 3) Malletts Creek Streambank Restoration (2012). Many places including high profile project at County Farm Park.
- 4) Buhr Park Children's Wet Meadow (ongoing since 1997)

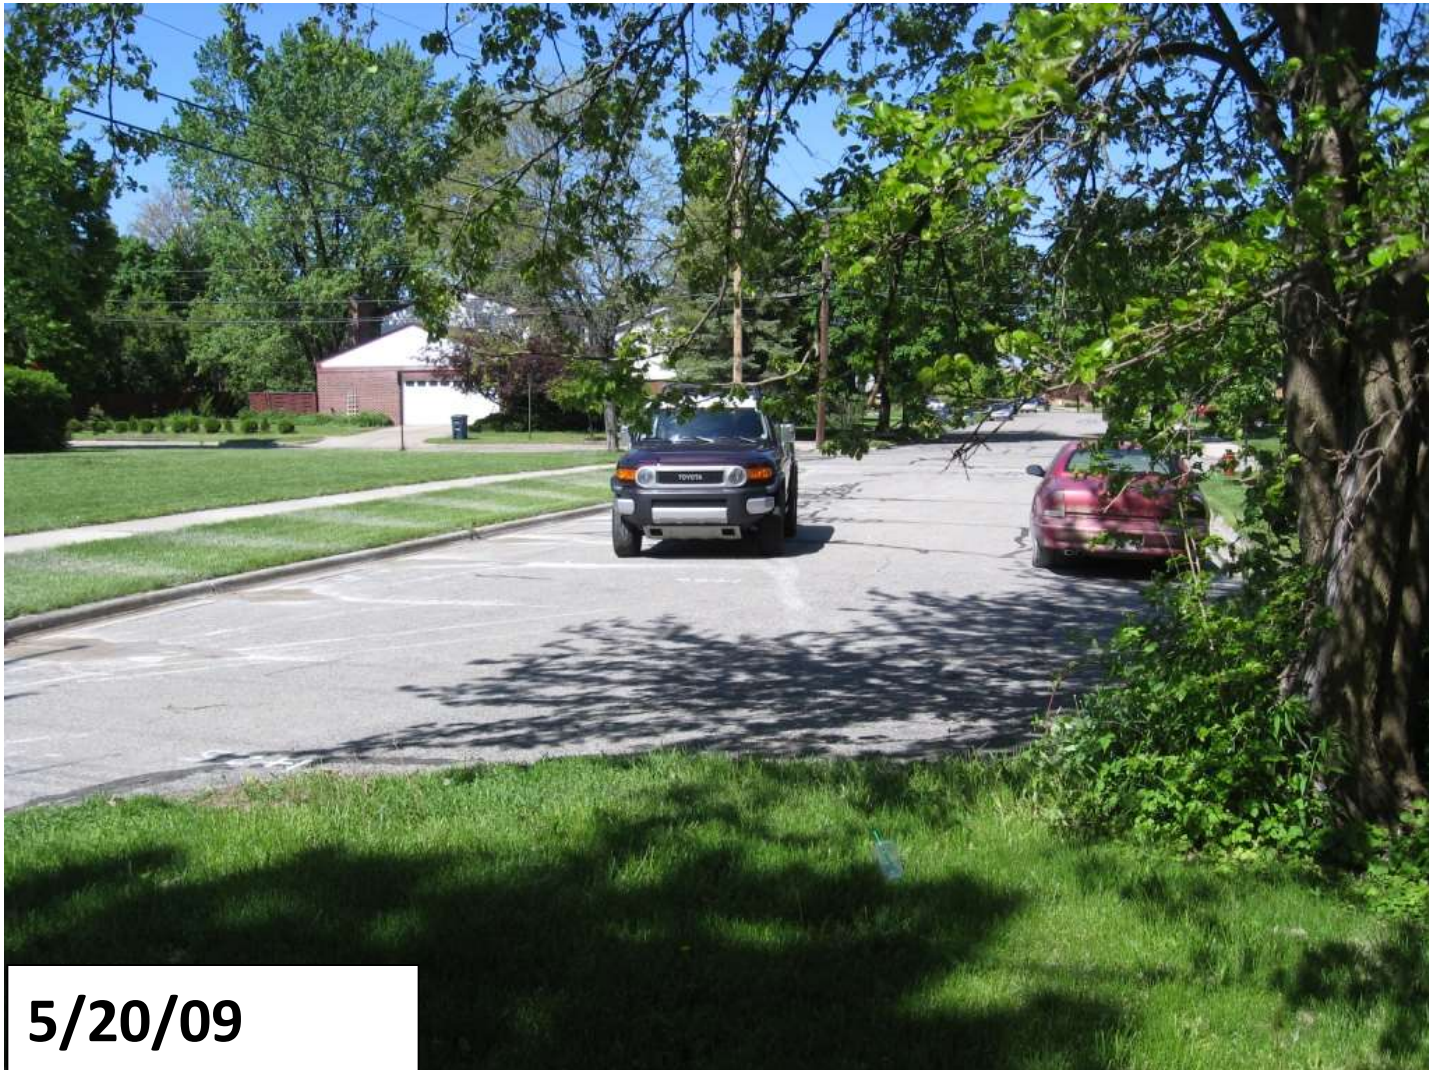
5/20/09

Millers Creek Stormwater and Erosion

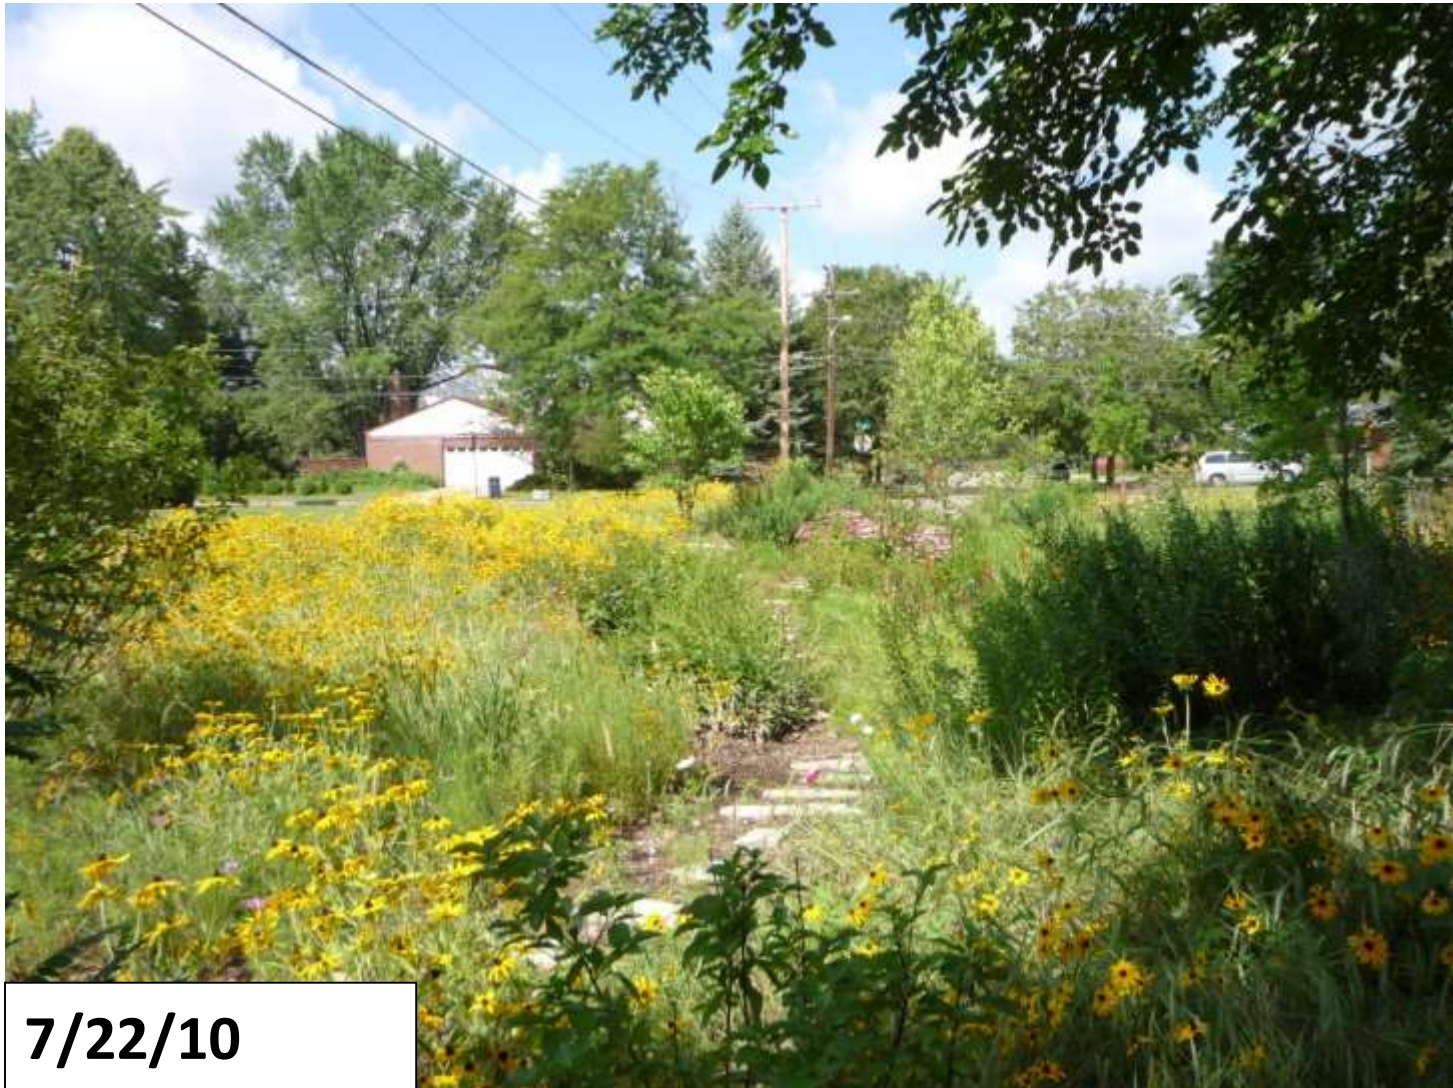
7/22/10

Millers Creek Stormwater and Erosion

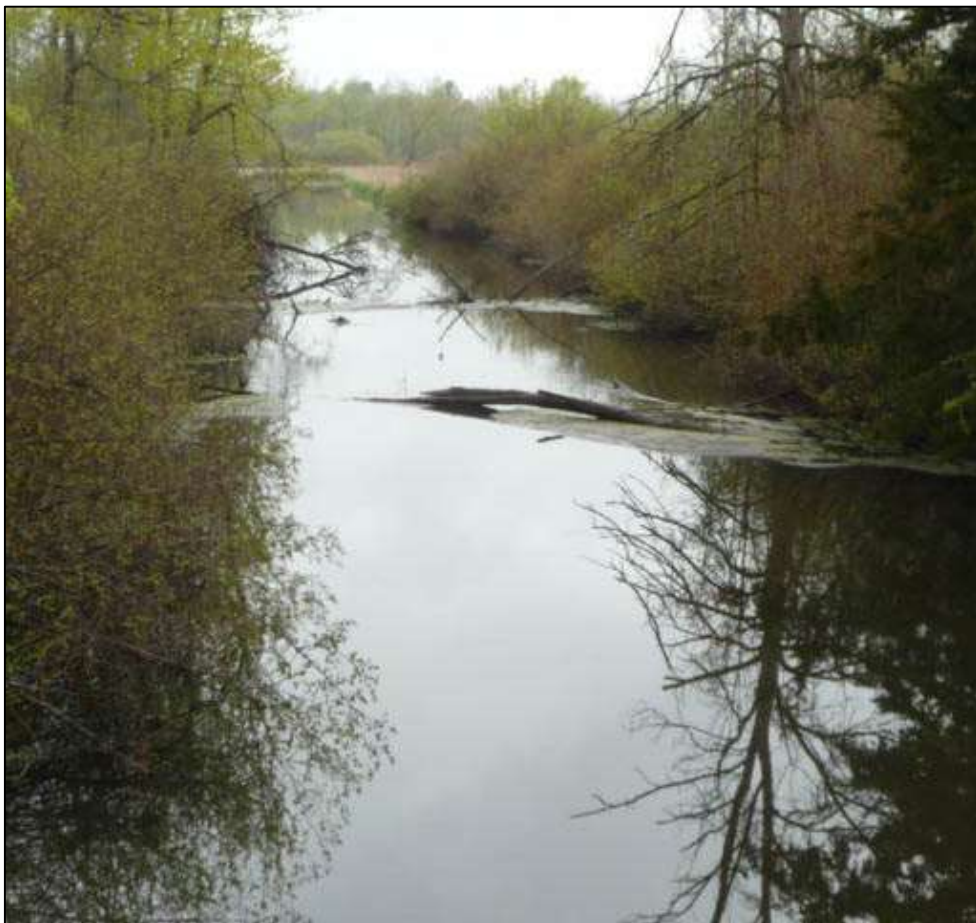
Channelized section of Norton Creek

- A creekshed with a long history of channelization, residential development, and industry.
- **Poor Scores in:**
 - Dissolved Oxygen
 - Phosphorus
 - Conductivity & TDS
 - Land use
 - Aquatic Insect Community
 - Fish
 - Flashy Water flow

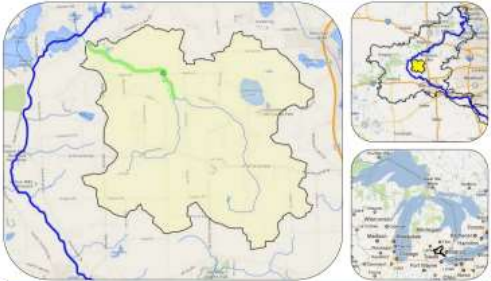
Monitoring site for Aquatic Insects, Stream Habitat, and Stream Temperature. For more details on these parameters, please see inside.
