RESTORING MILL CREEK

Stabilizing Streambanks with Bioengineering

Restoring Mill Creek: Stabilizing Streambanks with Bioengineering

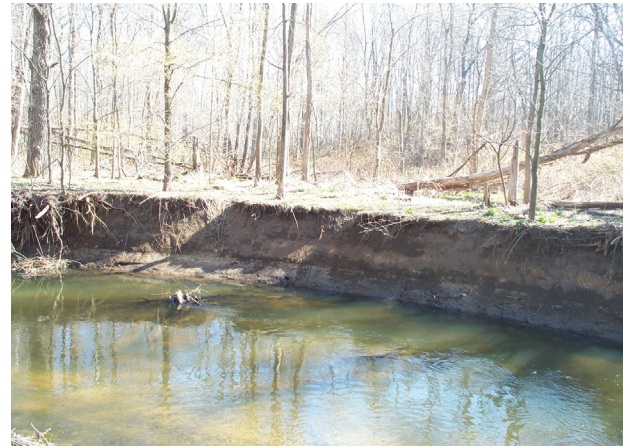
Before. Bare, vertical banks at this site were the result of dredging and upstream changes to hydrology in Mill Creek.

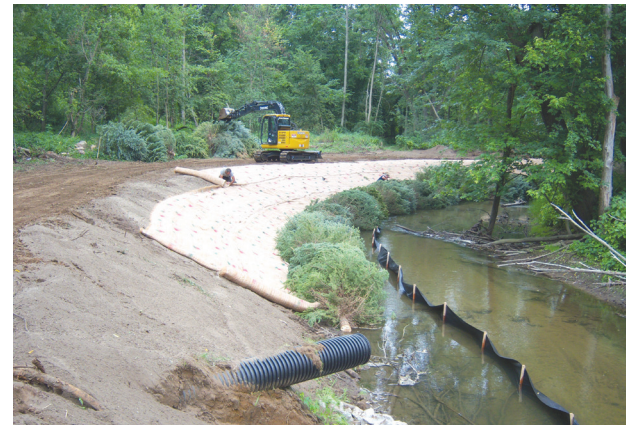
During. Crews pull back the slope and install soft engineering techniques such as erosion control blankets and trees sourced from a local tree farm. Photo: ECT

Tree revetments are rows of interconnected trees attached to the toe of the streambank to reduce flow velocities along eroding streambanks, trap sediment, and provide a substrate for plant establishment and erosion control. Tree revetments provide temporary bank protection while vegetation is getting established, then slowly degrade.

Live stakes are live, woody cuttings of native species that are tamped into the soil to root, grow and create a living root mat that stabilizes the soil by reinforcing and binding soil particles together, and by extracting excess soil moisture. At the Mill sites, stakes were placed in three rows spaced 1.5 ft apart at the upslope edge of the whole tree revetment.

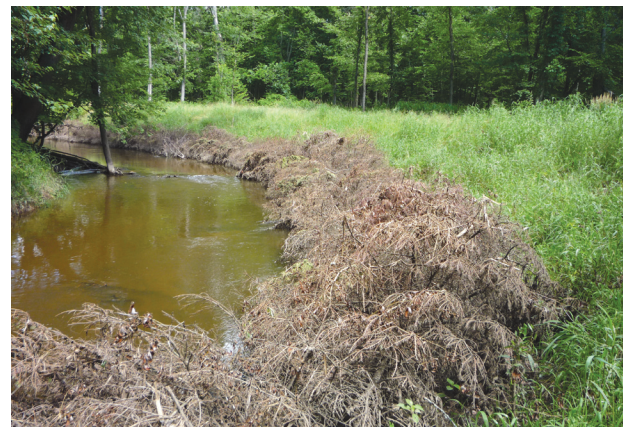
After streambank restoration. Nearly one year after construction and high flows, the banks are vegetated with native trees, shrubs and grasses.
