Huron River Watershed Council

# Traver Creekshed Report

## Creekshed Profile

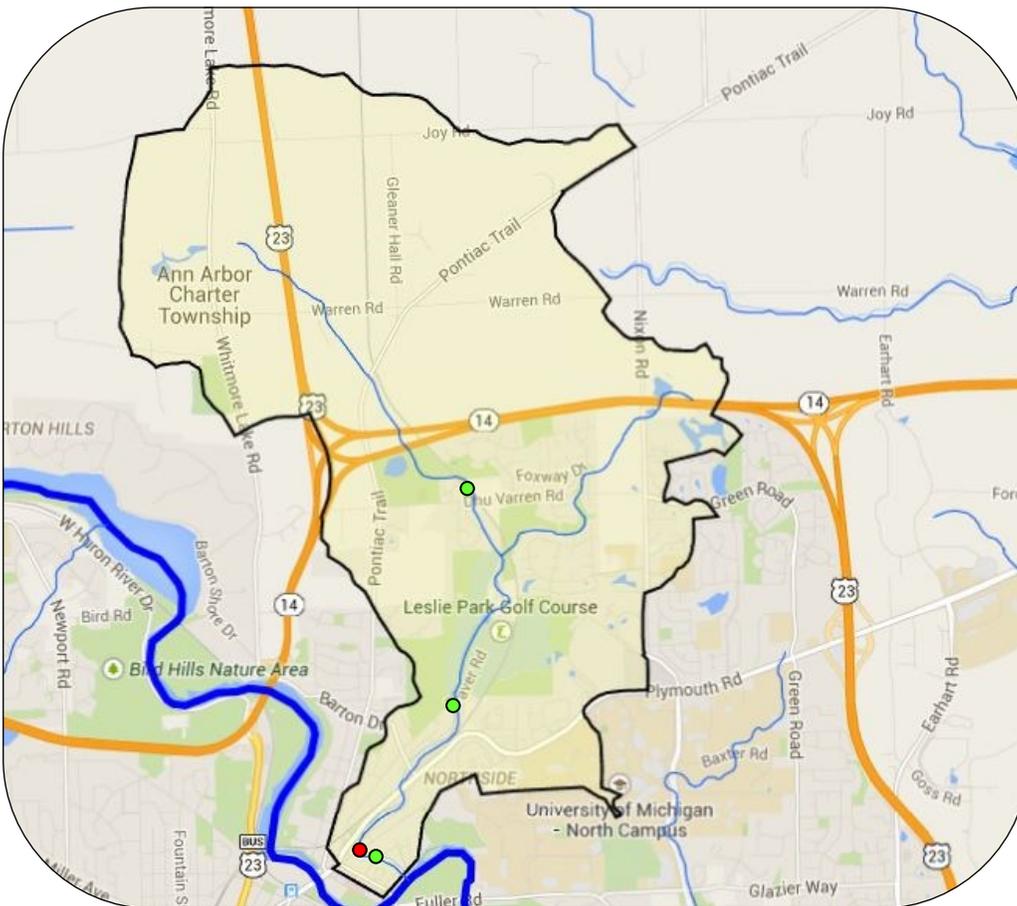
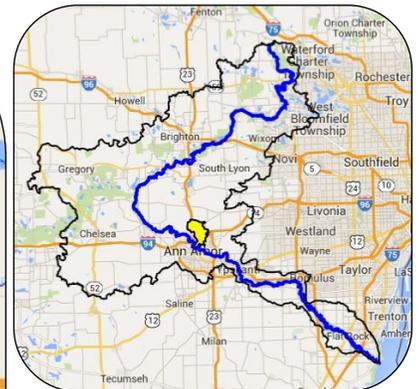
- Monitoring sites for Aquatic Insects, Stream Habitat, and Stream Temperature For more details on these parameters, please see inside.
- Monitoring site for Stream Flow, Phosphorus, Total Suspended Solids, and *E. coli*

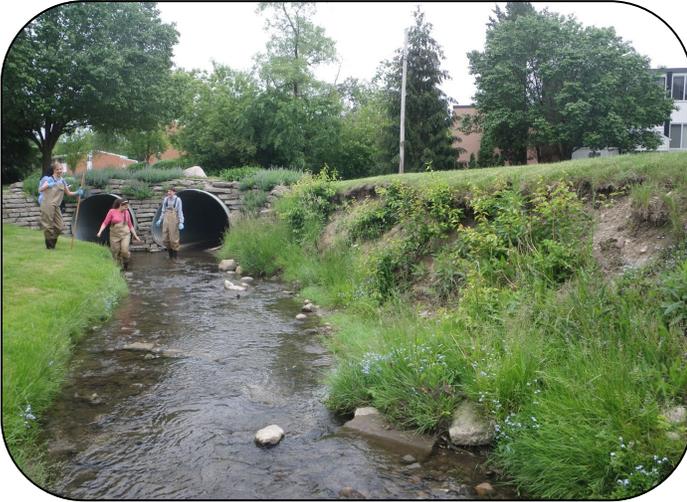
Many sections of Traver Creek have no vegetative buffers and are experiencing bank erosion. Credit: HRWC

Traver Creek has the substrate favorable for aquatic life throughout the creek; boulders, rocks, sand, and very little little muck or clay. However, eroding banks throughout the lower section of the creek indicate that flashy flow conditions are a serious issue. There is also little instream woody debris or depth variation to provide cover and flow refuges. The upper portions of the creek are better, although this habitat could not be considered healthy or diverse compared to other Huron River tributaries more removed from urban centers.

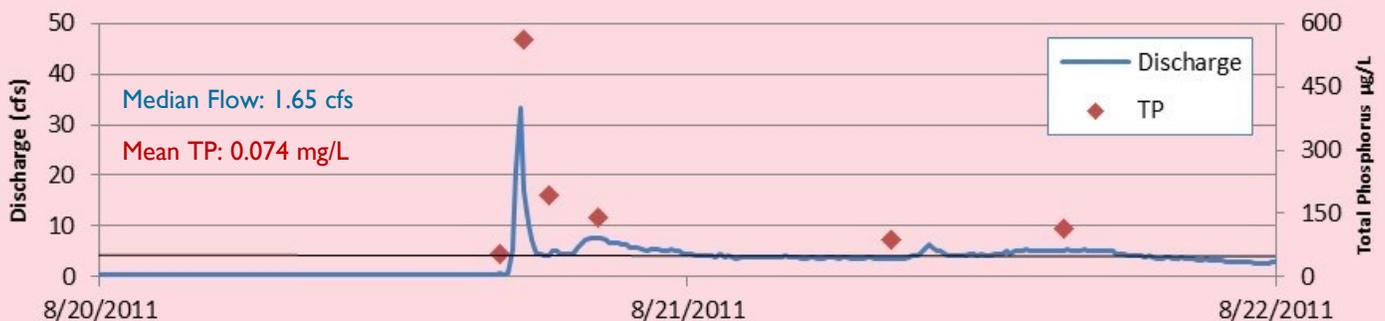
## 2011 Storm Event Graph 0.50 inch of rain fell on August 20.

Stream flow is an important underlying factor for determining likely erosion rates, stream habitat quality, and aquatic community diversity. An important measure is "flashiness" or the rate a stream rises and falls through a storm event (see below). Traver Creek has a flashiness rating that is high or less natural than comparable Michigan and Midwestern streams.

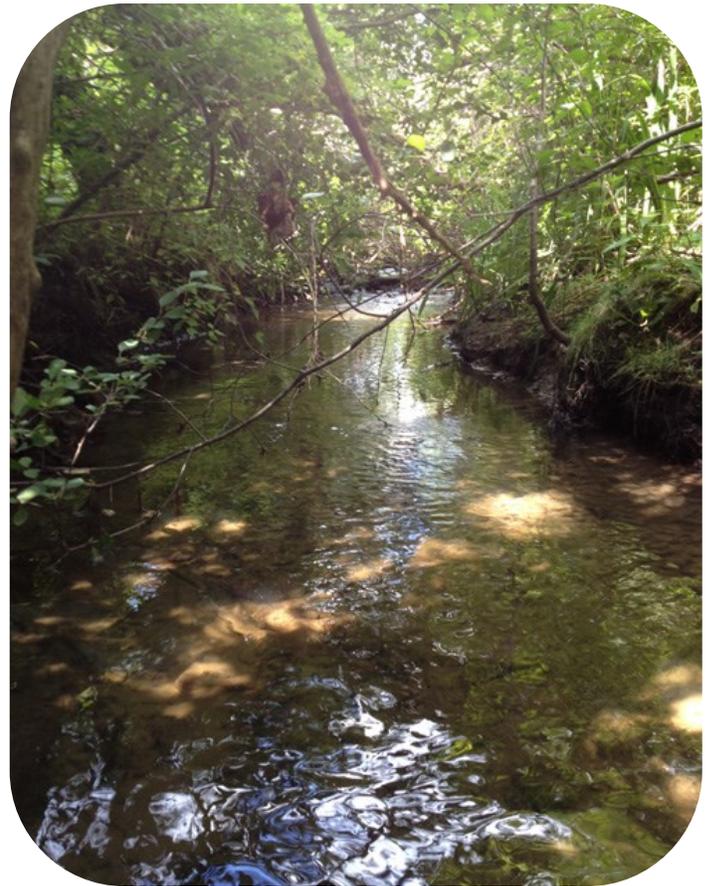
The upstream portion of Traver Creek runs through a shady riparian zone. Credit: HRWC
