A partnership between The Washtenaw County Drain Commissioner, The City of Ann Arbor, and Pittsfield Township.

EXECUTIVE SUMMARY

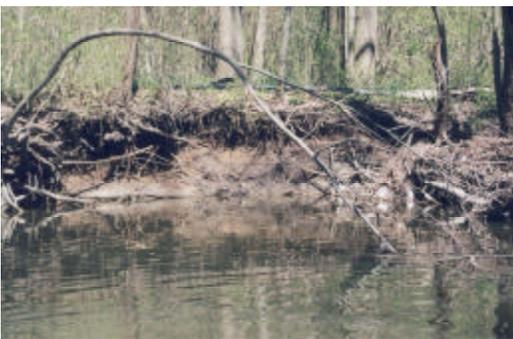
Severe bank erosion at Chalmers Road

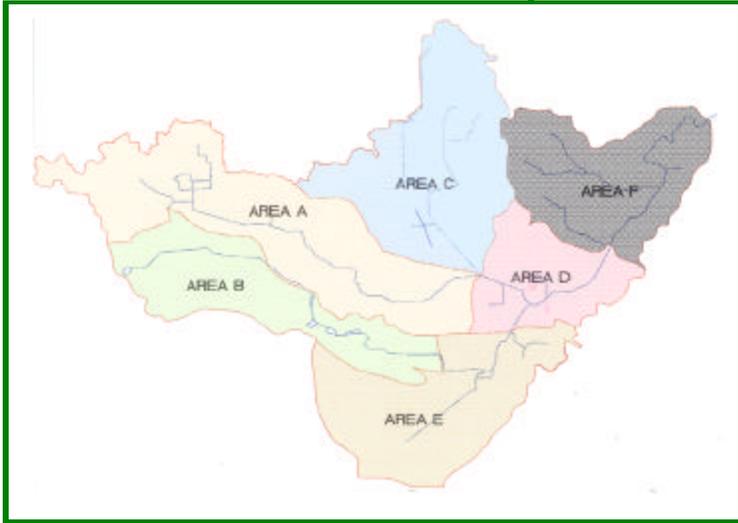
Malletts Creek Subwatersheds

This portion of the modeling study showed that Malletts Creek is experiencing extreme peak flows, most likely attributable to the fact that 22% of the land area in the watershed is impervious surface directly connected to the storm water system and creek. Half of the flow of Malletts Creek is from the Burns Park residential neighborhood (shown as area “C” on the map displayed to the left), which represents 20% of the watershed.

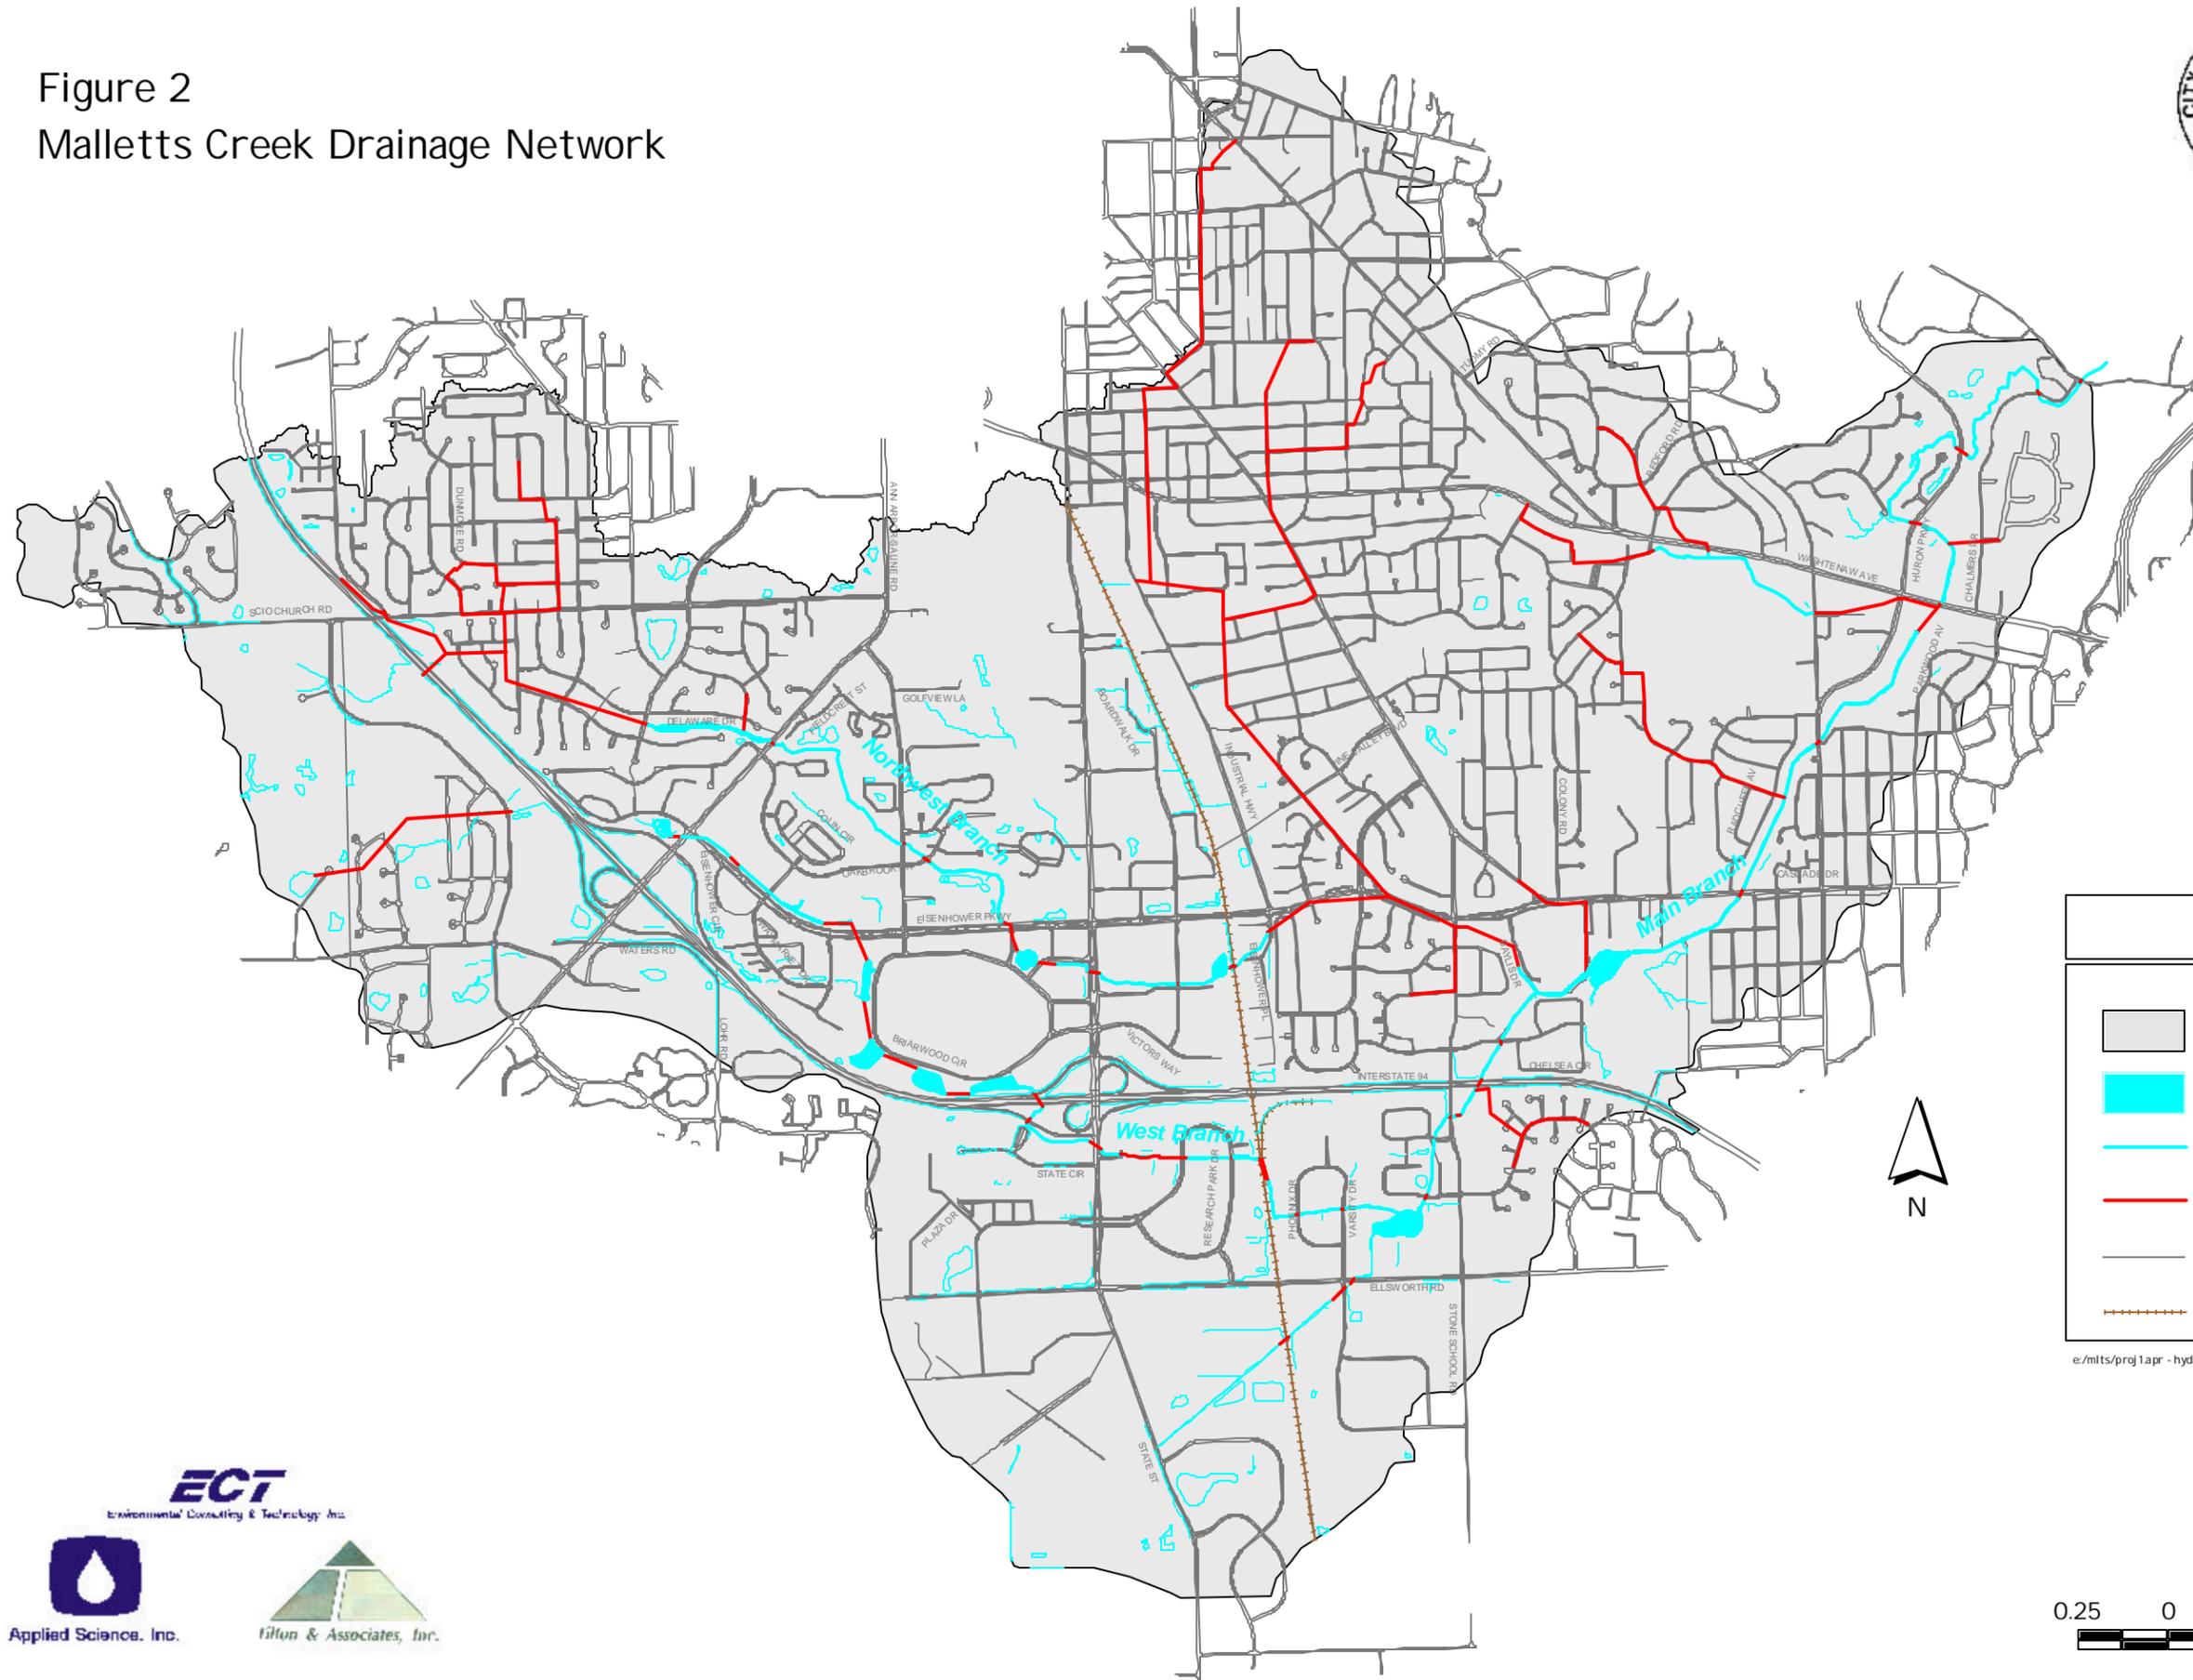
Figure 2
Malletts Creek Drainage Network

The Main Branch of Malletts Creek is the most easterly branch draining areas south of I-94 including the Ann Arbor Airport (see Figure 2). The West Branch drains the westerly portion of the watershed and extends east of I-94 past Ann Arbor-Saline Road. The West Branch includes the Briarwood commercial area as well as residential and commercial development in Pittsfield Township. The Northwest Branch drains the Dicken, Lansdowne and Briarwood neighborhoods. Several other tributaries to the Northwest Branch have been enclosed and serve the Ann Arbor Hills, Burns Park, Georgetowne and the Allen School neighborhoods. These storm sewer systems are depicted as red on Figure 2.

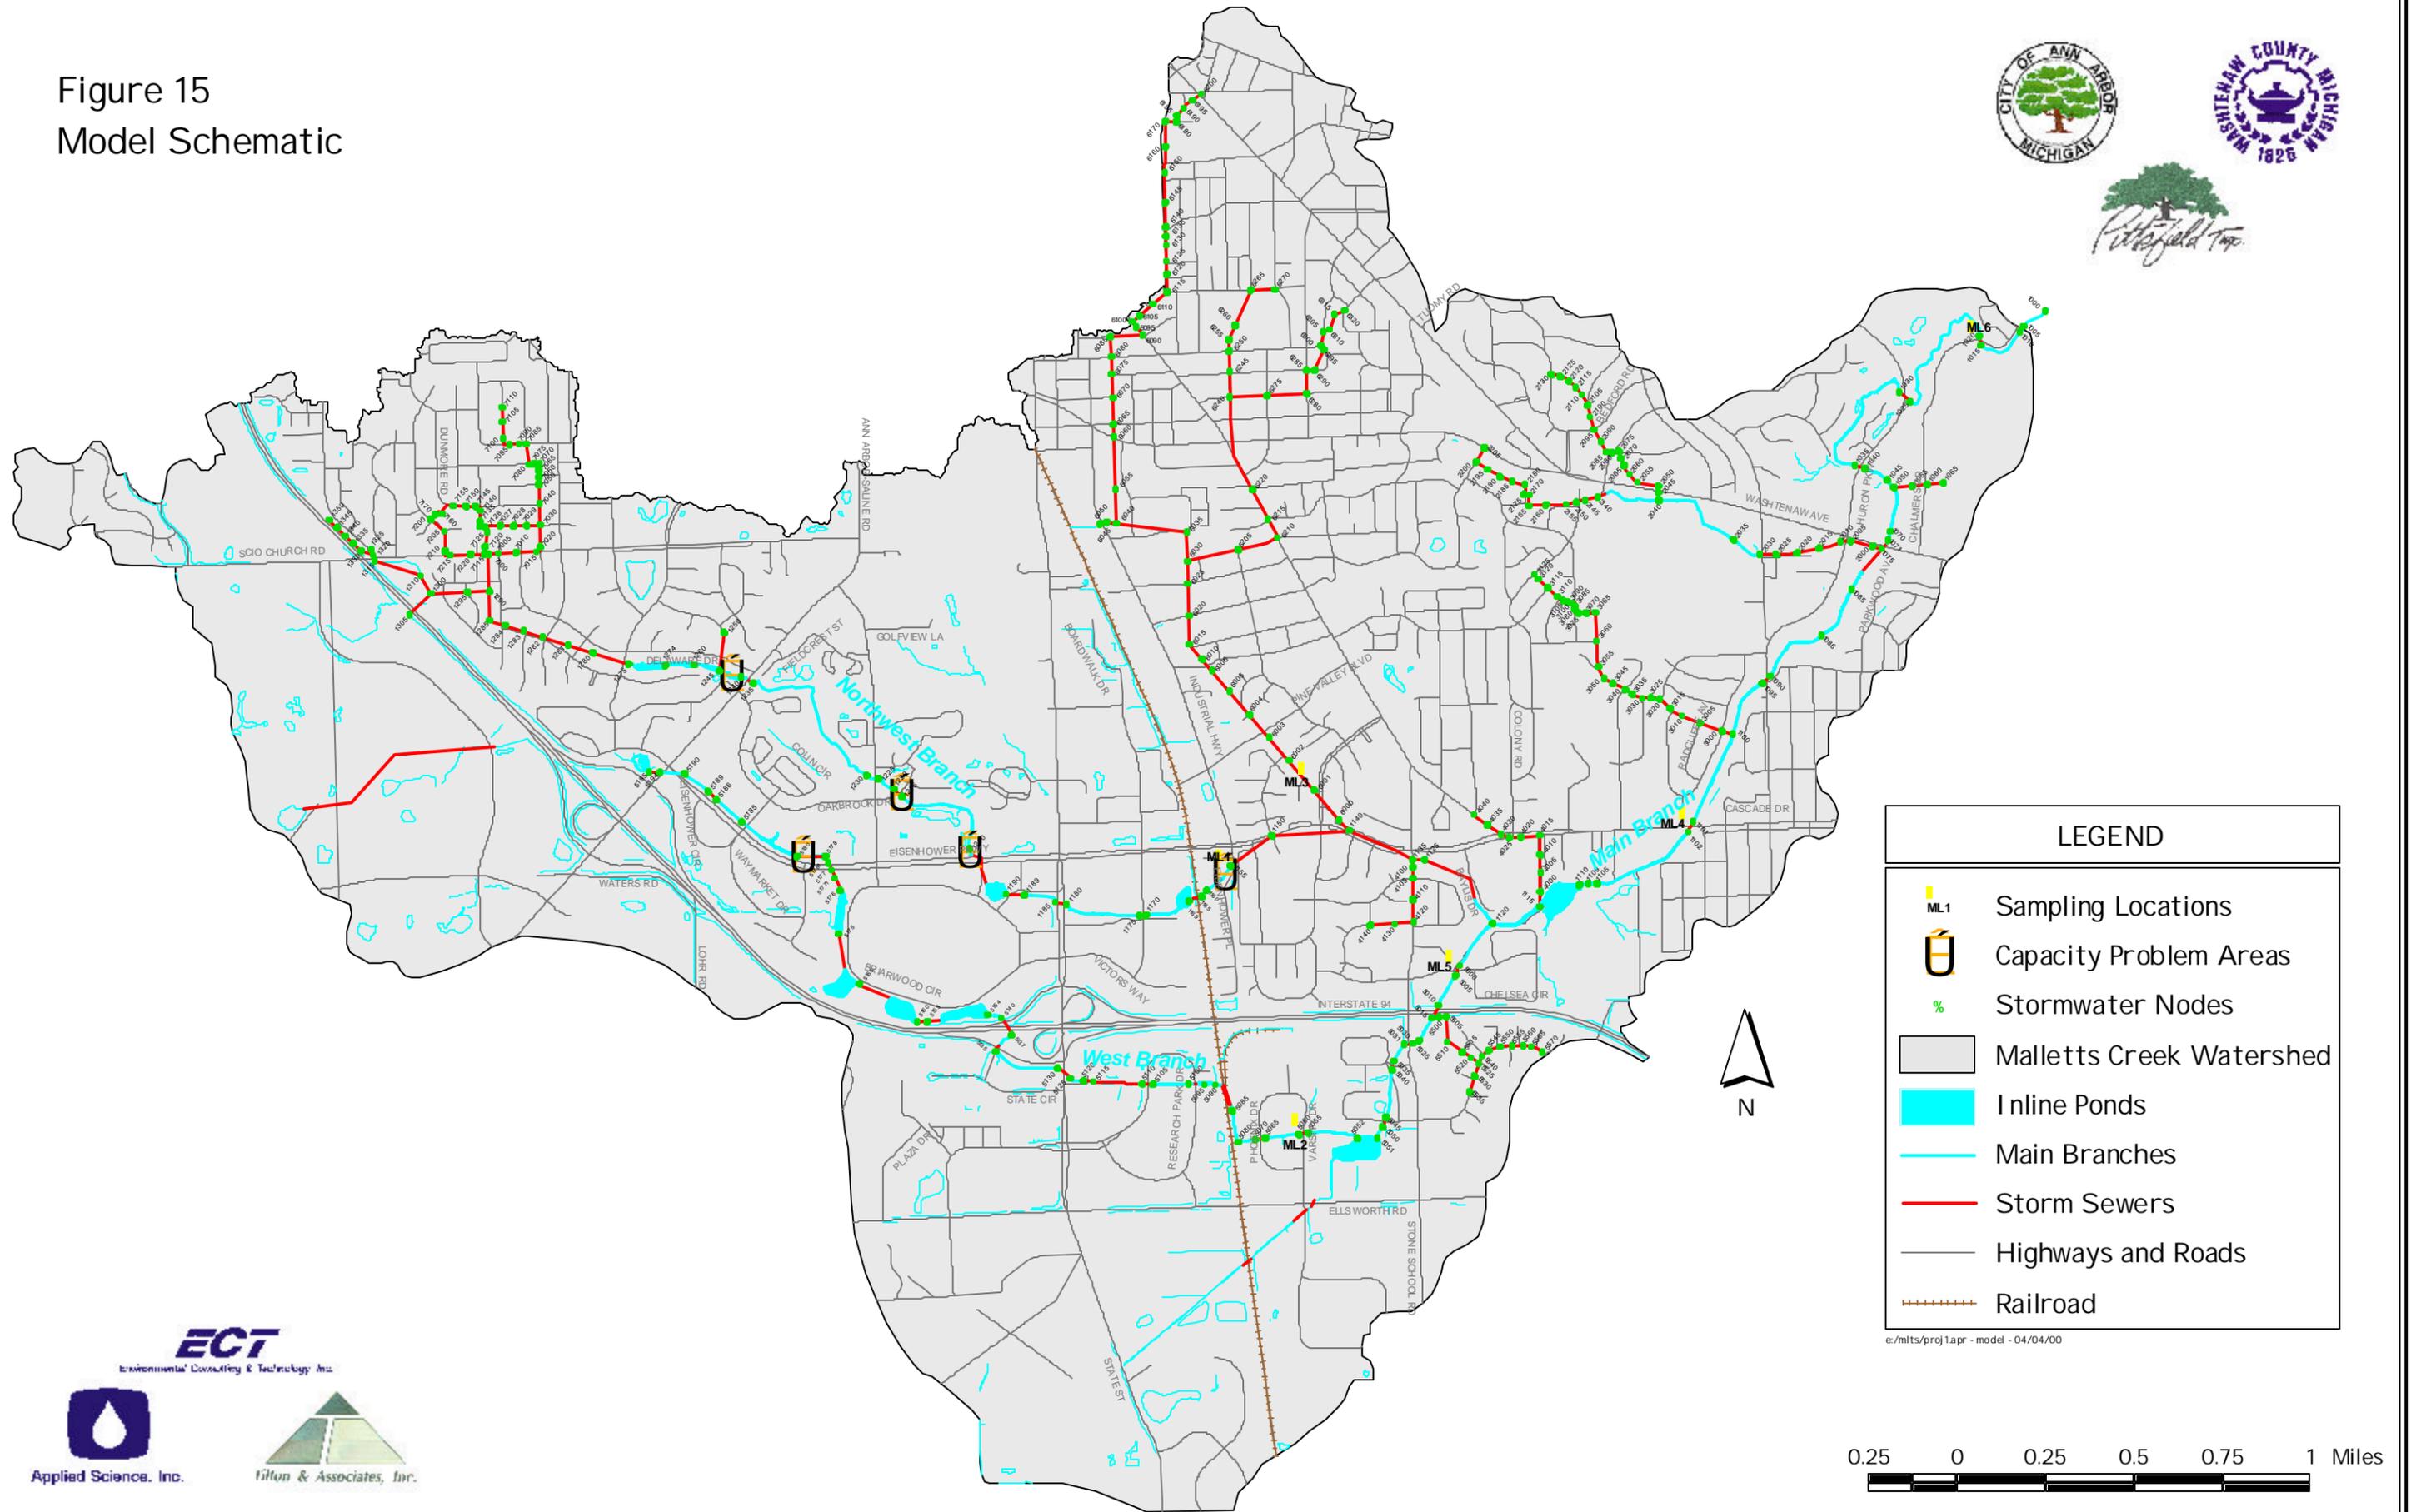
Figure 15
Model Schematic

This project involves investigating the flooding problems at the Eisenhower Office Park and in the area of Eisenhower Parkway west of State Street. The estimated cost is \$20,000 and includes, further study and analysis, including a survey of grades and building elevations. Research into the permits issued, and compliance with permit conditions will be done. Meetings between affected parties will occur to attempt to develop alternative solutions responsibilities for funding, and an implementation schedule. These areas are indicated on Figure 15, the model schematic.

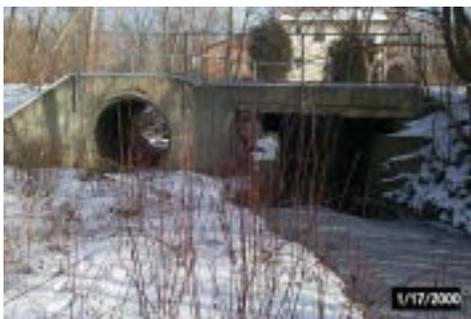
Old Stone School Road bridge in need of repair

The conduits passing under Old Stone School Road are eroding badly. The eroded sediment, of course, contributes to the sediment load. More importantly the road continues to be undermined. As a result the restoration plan recommends a detailed engineering analysis be performed and the required repairs be completed.

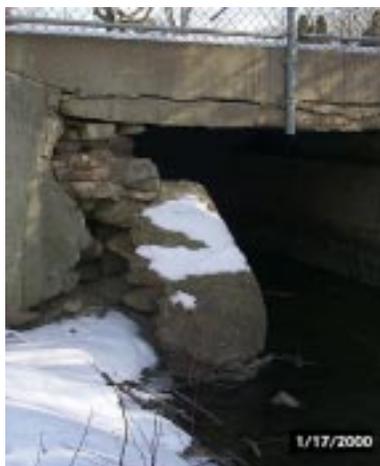
Close up of Old Stone School Road bridge damage
