Creekshed Profile

Boyden Creek has a small watershed, draining 7.4 square miles via 7.5 miles of creeks and streams. The creek's slope (averaging 18.6 feet per mile) makes Boyden Creek one of the steeper creeks in the Huron watershed. There are 2 lakes (open water > 5 acres) and 8 ponds (open water < 5 acres) in the Boyden creekshed. The townships of Scio, Webster, Northfield, and Ann Arbor, and Washtenaw County Water Resources Commissioners all make decisions that affect the creek.

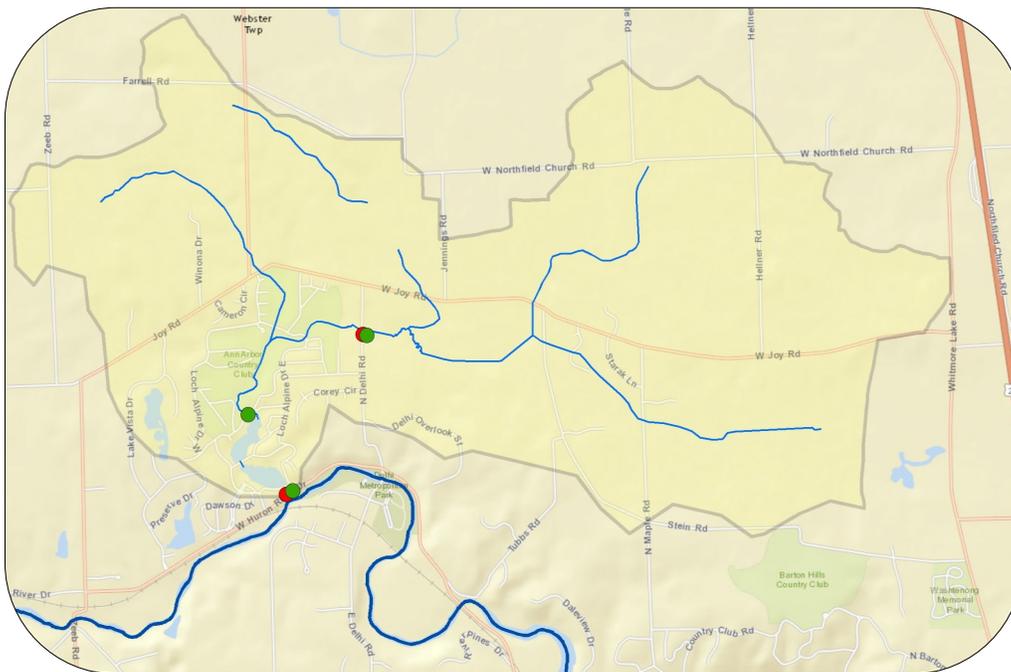
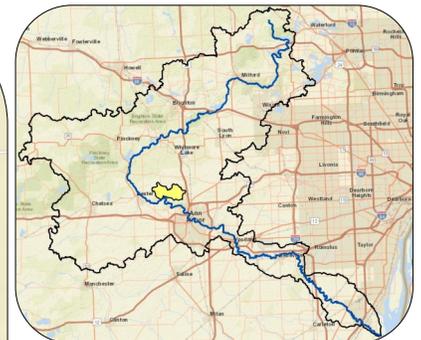
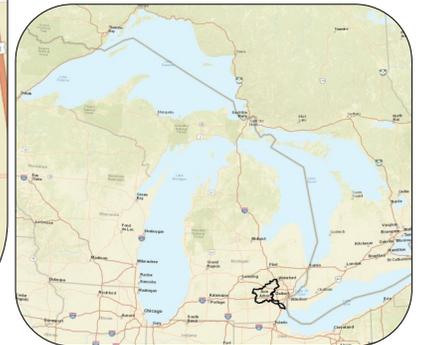
- Monitoring sites for Aquatic Insects, Stream Habitat, and Stream Temperature For more details on these parameters, please see inside.
- Monitoring site for Stream Flow, Phosphorus, Total Suspended Solids, and *E. coli*

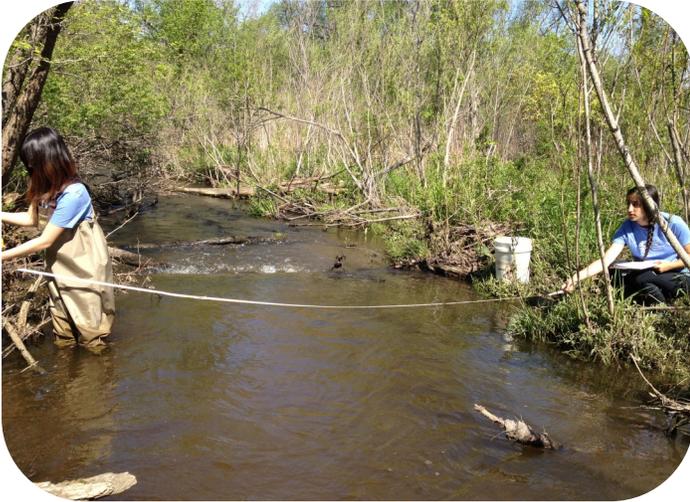
HRWC Interns take measurements in a headwater stretch of Boyden Creek
Credit: HRWC

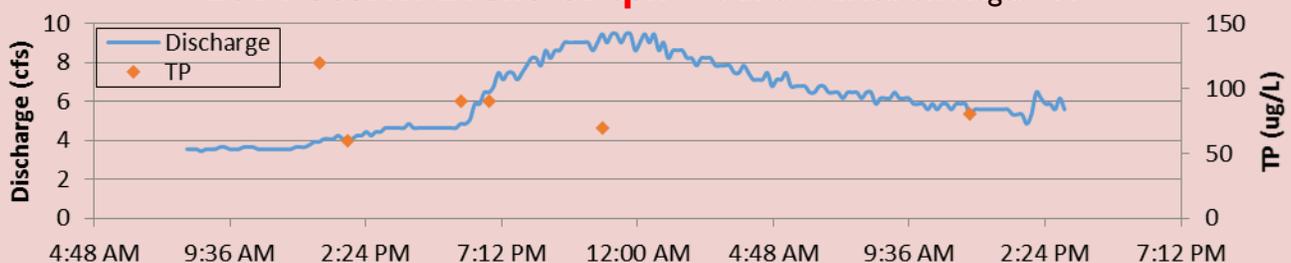
2014 Storm Event Graph 0.5 in of rain fell on August 11.

Stream flow is an important underlying factor for determining likely erosion rates, stream habitat quality, and aquatic community diversity. An important measure is "flashiness" or the rate a stream rises and falls through a storm event (see below). At the monitoring station, Boyden Creek has a flashiness rating that is high or less natural than comparable Michigan and Midwestern streams. This is likely due to the outlet structure of the dam, and is not necessarily representative of the entire creek.

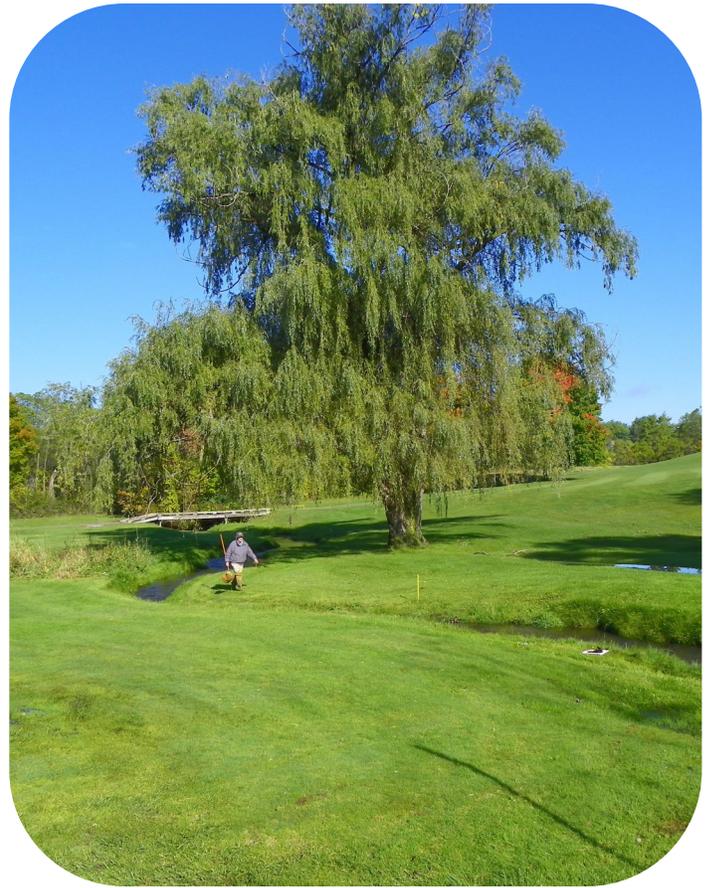
A section of Boyden Creek flows through a former golf course with no vegetated riparian zone and offers little shading. Credit: Jana Smith

- The Ann Arbor Country Club is no longer in business, and the property owner has proposed developing a housing project on the land. However, because of a restriction agreement with Loch Alpine Improvement Association, the developer is prohibited from building without the Association's approval. Therefore, it is not clear what will happen on the old golf course. This could be an opportunity to create a large riparian buffer along Boyden Creek. Doing so would create new habitat for wildlife, improve habitat in the creek, improve water quality, and lower water temperatures.
