Creekshed Profile

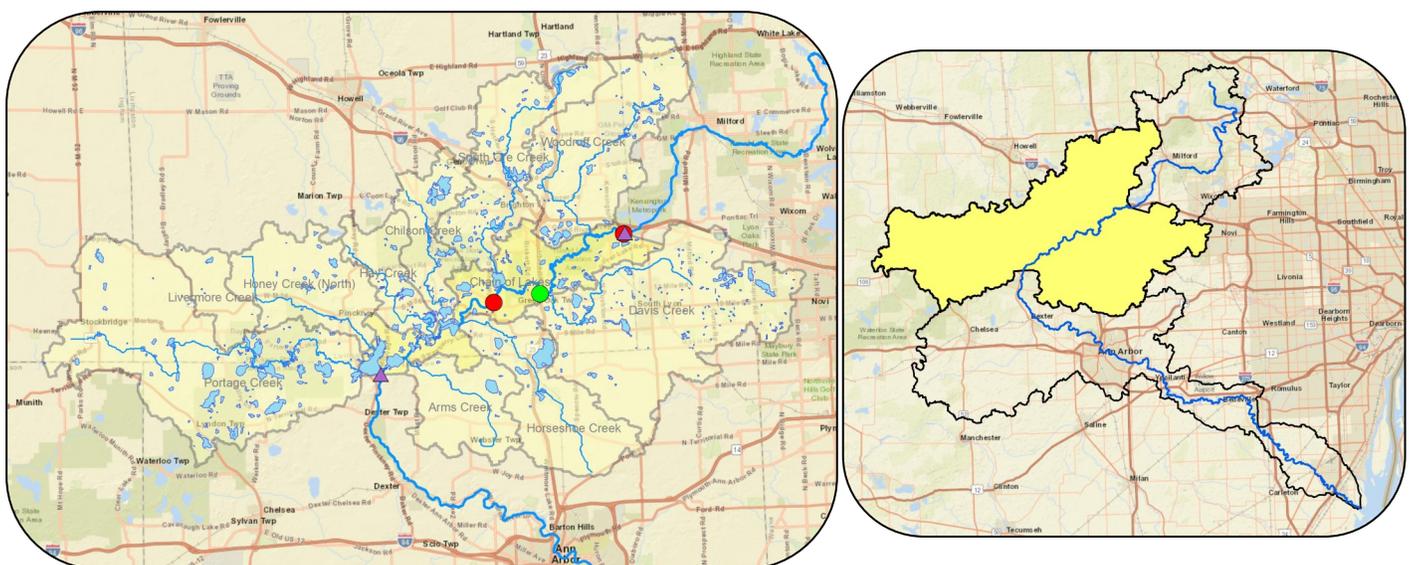
The Huron River flows 125 miles from its headwaters at Big Lake, near Pontiac in Oakland County, to its mouth at Lake Erie in Monroe County. HRWC divides the river into five sections based on its geology, ecology, and hydrology. This report is based on the section that runs between Kent and Portage lakes. The land immediately around the Huron River in this section (darker yellow, map below) is the focus of this report.

The river runs at a rapid pace for 12.3 miles starting at Kent Lake Dam, with a gradient of 10.7 feet per mile, as it flows through hills of sand and gravel created by the glaciers as they melted away 10,000 years ago. After Ore Lake, the river slows down in the flat terrain, running another 3.7 miles at a gradient of 0.8 feet per mile, picking up speed a little as it enters Strawberry Lake and the rest of the Chain of Lakes (Gallagher, Whitewood, and Baseline), and traveling the last 6 miles at a gradient of 1.5 feet per mile. Several other lakes are considered to be part of the Chain of Lakes and are connected to the system, but the Huron River does not flow directly through them (Loon, Little Portage, Portage, Tamarack, and Zukey). Altogether, there are 29 lakes (open water > 5 acres), and 22 ponds (open water < 5 acres) throughout the watershed area highlighted in darker yellow on the map below.

- Monitoring sites for Aquatic Insects, Stream Habitat, and Stream Temperature For more details on these parameters, please see inside.
- Monitoring site for Stream Flow, Phosphorus, Total Suspended Solids, and *E. coli*
- ▲ Dams

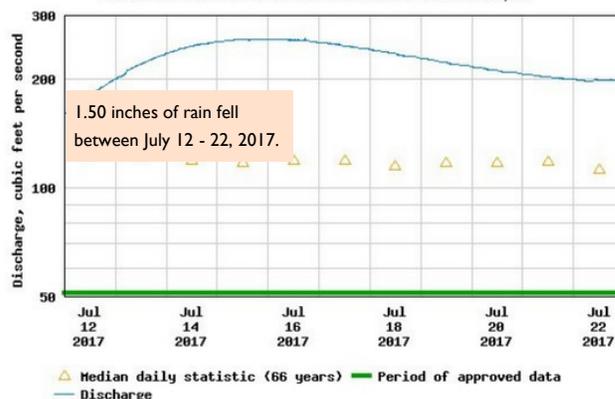
USGS 04172000 HURON RIVER NEAR HAMBURG, MI

Stream flow is an important underlying factor for determining likely erosion rates, stream habitat quality, and aquatic community diversity. In this section near Hamburg Road, the river exhibits flow characterized by slow rises during storms and long return periods, resulting in a stable base flow. This is good for aquatic life.

The graph below reflects the slow rise and fall of the river after a rainstorm.
