Chilson Creekshed Report

Creekshed Profile

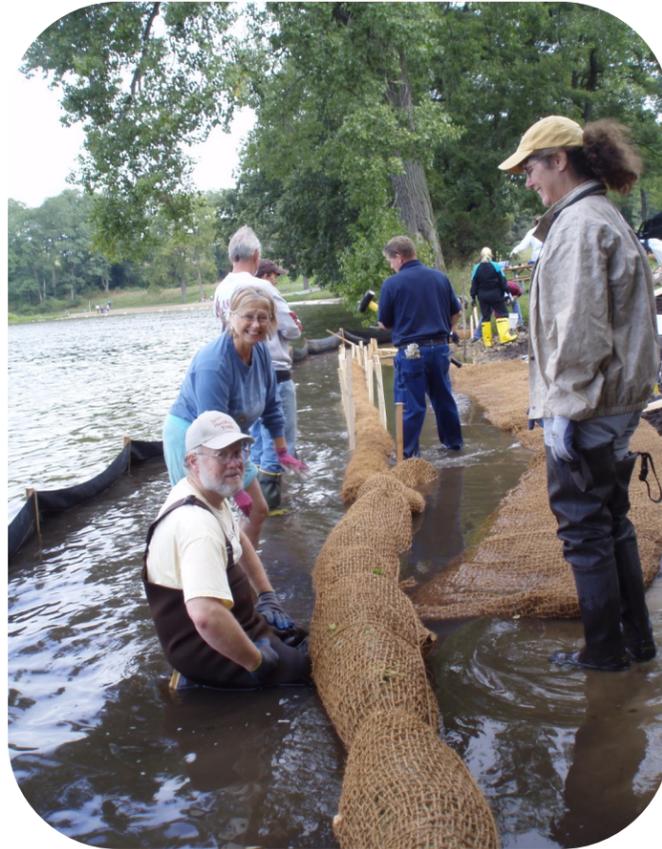
Volunteers installed natural shoreline protection at two sites along Bishop Lake in the Chilson creekshed. Credit: Michigan DEQ.

- The Livingston Watershed Advisory Group worked with Michigan Natural Shoreline Partnership on a demonstration shoreline restoration at Bishop Lake. The restoration was completed by volunteers and educated residents.

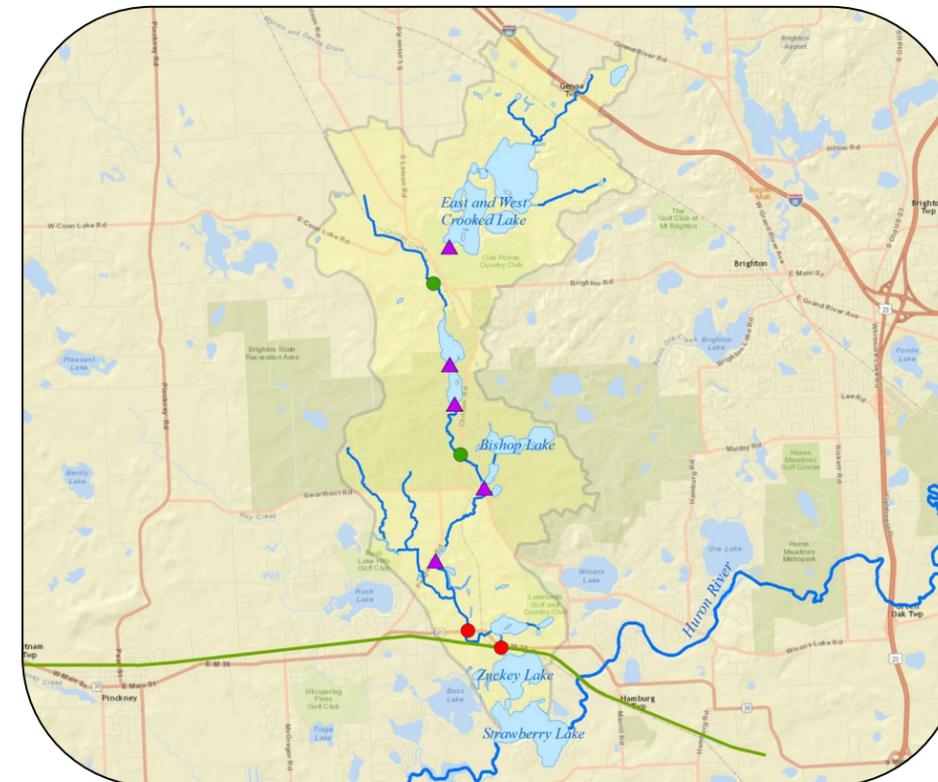
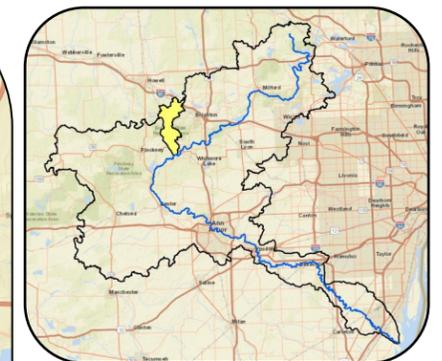
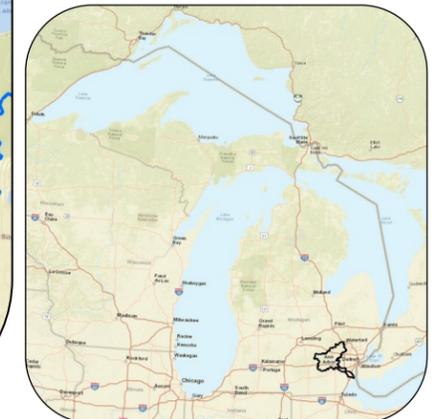
- Monitoring sites for Aquatic Insects, Stream Habitat, and Stream Temperature For more details on these parameters, please see inside.
- Monitoring site for Stream Flow, Phosphorus, Total Suspended Solids, and *E. coli*
- ▲ Dams
- Lakelands Trail

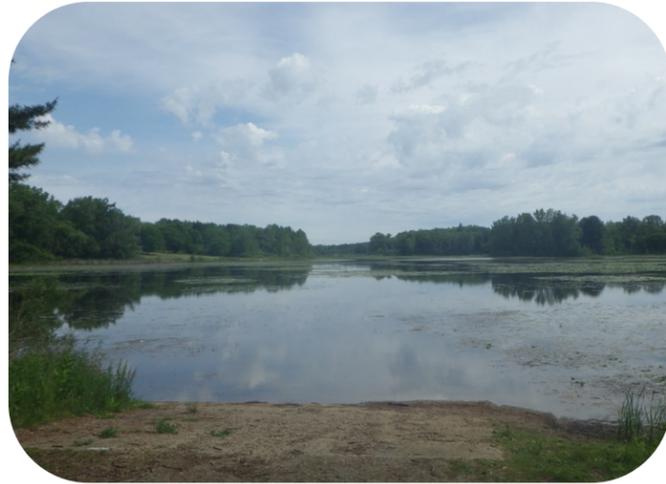
Lower Chilson Pond, one of the impoundments on Chilson Creek, is located in Brighton Recreation Area. Credit: HRWC

The two dams creating Lower and Upper Chilson Pond were both constructed in 1961 and are large earthen embankments running 100 feet long and 6 feet tall, and 150 feet long and 10 feet tall, respectively. The dams were built in the Brighton Recreation Area to create shallow lake habitat suitable for waterfowl hunting.

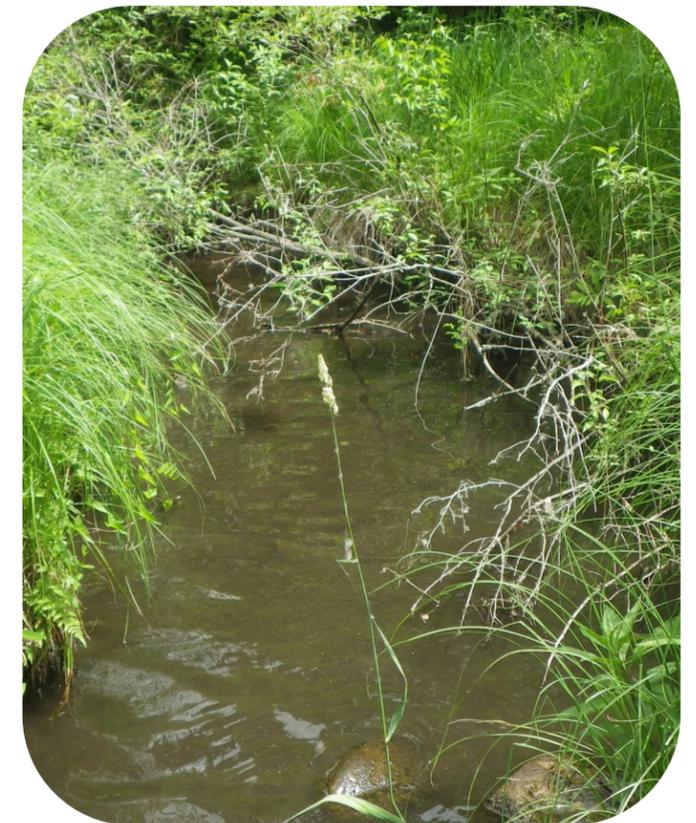
This section of Chilson Creek, downstream of the Brighton Recreation Area, is narrow and shallow with a gravel streambed. Credit: HRWC
