Creekshed Profile

Creekshed Status and Trends

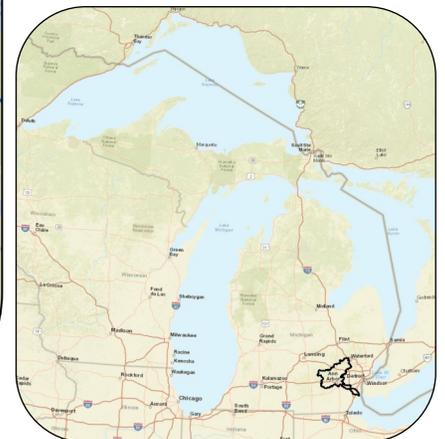
- Monitoring sites for Aquatic Insects, Stream Habitat, and Stream Temperature For more details on these parameters, please see inside.
- Monitoring site for Stream Flow, Phosphorus, Total Suspended Solids, and *E. coli*
- ▲ Dams
- Lakelands Trail

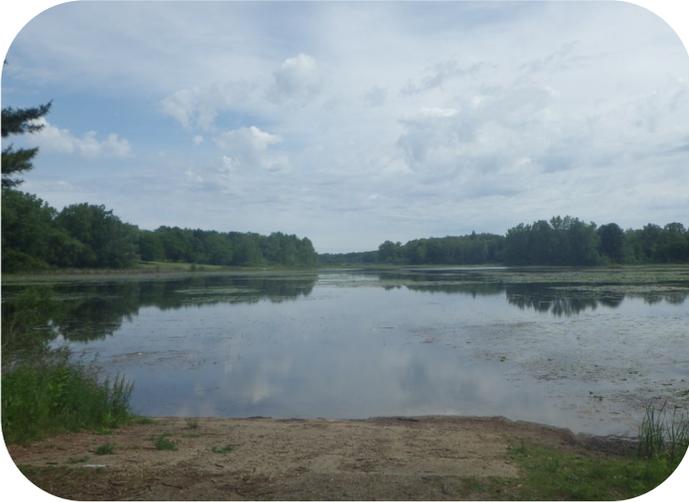
Lower Chilson Pond, one of the impoundments on Chilson Creek, is located in Brighton Recreation Area. Credit: HRWC

The two dams creating Lower and Upper Chilson Pond were both constructed in 1961 and are large earthen embankments running 100 feet long and 6 feet tall, and 150 feet long and 10 feet tall, respectively. The dams were built in the Brighton Recreation Area to create shallow lake habitat suitable for waterfowl hunting.

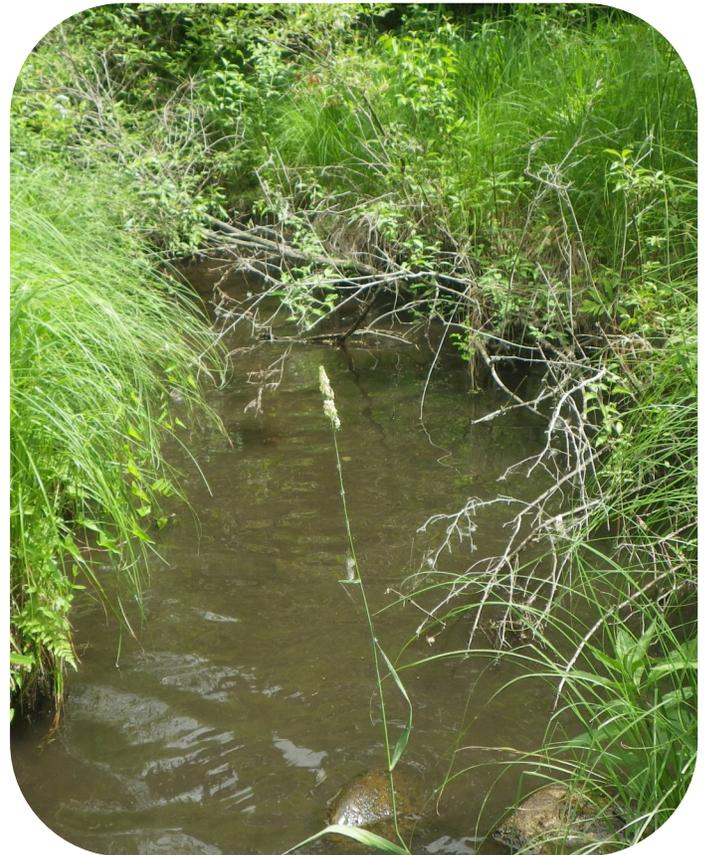
This section of Chilson Creek, downstream of the Brighton Recreation Area, is narrow and shallow with a gravel streambed. Credit: HRWC

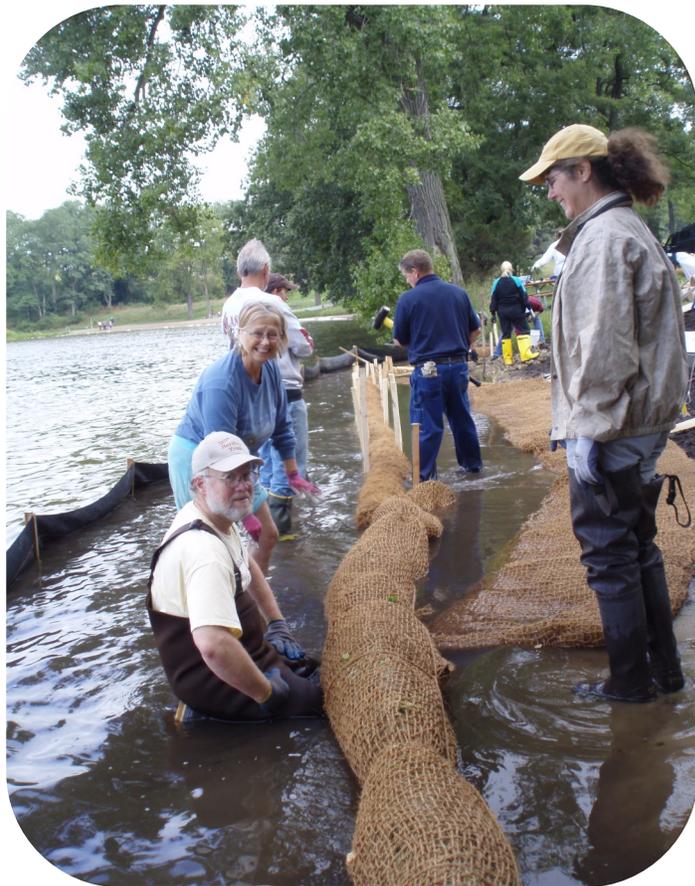
Volunteers installed natural shoreline protection at two sites along Bishop Lake in the Chilson creekshed. Credit: Michigan DEQ.

- The Livingston Watershed Advisory Group worked with Michigan Natural Shoreline Partnership on a demonstration shoreline restoration at Bishop Lake. The restoration was completed by volunteers and educated residents.
