# Honey Creekshed Report

## Washtenaw County

## Creekshed Profile

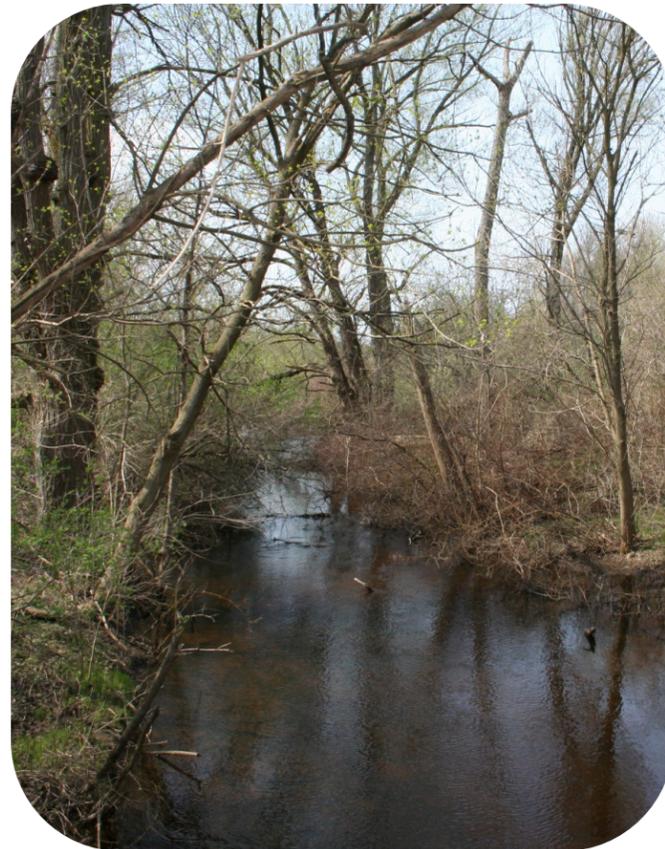
Honey Creek as it flows past Pratt Road. Credit: Chris Benedict

At the mouth of Honey Creek, the stream habitat is of good quality; large rocks, riffles, and pools are plentiful as it nears the Huron River. However, the middle to upper parts of the creek have unstable and eroding stream banks and the stream bed is full of sand and muck. The study site on Pratt Road (see map on cover, near Dexter Rd) has the worst substrate of all sites we monitor—100% of the streambed is covered by fine sediment.

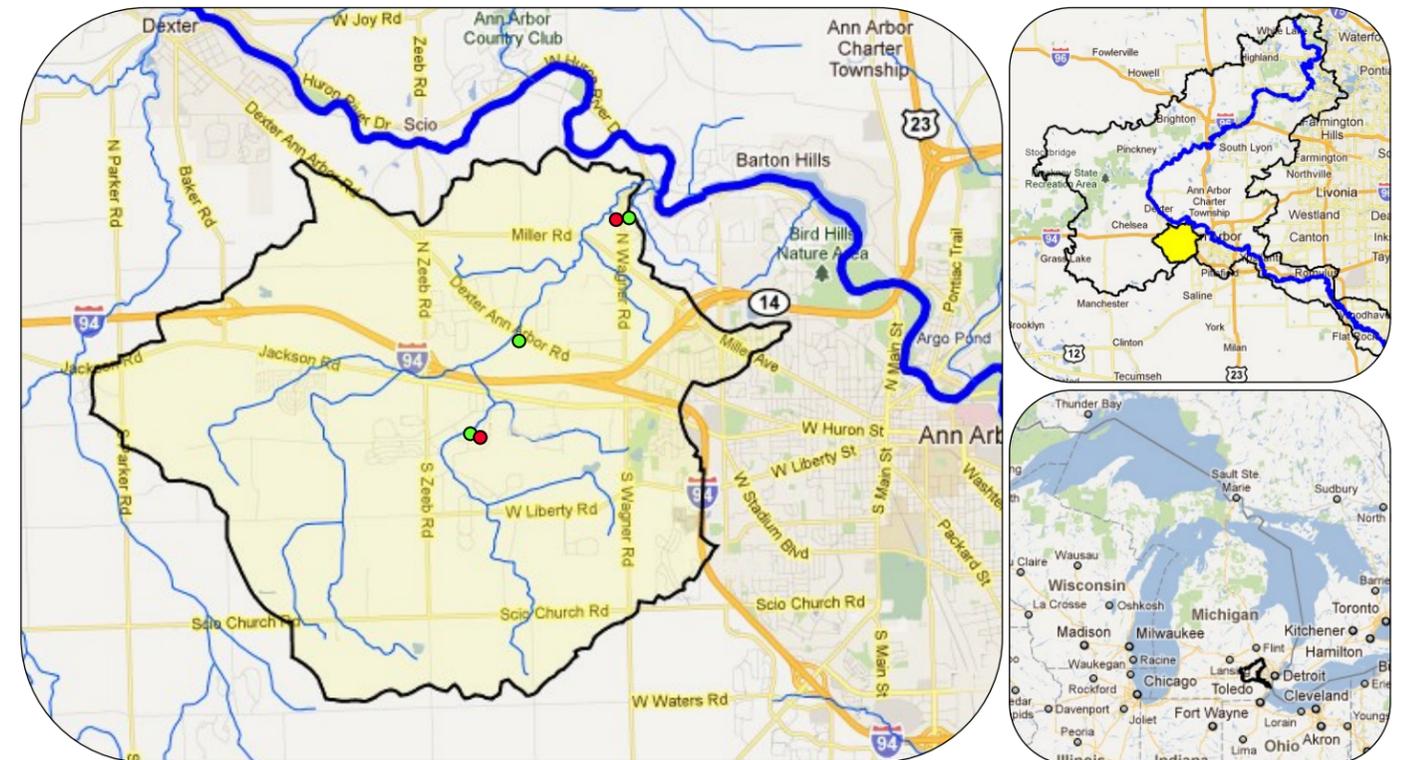
- Monitoring sites for Aquatic Insects, Stream Habitat, and Stream Temperature For more details on these parameters, please see inside.
- Monitoring site for Stream Flow, Phosphorus, Total Suspended Solids, and *E. coli*

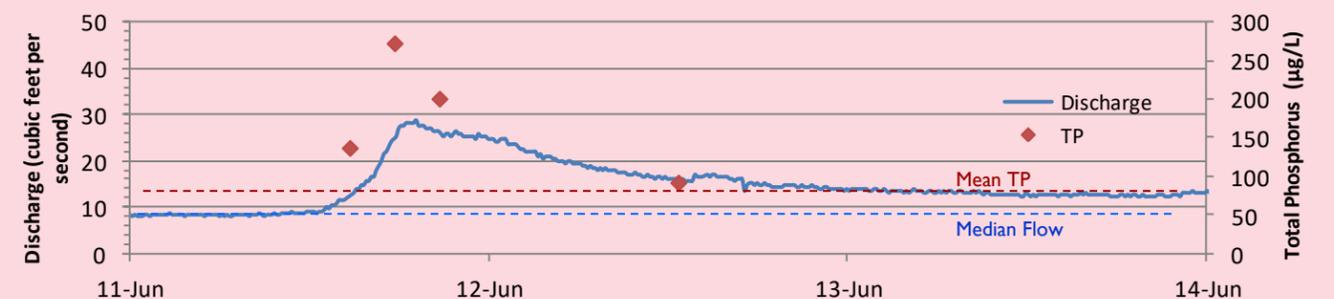
## 2009 Storm Event Graph 1.5 inches of rain fell on June 11.

Stream flow is an important underlying factor for determining likely erosion rates, stream habitat quality, and aquatic community diversity. An important measure is "flashiness" or the rate a stream rises and falls through a storm event (see below). Honey Creek has a flashiness rating that is average for comparable Michigan streams, and more natural than most in the Midwest.

Phosphorus is the limiting nutrient in most freshwater systems, and too much phosphorus can cause algal blooms and water quality problems. The target for area streams is < 50 µg/l. Honey Creek's mean total phosphorus (TP) is 69 µg/l, which is elevated, particularly after heavy storms (see below). This is likely due to residential and agricultural runoff.
