Protecting the river since 1965

Malletts Creekshed Report

Creekshed Profile

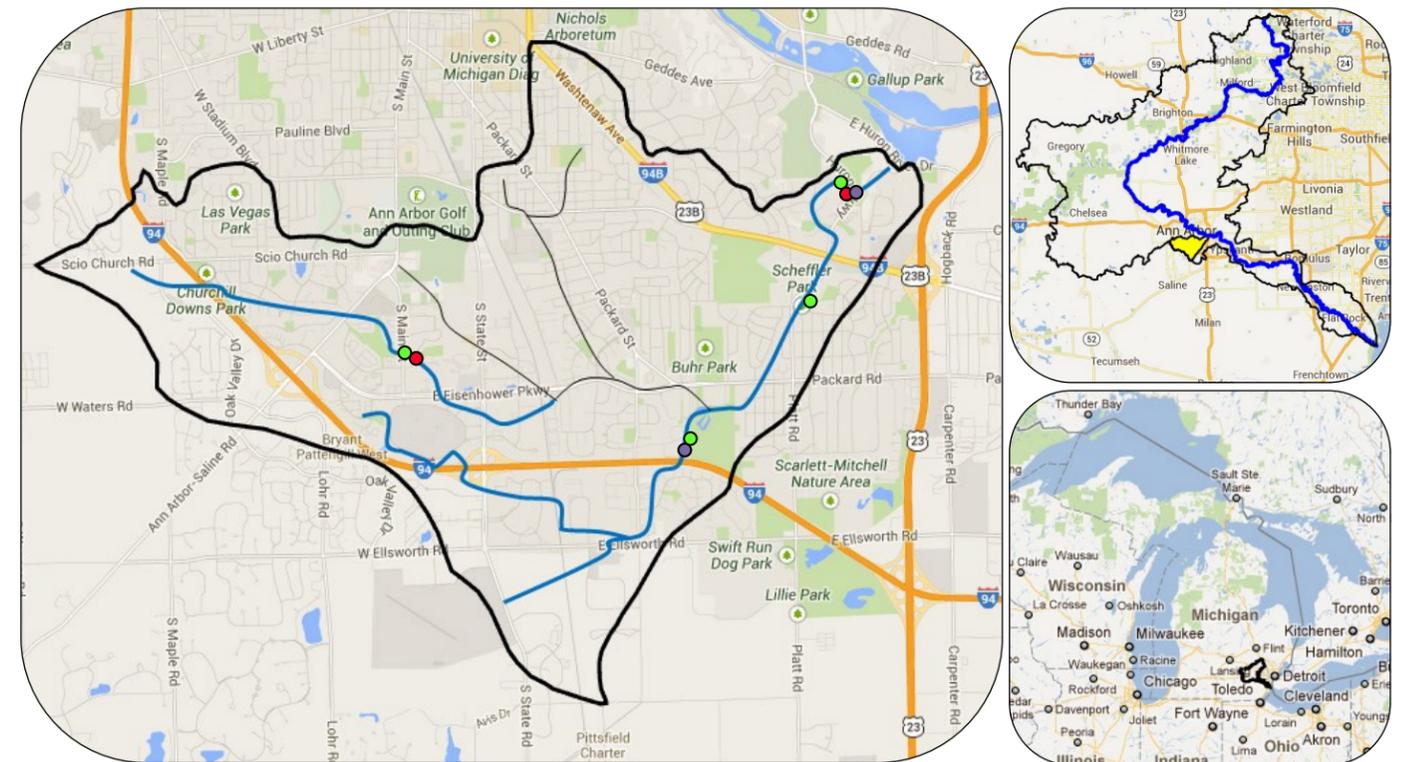
Malletts Creek is composed of 10 miles of opens streams, and it drains about 11 square miles of land. Several miles of the creek are disconnected from the main branch as they have been put underground into pipes. Malletts Creek flows into the 50 acre South Pond which then empties into the Huron River. South Pond is shallow and becoming a wetland as it fills with sediment. The creek's average slope is 20 feet per mile, which is slightly above average for the Huron River watershed as a whole (average is 16 feet per mile). With the exception of South Pond, there are no lakes (open water > 5 acres) in Malletts creekshed, but there are several ponds (open water < 5 acres) in the creekshed, which are used for stormwater retention.

- Monitoring sites for Aquatic Insects, Stream Habitat, and Stream Temperature
 - Monitoring site for Stream Flow, Phosphorus, Total Suspended Solids, and *E. coli*
 - USGS Stream gages
- For more details on these parameters, please see inside.
- Open channel — Pipe

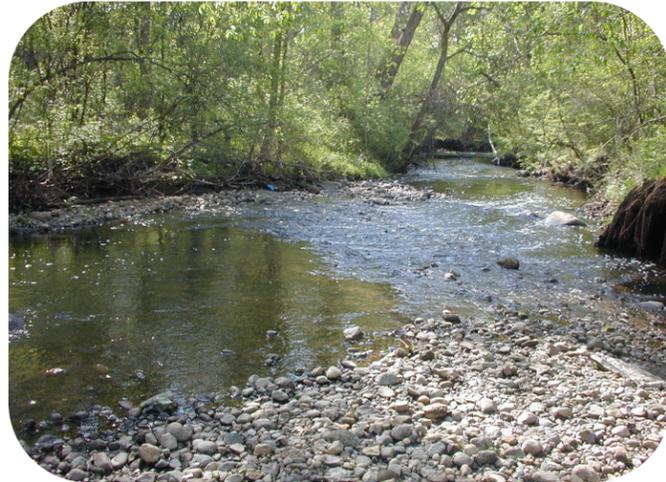
Malletts Creek trickles down a rocky streambed near the mouth, at the intersection of Chalmers Road. Credit: HRWC

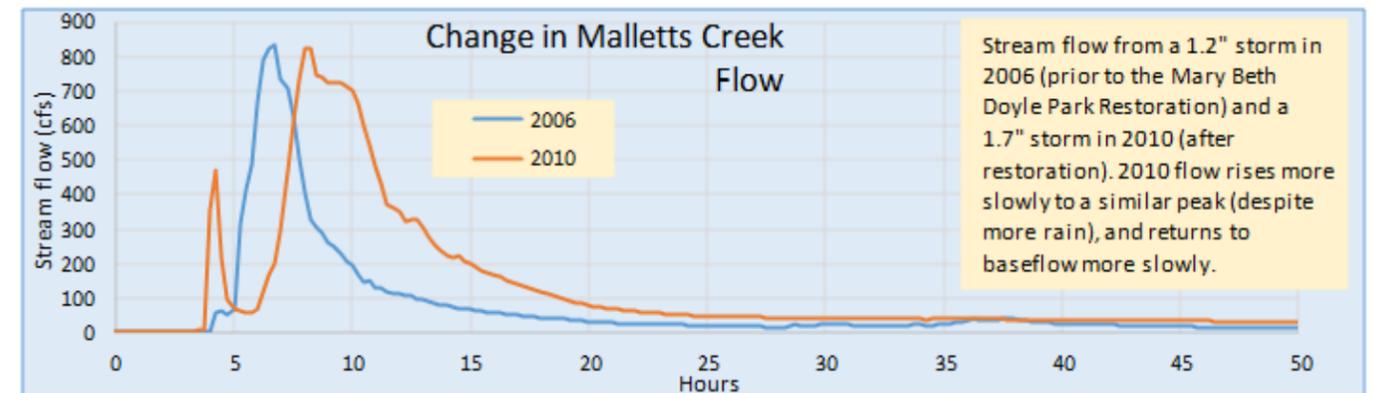
Flashy flow dynamics

Stream flow is an important underlying factor for determining likely erosion rates, stream habitat quality, and aquatic community diversity. An important measure is "flashiness" or the rate a stream rises and falls through a storm event (see below). Malletts Creek has a flashiness rating that is high for comparable Michigan streams, and more flashy than most in the Midwest.
