Mill Creekshed Report

Creekshed Profile

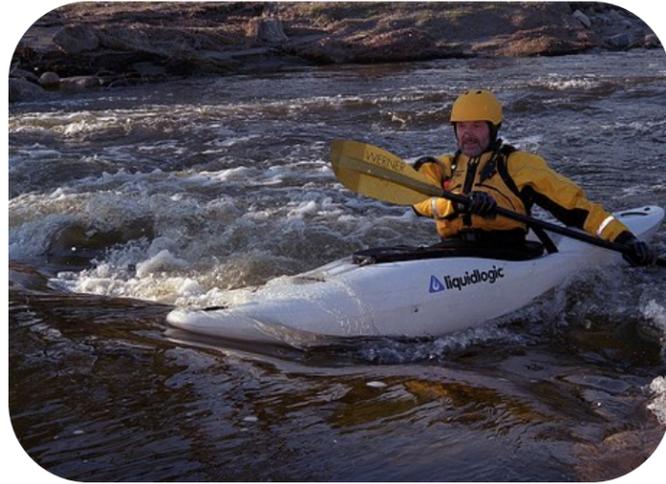
Kayaker and HRWC volunteer Lee Green rides the Mill Creek rapids. The whitewater feature was created in 2008 after the removal of the Mill Pond dam.

While dams provide recreational benefits, they greatly alter a stream's hydrology and degrade fish and insect habitat. A dam at the mouth of Mill Creek was removed in 2008, connecting the entire stream system to the Huron River. Other smaller dams are present but are not on the main branch of Mill Creek and only have minor impacts.

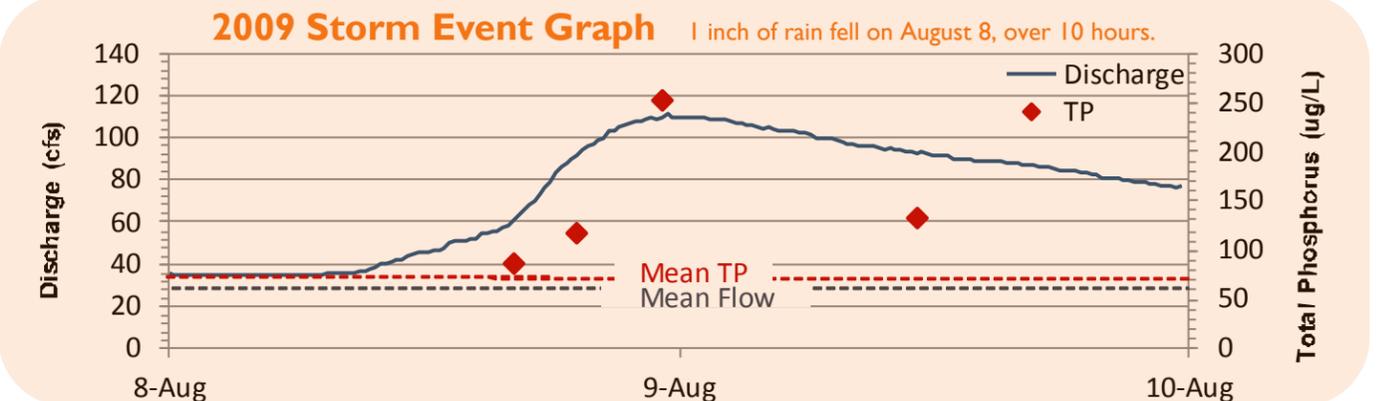
Stream flow is an important underlying factor for determining likely erosion rates, stream habitat quality, and aquatic community diversity. An important measure is "flashiness" or the rate a stream rises and falls through a storm event (see below). Mill Creek has a flashiness rating that is above average compared to other Michigan streams, but more natural than average for the Midwest.

Phosphorus is the limiting nutrient in most freshwater systems; too much phosphorus can cause algal blooms and water quality problems. While the target for area streams is < 50 µg/l, Mill Creek's (flow-weighted) mean total phosphorus (TP) is 97 µg/l, with more elevated levels particularly after heavy storms (see graph below). This is likely due to residential and agricultural runoff.
