Huron
River
Watershed
Council

Millers Creekshed Report

Creekshed Profile

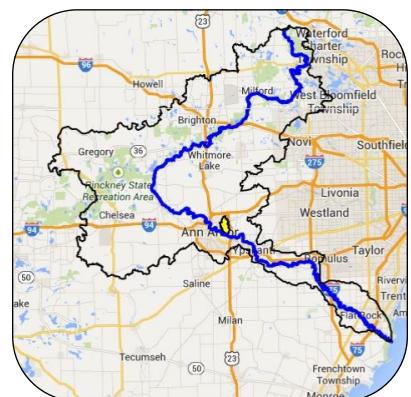
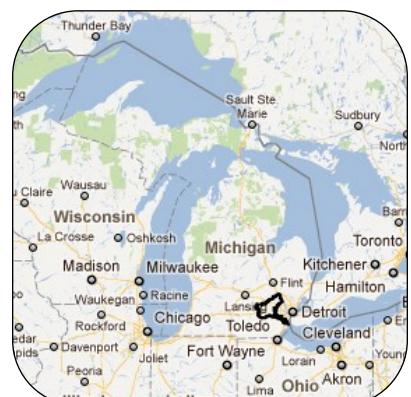
● Monitoring sites for Aquatic Insects, Stream Habitat, and Stream Temperature

● Monitoring site for Stream Flow, Phosphorus, Total Suspended Solids, and E. coli

For more details on these parameters, please see inside.

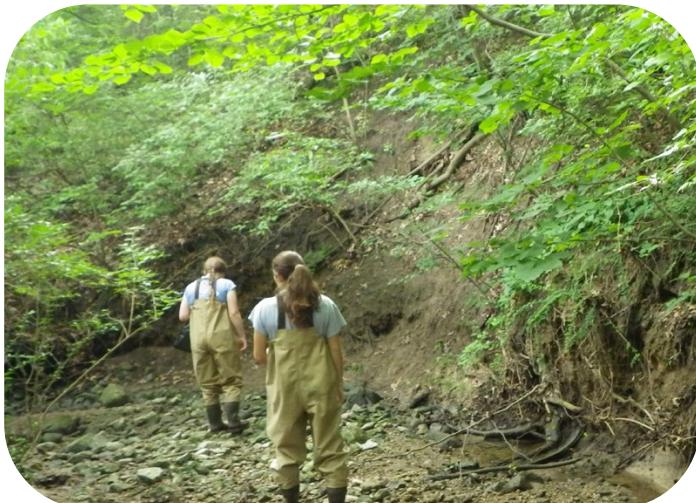
While the worst erosion area has been fixed on the main branch of Millers Creek, 15 foot tall eroding cliffs such as this one are still found on the smaller tributaries and are contributing massive amounts of sediment to the creek.

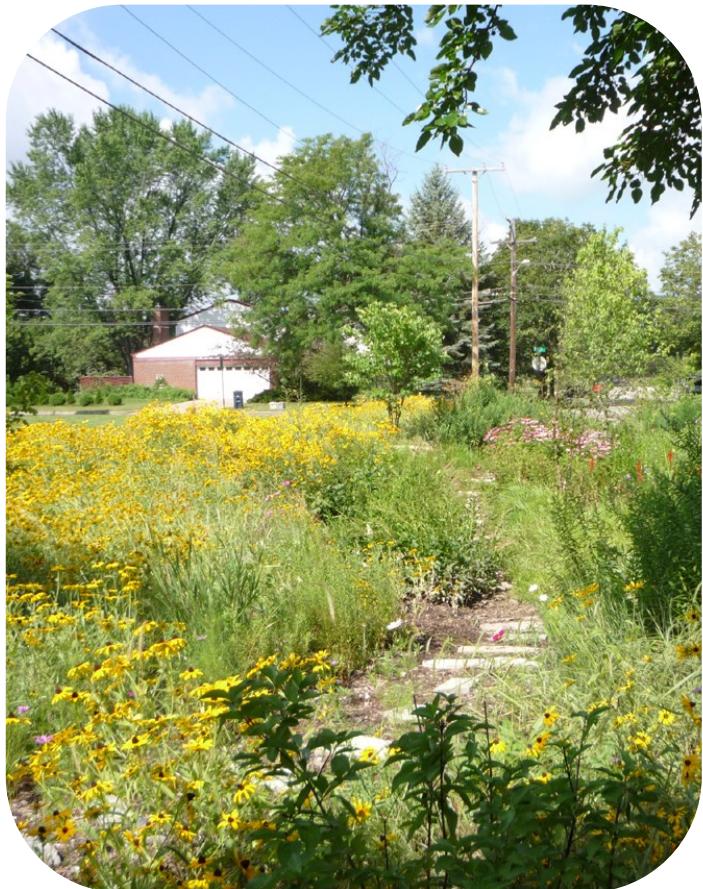
HRWC and the residents of the neighborhood built this raingarden in 2009 to reduce stormwater to Millers Creek. It is located on the corner of Briarcliff and Prairie Streets. Credit: HRWC
