Section VI. Portage Creek Management Strategy

Table VI-A. Watershed Management Goals and Objectives for Portage Creek

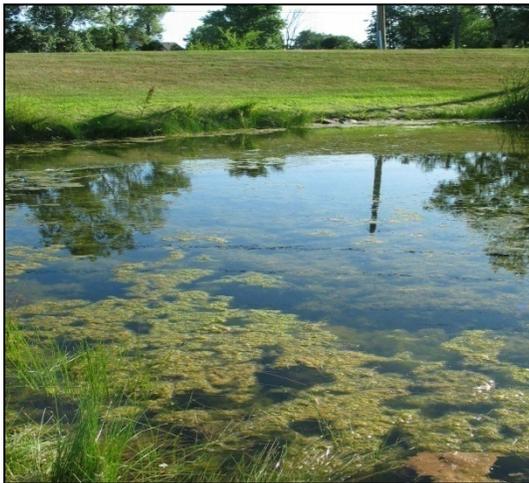
Too much phosphorus encourages nuisance algae blooms. Photo: HRWC

concern in the Portage Creek watershed because phosphorus is usually the limiting growth factor for algae and other nuisance plants in Michigan aquatic ecosystems. When excess phosphorus enters waterways from fertilizer or other sources, it encourages the accelerated growth of plants and algae reducing the dissolved oxygen and light entering the water and creating an environment where it is difficult for most fish and aquatic insects to live. High concentrations also negatively impact amphibians often at low concentrations. Lower dissolved oxygen leads to anoxic conditions in winter often leading to significant die offs of aquatic life including fish, amphibians, and turtles that hibernate under water. High nutrient concentrations interfere with recreation and aesthetic enjoyment of waterbodies by causing reduced water clarity, unpleasant swimming conditions, foul odors, blooms of toxic and nontoxic organisms, and interference with boating.

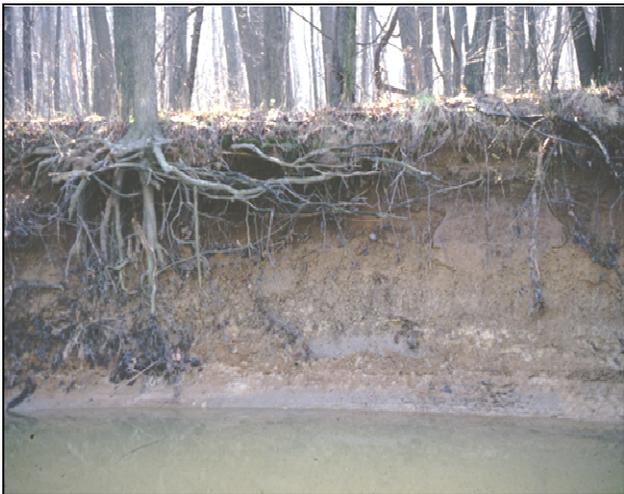
erosions caused by
 c

Flashiness can lead to severe erosion of streambanks (especially in areas where the streambank vegetation has been removed or altered) and sedimentation in the stream. These impacts create unstable conditions for the aquatic insects and fish. Altered hydrology can also have significant impacts to floodplain wetland systems via lower water levels in early spring and flashfloods during summer rains wiping out wetland inhabitants.
