57 Mill Creek at Klinger Rd.

Adopt-a-Stream Site Report

— Updated January 2020 —

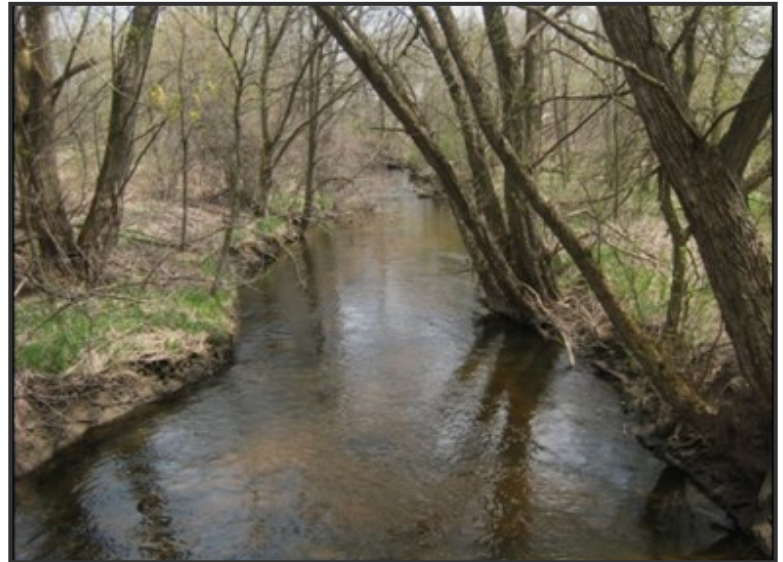
Site Condition: **FAIR**

At this site there is an average diversity bugs and some of them are sensitive. The water is clean but can get warm. This site has pretty good habitat and combined with the average diversity of aquatic life, the stream is rated on the mid-range of "fair". This is very close to the general average across the whole Huron River Watershed. The site condition has steadily increased slightly from a near "poor" in 2001.
