58 Portage Creek at Unadilla

Adopt-a-Stream Site Report

— Updated August 2021 —

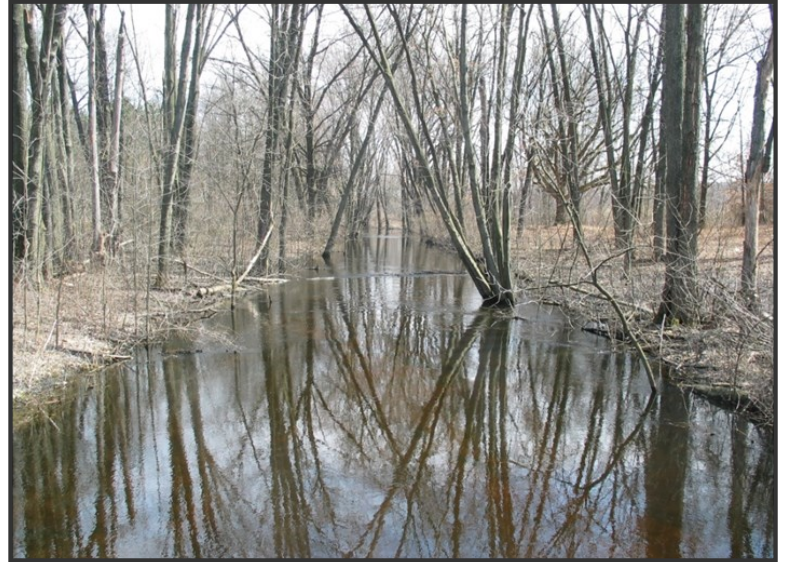
There is a below average level of insect diversity at this site, and the bugs found are not from sensitive groups. This section of Portage Creek has a high amount of sand and muck on the stream bed, which limits aquatic life. In 2005, a habitat study found that nearly 100% of the streambed was covered in these fine particles. Studies then found less fine sediment, but recent reports show the muck increasing again.

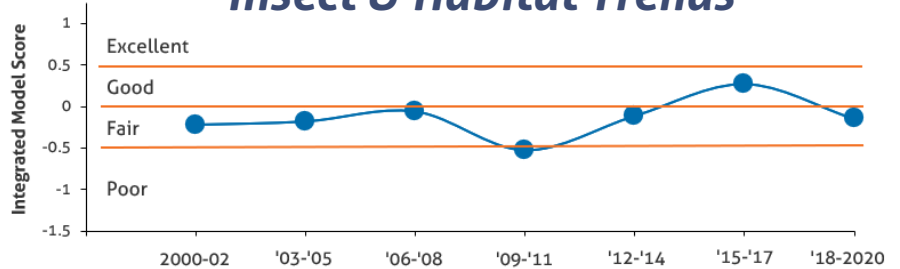
Insect & Habitat Trends

2000 - 2009	2010 - 2019	2020 - 2030
Number of Site Visits	Fall	12	1	1
	Spring	8	3	0
	Winter	7	4	1
Average Insect Diversity		10.4	12.9	12
Average Sensitive Diversity		0.6	0.9	1
Average Winter Stonefly Families		0.1	0	0
Habitat	# of Surveys	2 (2005, 2009)	2 (2015, 2018)	0
	Summer Water T (F)	72.5 - 74.5 (2000, 2001, 2010)	Not Monitored	-
	Stream Width (ft)	19.7	27.3	-
	% Big Rocks	4.1	0	-
	% Rocks & Gravel	11.5	5.5	-
	% Sand	54.5	22.2	-
	% Muck	28.5	59.3	-
