65 Norton Creek at West Maple

Adopt-a-Stream Site Report

— Updated August 2021 —

Adopt-a-Stream Creekshed Profile

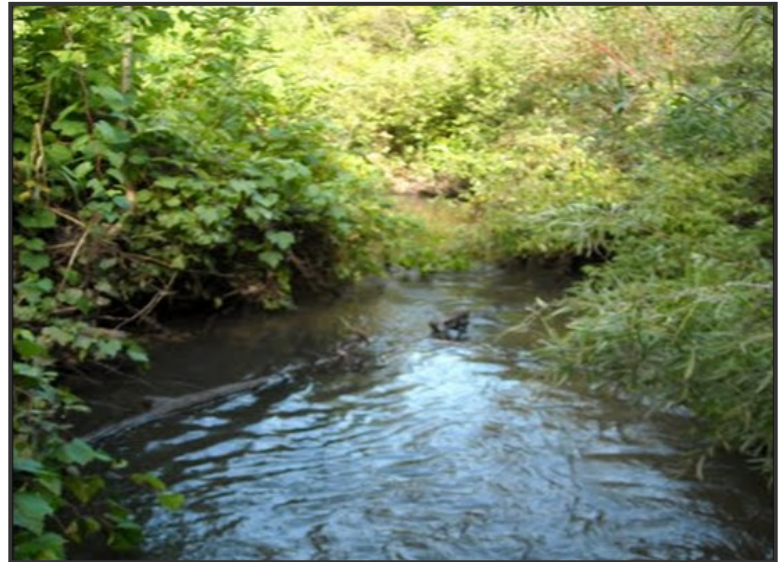
Site Condition: **POOR**

At this site there are very few kinds of bugs and none of them are sensitive. The water has a high concentration of unknown pollutants and is low in dissolved oxygen. The stream banks, streambed, and streamside vegetation are average here but overall the stream has a “poor” rating since it does not support a rich variety of aquatic life.
