# 80 Mill Creek at Shield Road

## Adopt-a-Stream Site Report

— Updated August 2021 —

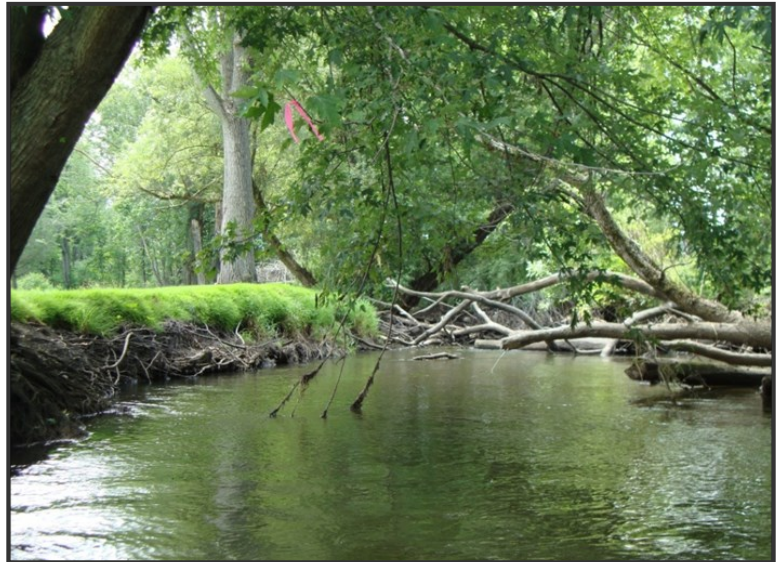
At this site there are several kinds of bugs and a few of them are sensitive. The stream banks and streamside vegetation are healthy here but the stream bed is very mucky. Unfortunately, one side of the creek has no natural riparian buffer at all (the stream bank is a residential lawn). Overall the stream is ranked "fair" for a decent insect community and stream habitat.

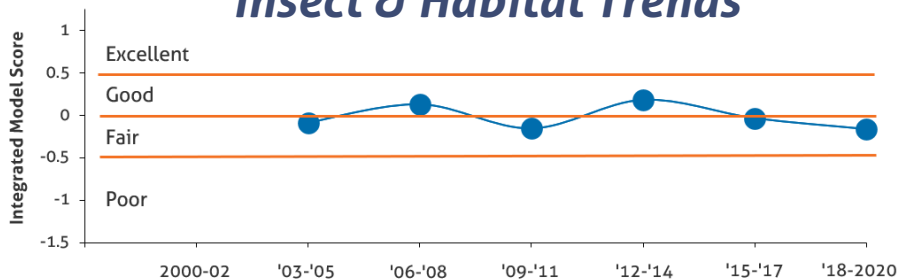
### Insect & Habitat Trends

2000 - 2009	2010 - 2019	2020 - 2030
Number of Site Visits	Fall	6	5	0
	Spring	6	4	0
	Winter	6	8	1
Average Insect Diversity		12.9	12.9	-
Average Sensitive Diversity		1.8	1.9	-
Average Winter Stonefly Families		1.8	1.9	2
Habitat	# of Surveys	2 (2004, 2007)	2 (2011, 2016)	1 (2020)
	Summer Water T (F)	66.5 - 76.5 (2002, 2006)	66.5 - 73.5 (2010)	-
	Stream Width (ft)	37.61	37	35.7
	% Big Rocks	6.0	10.0	16.5
	% Rocks & Gravel	19.1	49.4	45.5
	% Sand	31	22.6	14.9
	% Muck	39	11.3	16.5
