82 Walker Creek at 8 Mile

Adopt-a-Stream Site Report

— Updated August 2021 —

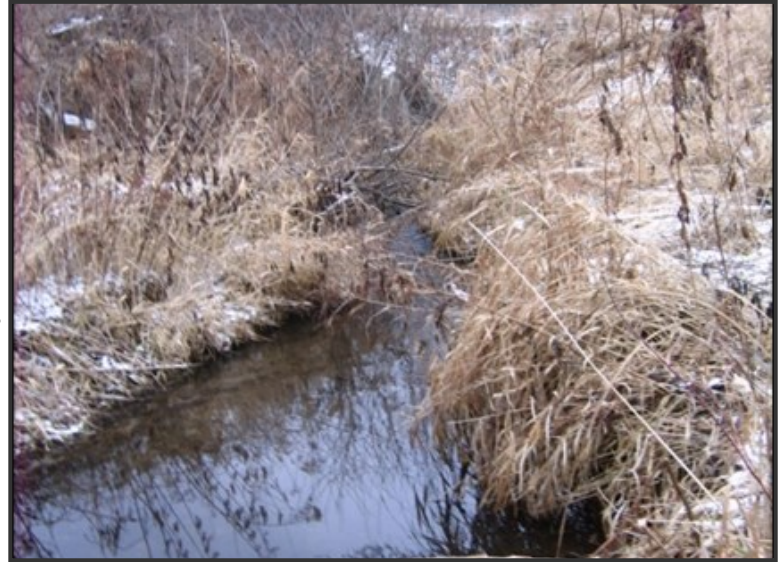
Site Condition: **FAIR**

At this site there are many families of bugs and a couple of them are sensitive. The water is clean and cold, but this is a sandy and silty site which lowers the rating since these fine sediments are not favorable to insect life. This site also lacks winter stoneflies, perhaps due to the mucky substrate. Overall, the site has been given an condition rating of "fair". The site has worsened over time, which is concerning.
