# Swift Run Creekshed Report

## Creekshed Profile

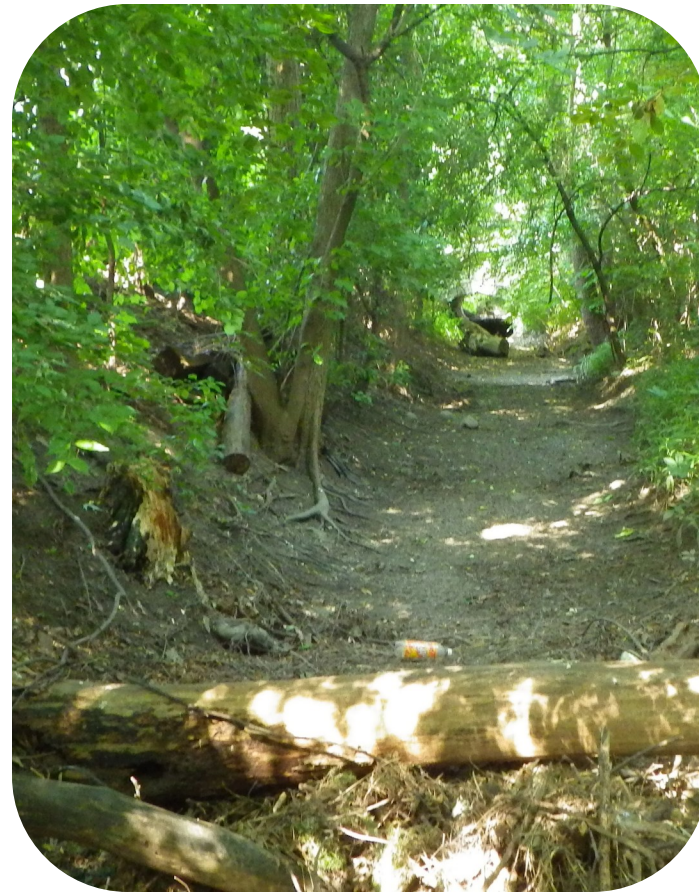
Upstream of US-23, Swift Run is ephemeral— the water only flows after a storm. Credit: HRWC

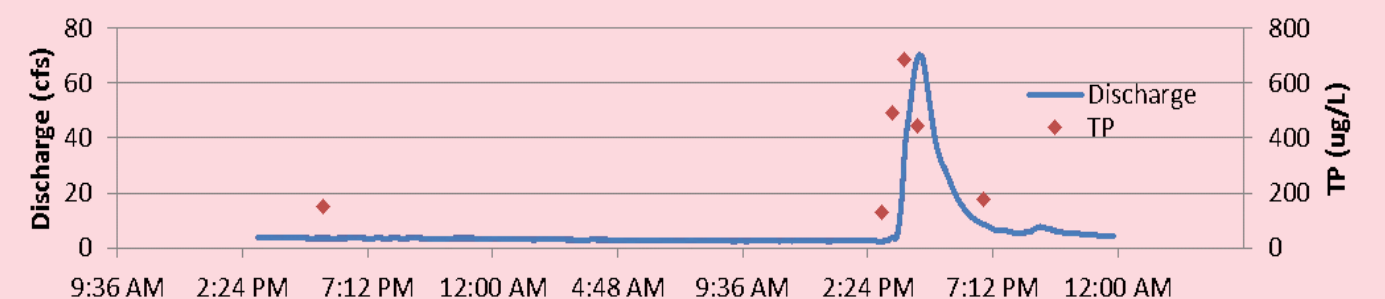
## 2010 Storm Event Graph 0.53 inches of rain fell on July 28,

Stream flow is an important underlying factor for determining likely erosion rates, stream habitat quality, and aquatic community diversity. An important measure is "flashiness" or the rate a stream rises and falls through a storm event (see below). Swift Run has a flashiness rating that is high for comparable Michigan streams, but average for the Midwest.

Phosphorus is the limiting nutrient in most freshwater systems; too much phosphorus can cause algal blooms and water quality problems. While the target for area streams is < 50 ug/l, Swift Run's mean total phosphorus (TP) is 103 ug/l. Even more elevated levels occur after heavy storms (see below). This is likely due to residential runoff.

Total suspended solids (TSS) is a measurement of the amount of sediment and organic material held by the stream. A high TSS indicates high turbidity and erosion problems. Good TSS values are below 80 mg/l. While Swift Run's mean TSS is 20 mg/l, levels can reach up to 384 mg/l during periods of high flow.
