# The Huron River Data Report

## Upper Huron Headwaters

### Creekshed Profile

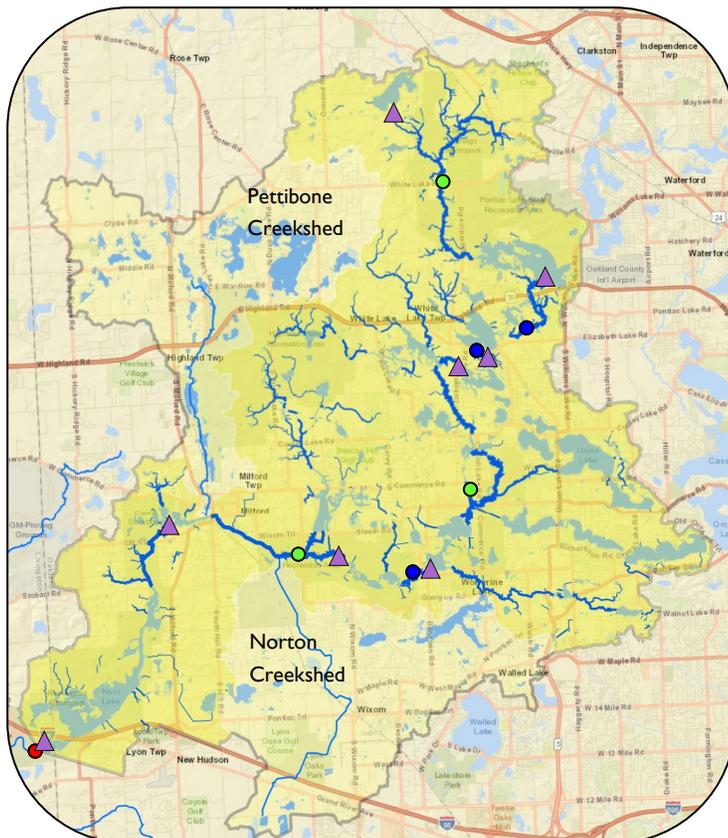
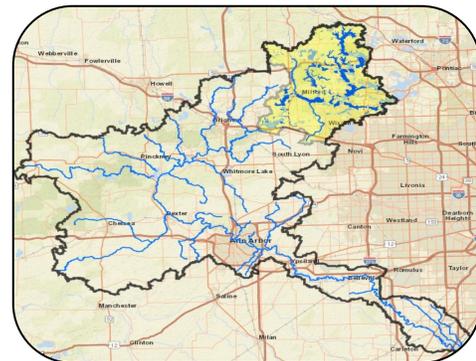
The Huron River flows 125 miles from its headwaters at Big Lake, near Pontiac in Oakland County, to its mouth at Lake Erie in Monroe County. HRWC divides the river into five sections based on its geology, ecology, and hydrology. This report is based on the section that runs between Big Lake and Kent Lake. The land immediately around the Huron River in this section (darker yellow, map below) is the focus of this report.

A river ecosystem is only as healthy as the quality of the water flowing into it. Both Norton Creek and Pettibone Creek flow into the Huron River in this area (lighter yellow on the map). Reports exist for both of these sections (<https://www.hrwc.org/our-watershed/features/>.)

- Monitoring sites for Aquatic Insects, Stream Habitat, and Stream Temperature
- Monitoring site for Stream Flow, Phosphorus, Total Suspended Solids, and *E. coli*
- Stream Flow only
- ▲ Dams (main branch only)
