Honey Creekshed Report

Livingston County

Creekshed Profile

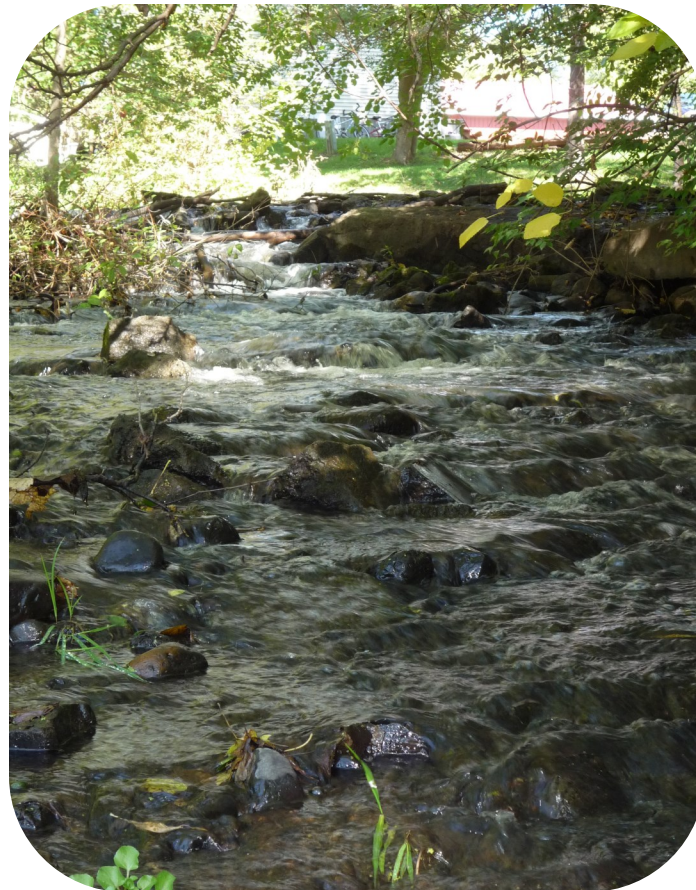
The “dam” at Mill Pond in Pinckney is now a steep slope made of concrete, logs, and rocks. It drops about 3 vertical feet over 45 horizontal feet.

- Mill Pond Dam should be removed and Honey Creek should be allowed to return to a free flowing stream. The dam has been falling apart for years and there is a chance that it could wash away and cause a flood for homes, roads, and aquatic life downstream.
- Honey Creekshed contains many unprotected natural lands that could fall victim to development. Local government and property owners alike should explore options to protect this natural land. It is these areas that protect the high water quality of Honey Creek.

While dams provide recreational benefits, they greatly alter a stream's hydrology, and degrade fish and insect habitat. There are 2 dams on Honey Creek, one of which creates a large Mill Pond in the Village of Pinckney. This dam was once used to power a mill but its only function now is to maintain the lake level for aesthetic purposes. The other dam also is used for aesthetic purposes only and is also in the Village of Pinckney. Both dams are located about 2.5 miles from the creek mouth, preventing fish passage from the Huron River into the creek's headwaters.

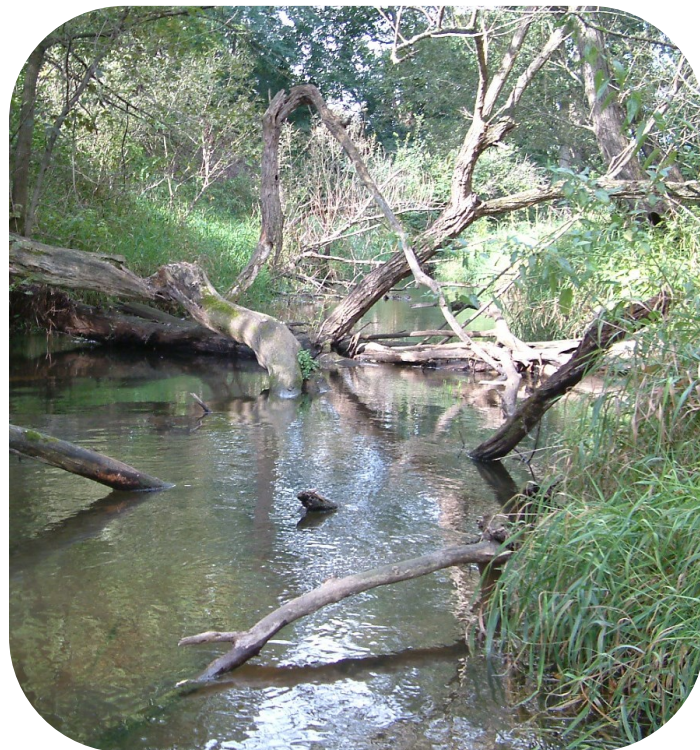
Like many small creeks, the amount of woody debris in Honey Creek is great for aquatic life but makes paddling the creek virtually impossible. Credit: Graham Battersby

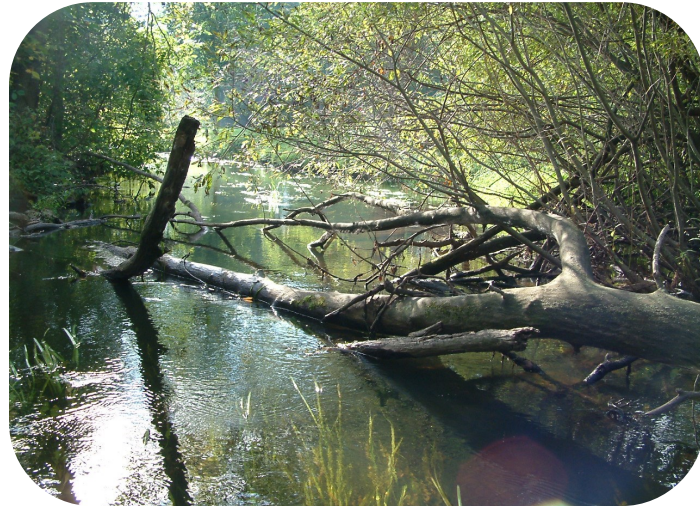
Honey Creek flows through a near even mix of forest, wetland, agriculture, and suburban neighborhoods. Credit: Graham Battersby

Total creekshed Size: 27 square miles
Land use based on the year 2000:
Agriculture: 22%, 6 square miles
Residential & urban: 19%, 5 square miles
Forest: 16%, 4 square miles
Open: 22%, 6 square mile
Wetland: 21%, 6 square miles

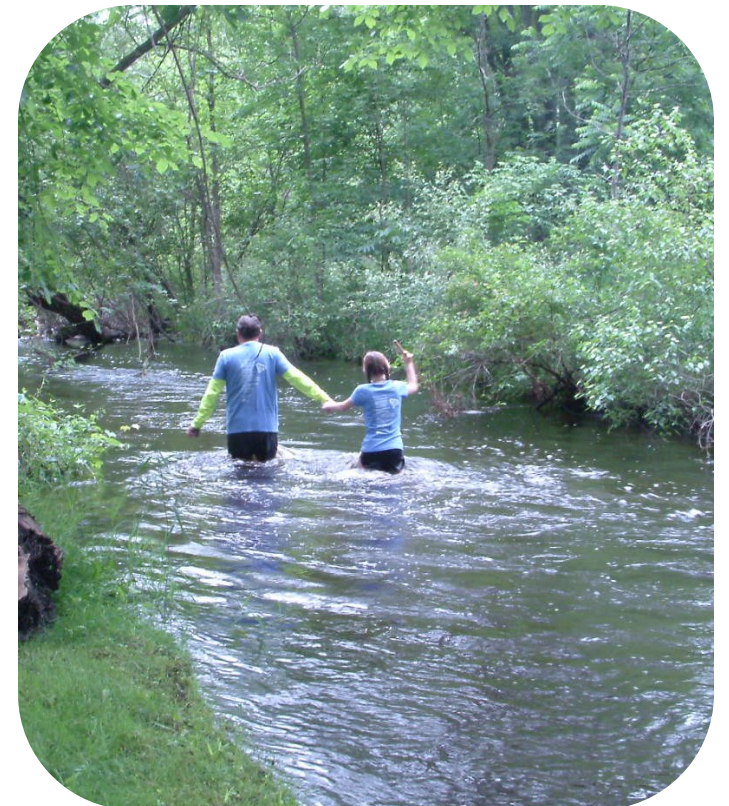
HRWC volunteers explore Honey Creek at Darwin Road. This picture was taken several days after a large storm and the water is about 6 inches higher than normal baseline conditions. Credit: Alison Battersby

Honey Creek at Darwin Road, near the mouth of the creek, has one of the most diverse aquatic insect communities in the entire Huron River watershed, and several insect families that are intolerant to pollution can be found here. Hummock Lick, a tributary to Honey Creek, also has a high insect diversity.
