Summary of Geomorphology Assessment Results for the Middle Huron River Watershed, Section 1

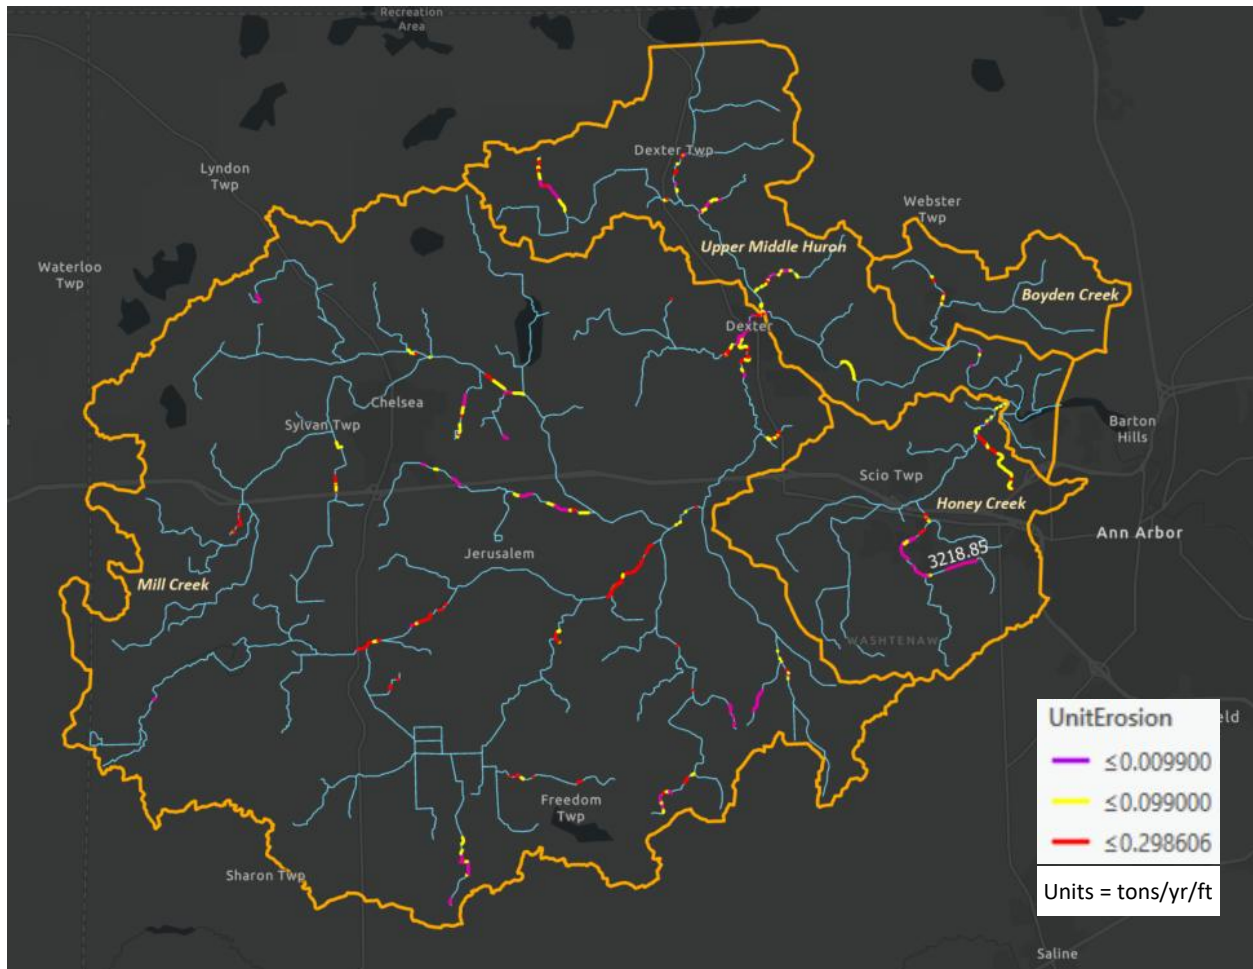
Figure 2. Estimated Unit Erosion from Observed Stream Banks

Results from the geomorphic assessment can be presented in a variety of ways. First, as each bank segment is assessed, an erosion estimate can be generated such that each assessment can have many banks assessed. In most cases, one bank is eroding, while the other bank is aggrading or unaffected. However, in downcutting or widening segments, both banks may be eroding at the same time. This would result in twice the estimated erosion of a single bank impact. Many other lengths of streambank exhibit no significant observable erosion signs. Each potentially eroding bank length can be represented visually (see Figure 2) with its estimated unit erosion (in tons/yr per ft of stream length

observed), and in an area the size of the study watershed patterns can be observed. First, most of the stream length shown appears to be unevaluated. This is only partially true. Yes, more than half of the known stream length was not indeed assessed, but much of what was assessed (compare with Figure 1), was observed to have so little evidence of erosion that it did not merit mapping as an eroding bank. Such banks were observed, but recorded as “very low” BEHI and NBS ratings, or essentially estimated erosion rates of zero tons/year. In general, it can also be observed that erosion rates were in the lower ranges across the watershed. A second observation is that a number of the stretches of high erosion rates were along the larger main and southwestern branches of Mill Creek. Land use in that section of the watershed is dominated by row crop agriculture, and the creek in this area shows strong evidence of channelization with high, steep banks with little protection. Another important use of this fine-scale data is to isolate target lengths within a longer reach that have higher erosion potential and could serve as the best targets for restoration.

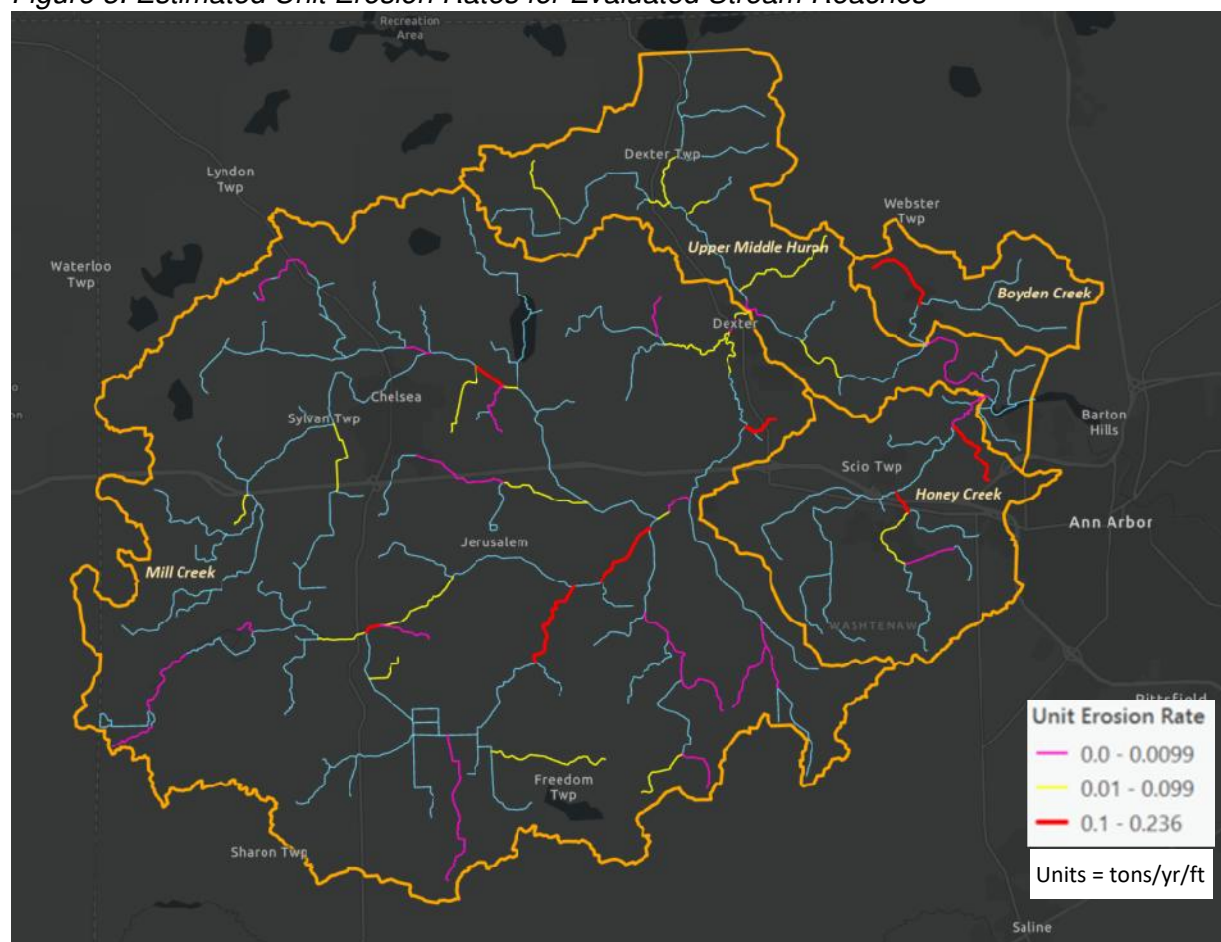
Figure 3. Estimated Unit Erosion Rates for Evaluated Stream Reaches

ranking of stream reaches is a good approach to identify initial restoration targets. Figure 3 shows the evaluated stream reaches and their erosion rates. Within the watershed, there are a small number (9) of stream reaches with high erosion rates (> 0.1 and < 0.236 tons/yr/ft, marked red). A third of the streams (21 of 60 evaluated reaches) fall within a moderate erosion rate range of 0.01 to 0.099 tons/yr/ft, marked yellow. The remaining half of the reaches have stable banks with little evidence of active erosion (< 0.01 tons/yr/ft), marked purple, so the majority of stream reaches evaluated showed very little evidence of active erosion. This grouping of erosion rates differs somewhat from the set evaluated in the more urbanized Section 2 of the watershed just downstream. In that watershed, while there were a similar number of stream reaches with high erosion rates, the majority of streams fell into the middle or moderate erosion range.

Table 1 lists the stream reaches with the 20 highest erosion rates. Examining this table along with the geographic distribution high erosion reaches in Figure 3 shows that the most vulnerable reaches are distributed across the watershed, with six in Mill Creek (including the four worst reaches), two in Honey Creek and one in Boyden Creek above 0.1 tons/yr/ft. No direct drainages or reaches of the Huron River had high erosion rates.
