Summary of Geomorphology Assessment Results for the Middle Huron River Watershed, Section 3

Overview

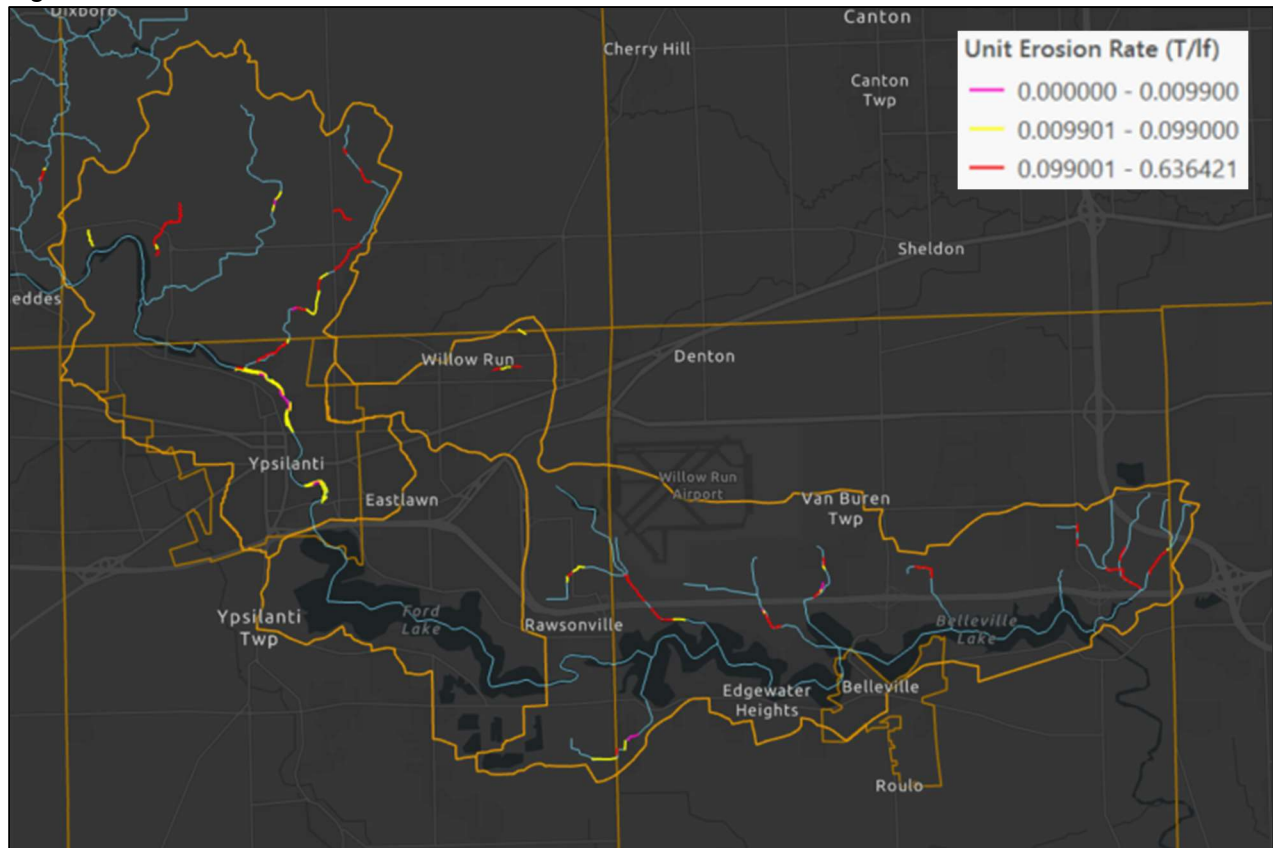
Figure 2. Estimated Unit Erosion from Observed Stream Banks

First, most of the stream length shown appears to be unevaluated. This is only partially true. Yes, more than half of the known stream length was not indeed assessed, but some of what was assessed (compare with Figure 1), was observed to have so little evidence of erosion that it did not merit mapping as an eroding bank. Such banks were observed, but recorded as “very low” BEHI and NBS ratings, or essentially estimated erosion rates of zero tons/year. Also, many reaches were determined to be inaccessible during field visits. This was true, for example, for a long length of stream that runs along Willow Run Airport. Access was prohibited by a locked security fence, and the airport authority refused to grant access when asked.

In general, it can also be observed that erosion rates were in the upper ranges across the watershed. Every stream assessed had at least one stretch of banks that fell in the highest unit erosion rate category. Land use in the watershed is a mix of heavy industry (like the airport), urban to suburban residential, and some small row-crop farms in the uppermost watershed. The tributary creeks in the watershed show strong evidence of channelization with high, steep banks with little protection. An exception to this general trend is the river reaches, which showed low to moderate unit erosion rates. Another important use of this fine-scale data is to isolate target lengths within a longer reach that have higher erosion potential and could serve as the best targets for restoration.

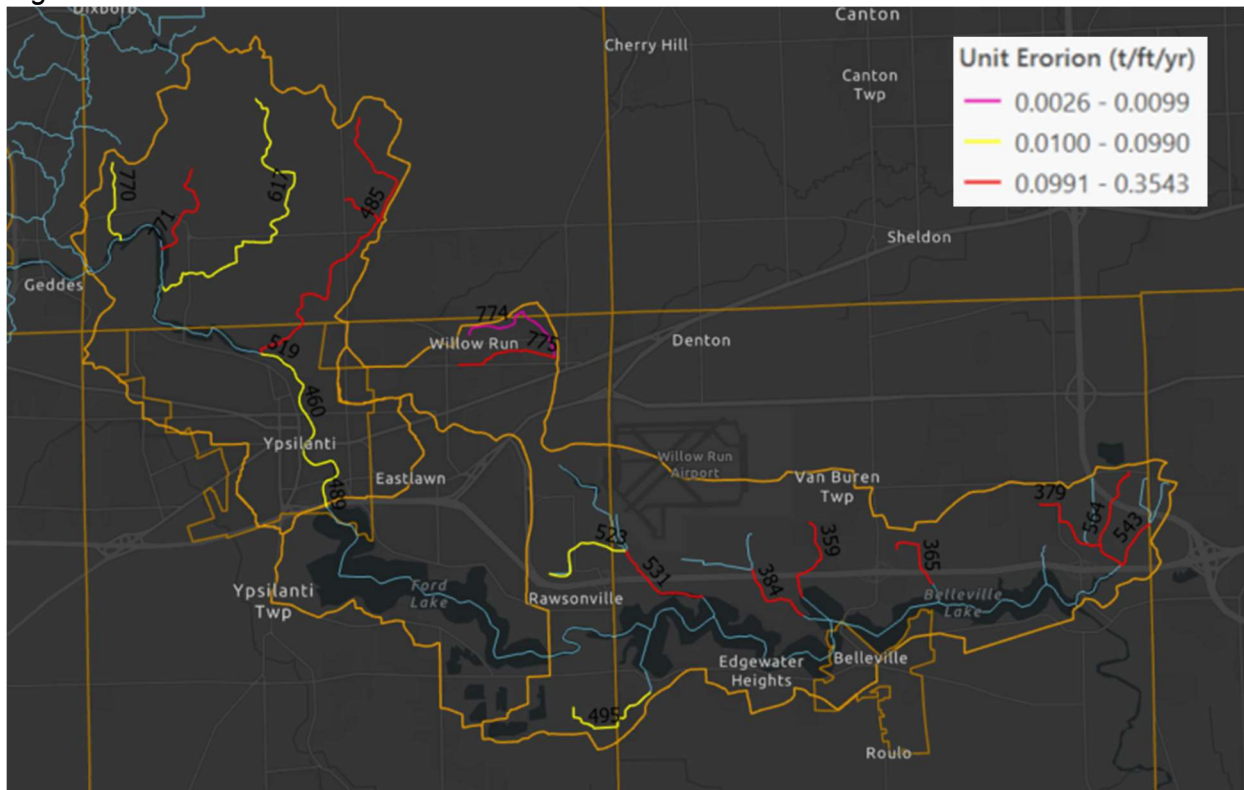
Figure 3. Estimated Unit Erosion Rates for Evaluated Stream Reaches

A second step in analysis is to compile assessment observations into mean erosion rates for entire reaches. Given the size of the study watershed and the total evaluated reach length, a comparative ranking of stream reaches is a good approach to identify initial restoration targets. Figure 3 shows the evaluated stream reaches and their erosion rates. Within the watershed, over half (14 of 23) of the stream reaches evaluated had high erosion rates (> 0.1 and <0.35 tons/yr/ft, marked red). Eight of the streams fall within a moderate erosion rate range of 0.01 to 0.099 tons/yr/ft, marked yellow. Only one of the reaches have stable banks with little evidence of active erosion (< 0.01 tons/yr/ft), marked pink in the Willow Run headwaters, so the majority of stream reaches evaluated showed quite a bit of evidence of active erosion. This grouping of erosion rates differs somewhat from the set evaluated in the more urbanized Section 2 of the watershed just upstream. In that watershed, there was a mix of stream reaches with high erosion rates, moderate erosion rates and low erosion rates.

Table 1 lists the stream reaches with the 20 highest erosion rates. Examining this table along with the geographic distribution high erosion reaches in Figure 3 shows that the 14 most vulnerable reaches are all tributaries to the river, with many direct tributaries to Belleville Lake. Huron River reaches showed only moderate erosion rates.
