Millers Creek at Huron River Drive

Adopt-a-Stream Site Report, 2011

Overall Condition: **Poor**

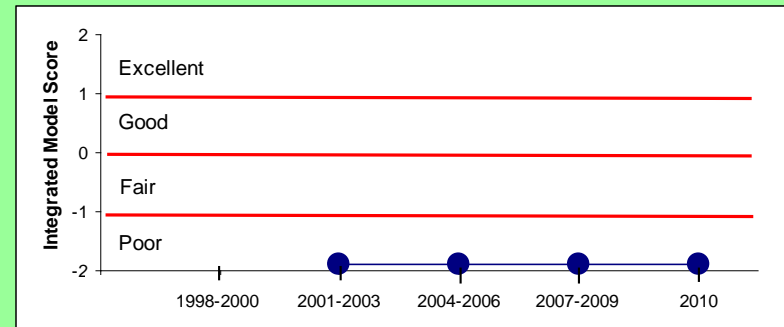
There is very poor diversity of bugs here, even for such a small stream. We typically find only three different families and none of them are sensitive families that require a good quality stream. Stoneflies are very sensitive insects that are only found in clean water. In the winter we have never found the two kinds of "winter stoneflies" that grow only in winter and are dormant the rest of the year. This suggests a pollution problem here since streams that are not polluted should have sensitive families in the winter.

To determine the overall condition rating, HRWC uses an integrative model that compares this site to all of HRWC's other monitoring sites in the Huron watershed. The model uses insect, habitat, temperature, and stream size data.
