# Millers Creek at Hubbard Road

Adopt-a-Stream Site Report, 2012

# Millers Creek at Lakehaven Court

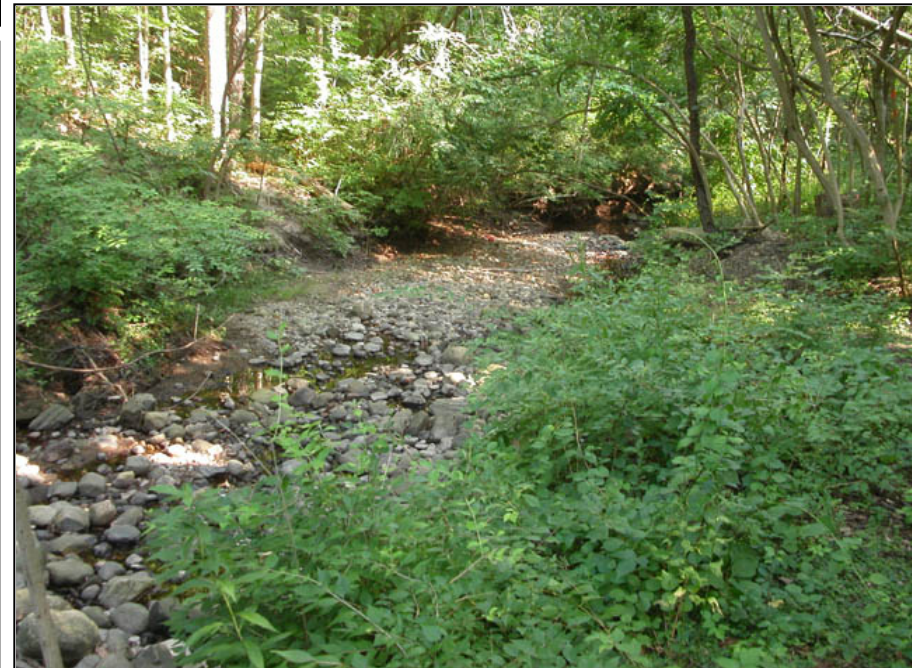
To determine the overall condition rating, HRWC uses an integrative model that compares this site to all of HRWC's other monitoring sites in the Huron watershed. The model uses insect, habitat, temperature, and stream size data.
