# Fleming Creek at Galpin Road

*Adopt-a-Stream Site Report, updated January 2012*

## Overall Condition: **Fair/Good**

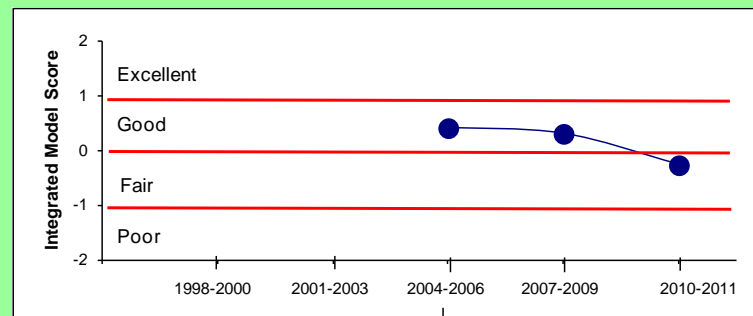
There is good diversity of bugs here but few of the families are sensitive. In the spring we typically find 14 different families and one is a sensitive family that requires a good quality stream. In the fall an average of 16 families are typically found, with no sensitive ones. Stoneflies are very sensitive insects that are only found in clean water. We find the smaller of the two kinds of “winter stoneflies” that grow only in winter and are dormant the rest of the year.
