Huron River Watershed Council

Honey Creekshed Report

Washtenaw County

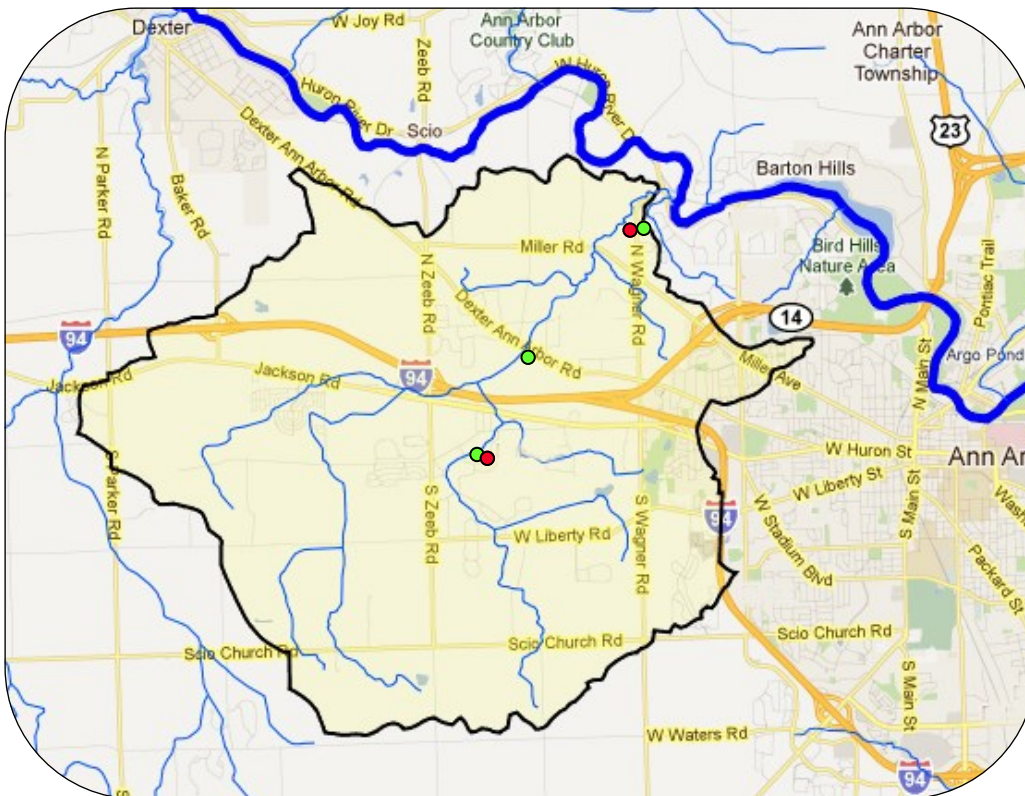
● Monitoring sites for Aquatic Insects, Stream Habitat, and Stream Temperature

● Monitoring site for Stream Flow, Phosphorus, Total Suspended Solids, and E. coli

At the mouth of Honey Creek, the stream habitat is of good quality; large rocks, riffles, and pools are plentiful as it nears the Huron River. However, the middle to upper parts of the creek have unstable and eroding stream banks and the stream bed is full of sand and muck. The study site on Pratt Road (see map on cover, near Dexter Rd) has the worst substrate of all sites we monitor—100% of the streambed is covered by fine sediment.

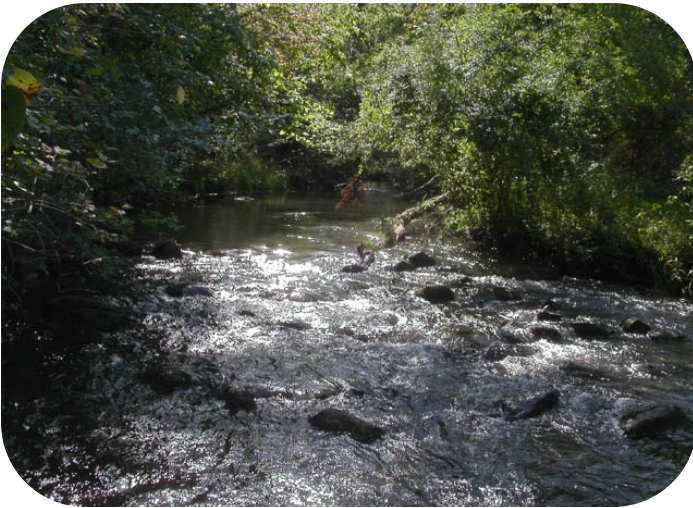
Honey Creek flows swiftly down a rocky path as it nears the Huron River.
Credit: Dick Chase

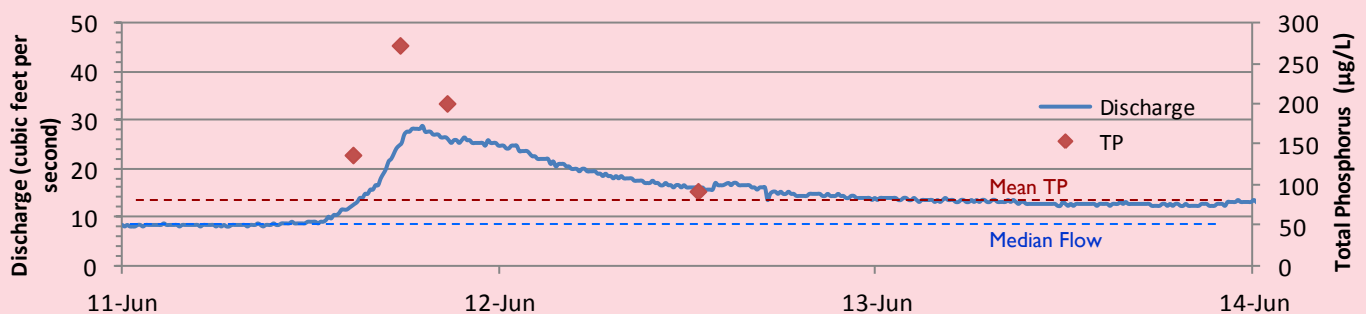
2009 Storm Event Graph

1.5 inches of rain fell on June 11.

Phosphorus is the limiting nutrient in most freshwater systems, and too much phosphorus can cause algal blooms and water quality problems. The target for area streams is < 50 µg/l. Honey Creek's mean total phosphorus (TP) is 69 µg/l, which is elevated, particularly after heavy storms (see below). This is likely due to residential and agricultural runoff.

Stream flow is an important underlying factor for determining likely erosion rates, stream habitat quality, and aquatic community diversity. An important measure is "flashiness" or the rate a stream rises and falls through a storm event (see below). Honey Creek has a flashiness rating that is average for comparable Michigan streams, and more natural than most in the Midwest.

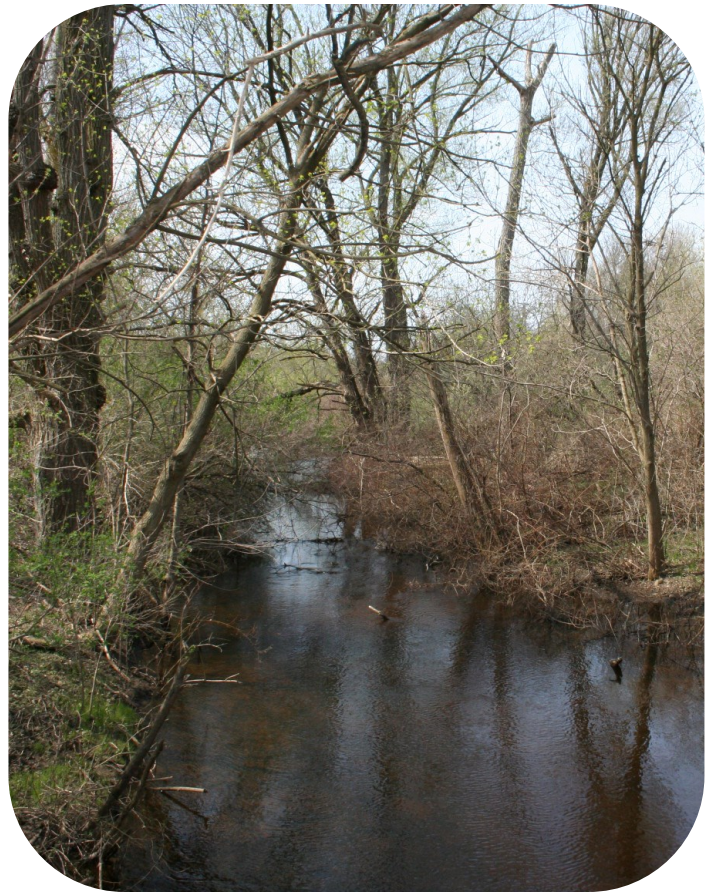
Honey Creek as it flows past Pratt Road. Credit: Chris Benedict
