Fleming Creek at Warren Road

Adopt-a-Stream Site Report, updated January 2012

Overall Condition: **Excellent**

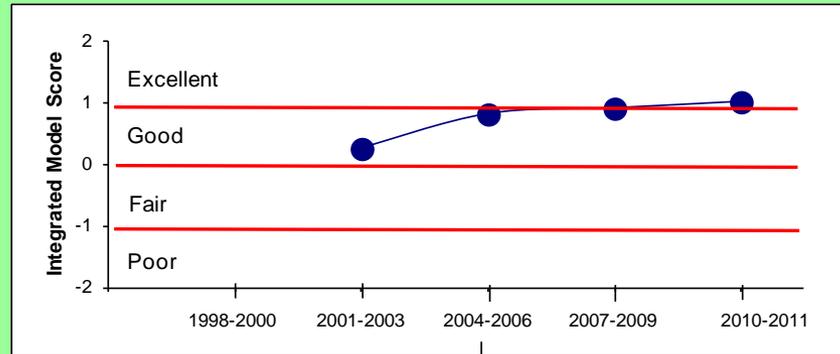
To determine the overall condition rating, HRWC uses an integrative model that compares this site to all of HRWC's other monitoring sites in the Huron watershed. The model uses insect, habitat, temperature, and stream size data.

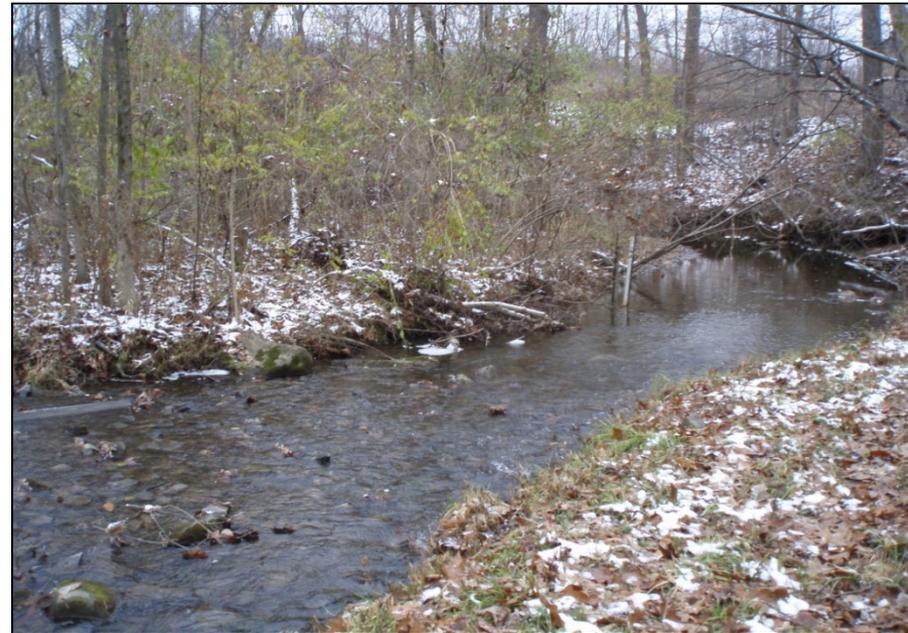
Photo credit: HRWC

This site on the western branch of Fleming Creek is 17 feet wide and shallow (less than a foot), with at least one pool nearly 3 feet deep. In 2008 we found good habitat with sturdy substrate on the bottom, stable banks, and rocks in the riffles free of silt. It has clean water that can warm to 84°F in summer. There is very little urban runoff here, as the land has only 4% impervious surface.
