Mill Creek at Warrior Park

Adopt-a-Stream Site Report, updated January 2012

Overall Condition: *Fair*

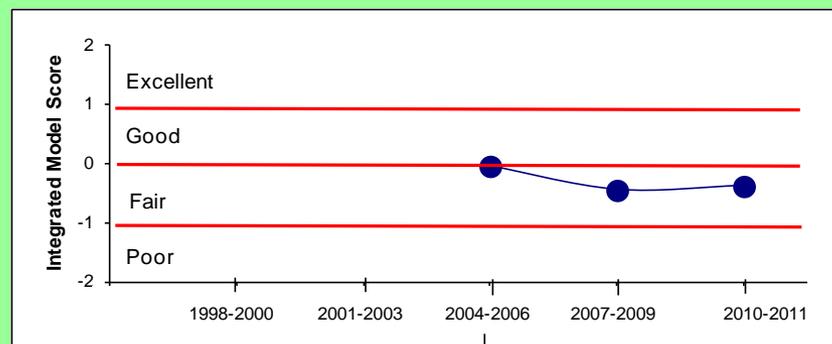
To determine the overall condition rating, HRWC uses an integrative model that compares this site to all of HRWC's other monitoring sites in the Huron watershed. The model uses insect, habitat, temperature, and stream size data.
