Woods Creekshed Report

Creekshed Profile

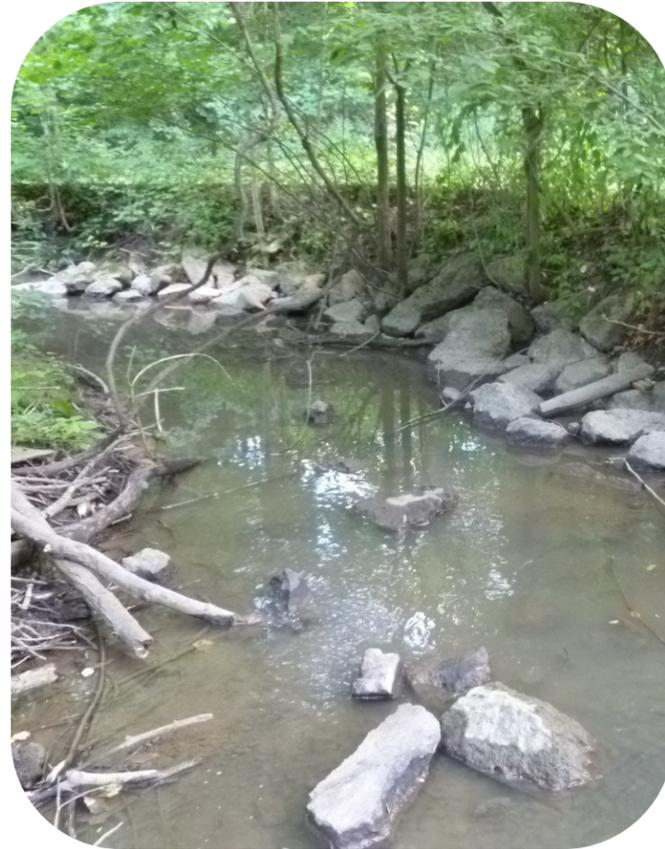
Woods Creek as it flows through the Lower Huron Metropolitan Park. In this section, the banks are heavily fortified against erosion. Credit: David Wilson

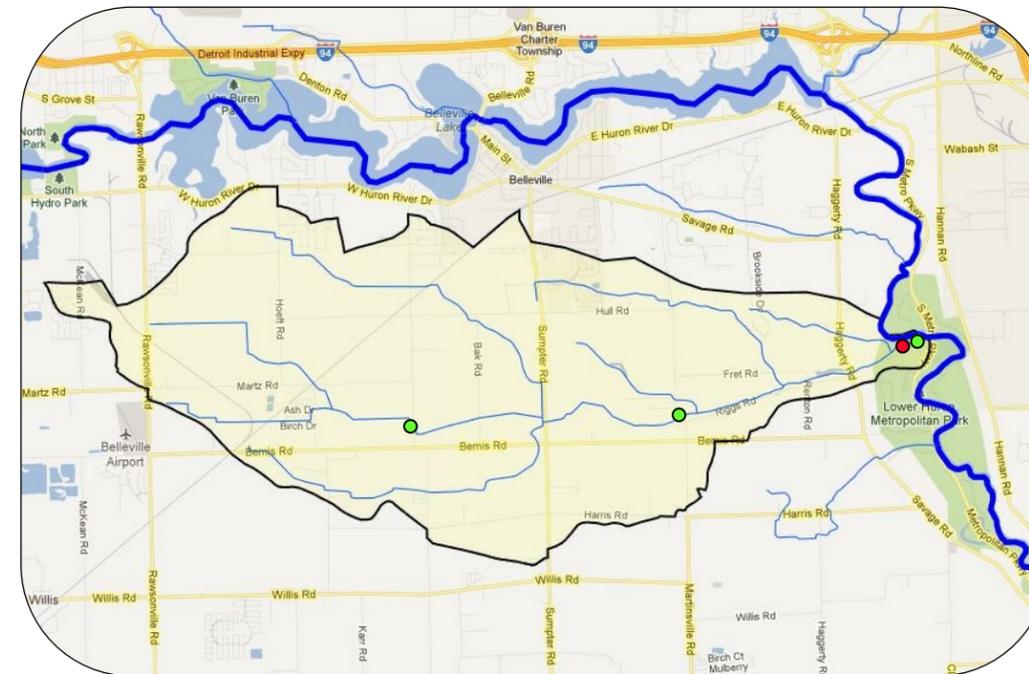
- Monitoring sites for Aquatic Insects, Stream Habitat, and Stream Temperature For more details on these parameters, please see inside.
- Monitoring site for Stream Flow, Phosphorus, Total Suspended Solids, and *E. coli*

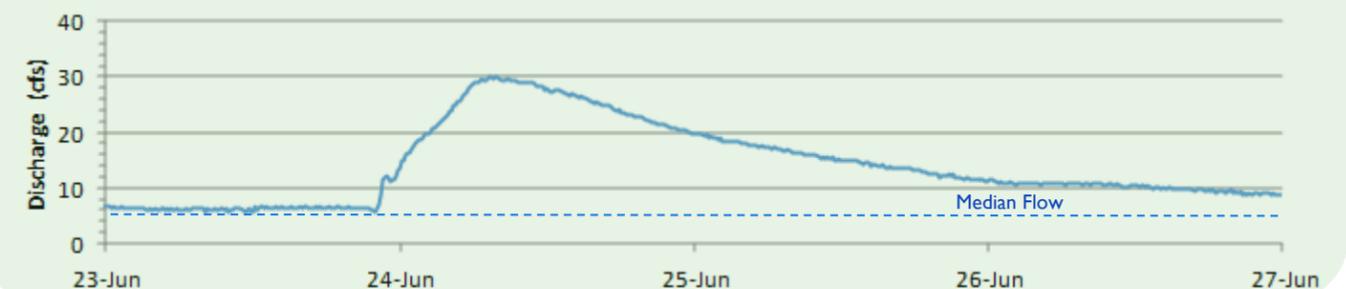
2010 Storm Event Graph

0.93 inches of rain fell June 23-24.

Phosphorus is the limiting nutrient in most freshwater systems, and too much phosphorus can cause algal blooms and water quality problems. The target for area streams is < 50 µg/l. Woods Creek's mean total phosphorus (TP) is 65 µg/l, which is elevated, particularly after heavy storms (see below). This is likely due to residential and agricultural runoff.

Stream flow is an important underlying factor for determining likely erosion rates, stream habitat quality, and aquatic community diversity. An important measure is "flashiness" or the rate a stream rises and falls through a storm event (see below). Woods Creek has a flashiness rating that is average for comparable Michigan streams, and more natural than most in the Midwest and other Wayne County streams.
